## **5.0 Phase 2 - Initial European occupation of the site c. 1800 – c. 1815**

### **5.2 Bakehouse**

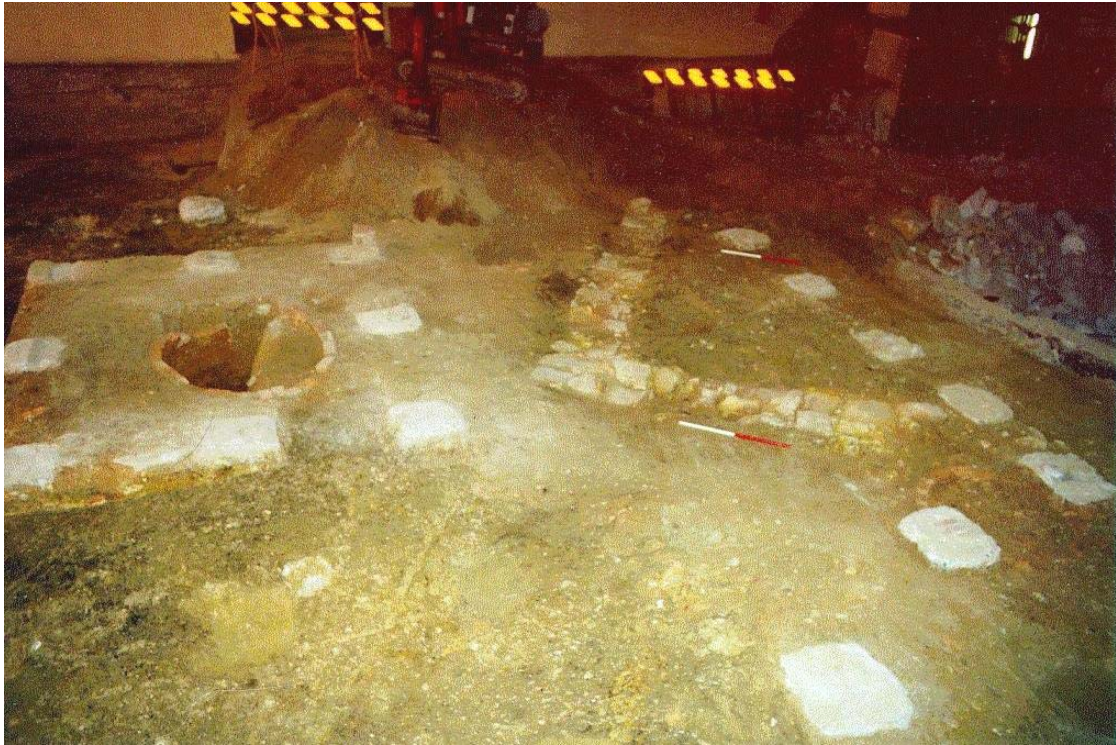
**Photo 5.1:** View to the northeast over eastern room showing the most intact section of bakehouse remains. Scale 1 m. CP 82/28.

The recent work within the Verbrugghen Hall found remains of stone footings (Map 5.1, Plan 10, **Photo 5.1**)<sup>4</sup> which approximately conforms to the location of the bakehouse as shown on an 1832 overlay. These remains consist of the two lines of shallow stone footings with two other lines of less intact wall footings within the original footing trenches. These footings form part of two rooms, the northern corner of the L-shaped bakehouse.

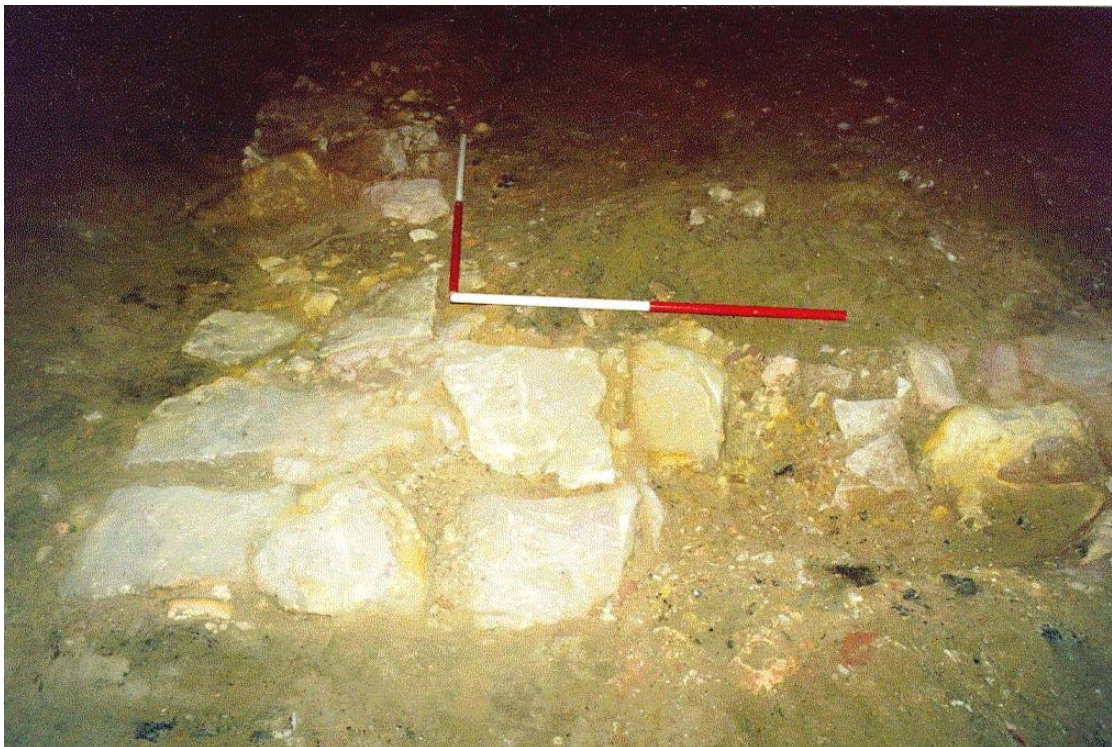
**Photo 5.2:** Looking to the east over the corner of western wall of eastern room of bakehouse showing large rubble stone footings. Scale 1 m. CP 82/34.

The northern wall of the eastern room (#1015) had an interior length of 4.35 m and was 600 to 660 mm wide. Where the footings were intact they included larger pieces of sandstone (**Photo 5.2**). The evidence for the eastern wall mostly consisted of the line of footing trench (#1021) with rubble fill (#1059) from the wall footing which was removed when this area was cut down for the construction of Verbrugghen Hall (**Photo 5.3**). The evidence for the western wall consists of remnant stone footing (#991), the continuation of the trench to the south (#992) and the rubble fill of the trench (#993). The footing trench was 6.5 m long with the extant interior room dimension of 4.74 m.

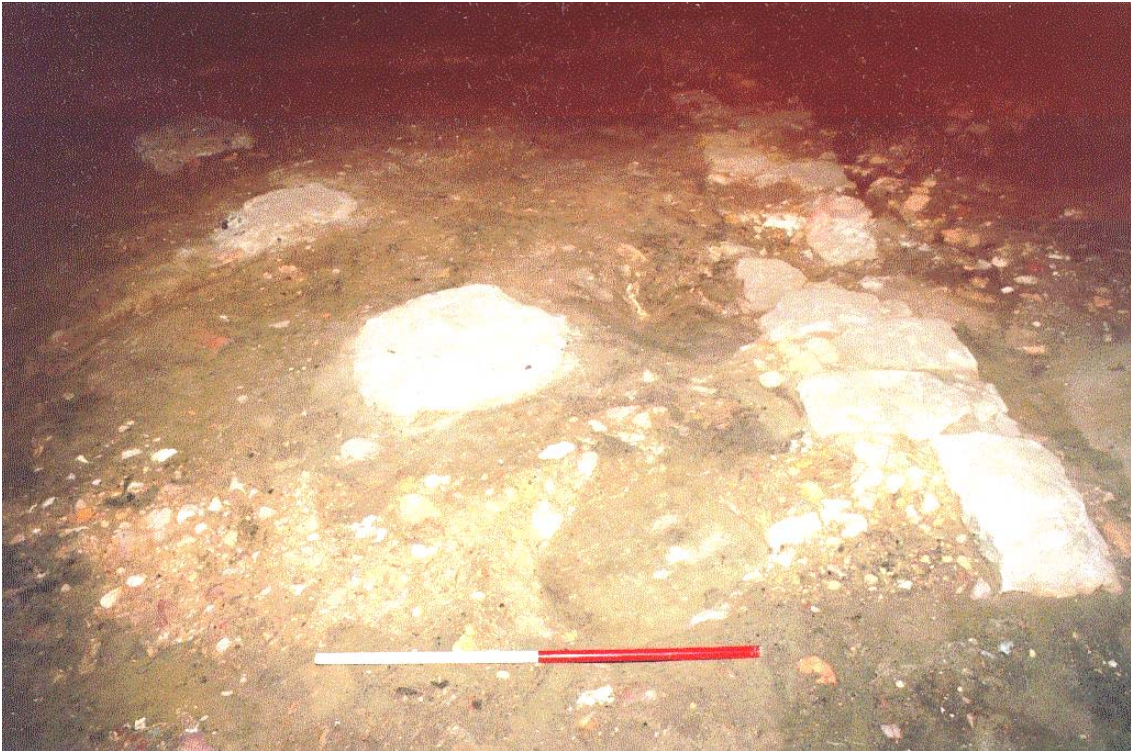
**Photo 5.3:** Northwest corner of Bakehouse showing corner of footings of eastern room, #1021, #1015. Scale 1 m. CP 84/32.

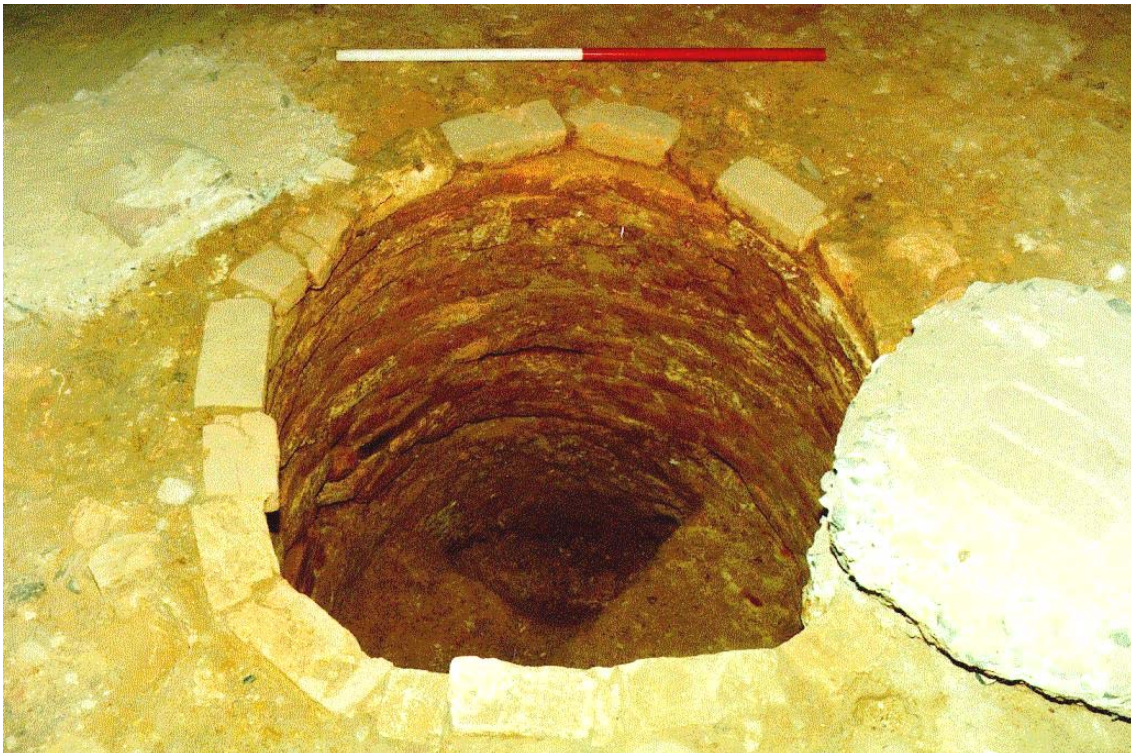
**Photo 5.4:** View to south of small well (#1019) inside the bakehouse footings partially excavated down to top of bedrock. Cement pier base from Verbrugghen Hall footings on right. Scale 1 m. CP 90/13.

Inside the western room of the bakehouse, in the northeast corner, was a small well (#1019) (**Photo 5.4**). This well was 1 m by 1.15 m and therefore was not a true circle. Twelve to 13 courses of the brick superstructure survived. It was built in sandstock brick with a brown clay/mud mortar. Bedrock was encountered at 880 mm on the southeastern side while there was a shelf cut into the rock at a depth of 900 mm on the northwestern side (Section 21). A wooden plank was placed on this shelf in the rock to provide a level for the first course of bricks. There was some evidence to suggest that there was brown clay on the face of some of the bricks, especially on the southern side of the well.

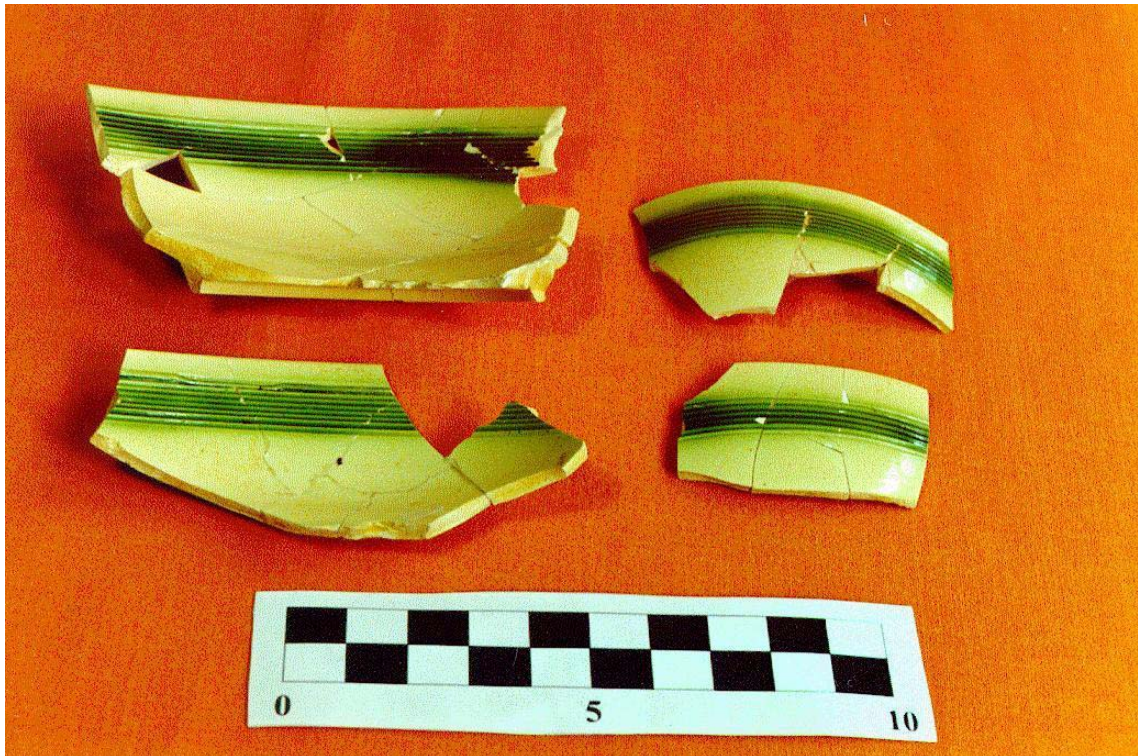
**Photo 5.5:** Annular creamware cup (right) and saucer (left) found in alluvial deposit #1005. Scale 10 cm. Photo 93/24.

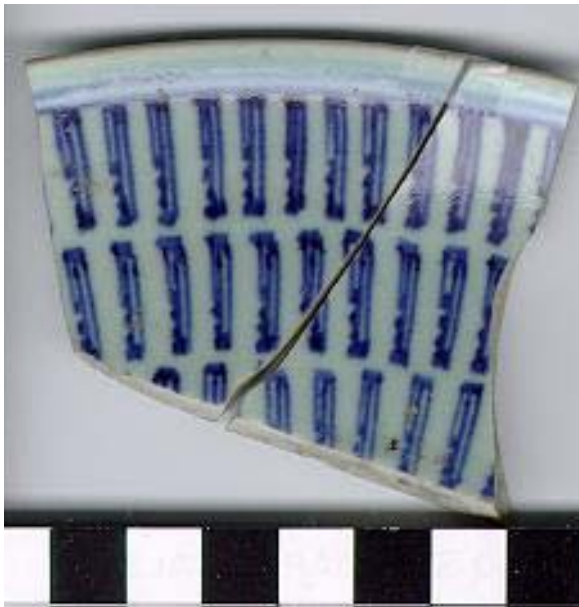
Chinese ceramic 'Patten 21'

with the Sanskrit characters (Pattern 21) which may be an 'om' pattern but could also be from a few other patterns, such as 'praying', or 'long life'.<sup>10</sup>

A comparison of the rim diameters of these vessels with pottery from the *Sydney Cove* shipwreck helps provide some idea of what complete forms may have looked like (Table 1000.21).<sup>11</sup> The rim diameters of the two tea saucers at 140 mm was generally smaller than those found on the *Sydney Cove* where the rim diameter were 156-158 mm. The plate with a diameter of 140 mm, is much smaller than *Sydney Cove* dinner plates which had a diameter of 236 mm. The plate with a diameter of 220 mm was similar in size to *Sydney Cove* plates. The bowl diameters of 180, 200 and 240 mm are in line with the diameters on *Sydney Cove* nested bowls types 1, 2 and 3.<sup>12</sup> They are larger than individual rice bowls and were possibly used in the home of an European person as a serving bowl on a table or as an ornament. None of the identifiable decorations from the Verbrugghen Hall vessels were the same as those from the *Sydney Cove*. The Pattern 21 bowls are similar to ones found in the Rocks, such as at Samson's Cottage.<sup>13</sup> None of the identifiable vessels were rice bowls which would have been used by Chinese people as a normal part of a meal. In 1809, sales of Chinese vessels included China cups and saucers at 2 shillings 6 pence each, which was one-tenth the price paid for salvaged ceramics from the *Sydney Cove* in 1798.<sup>14</sup>

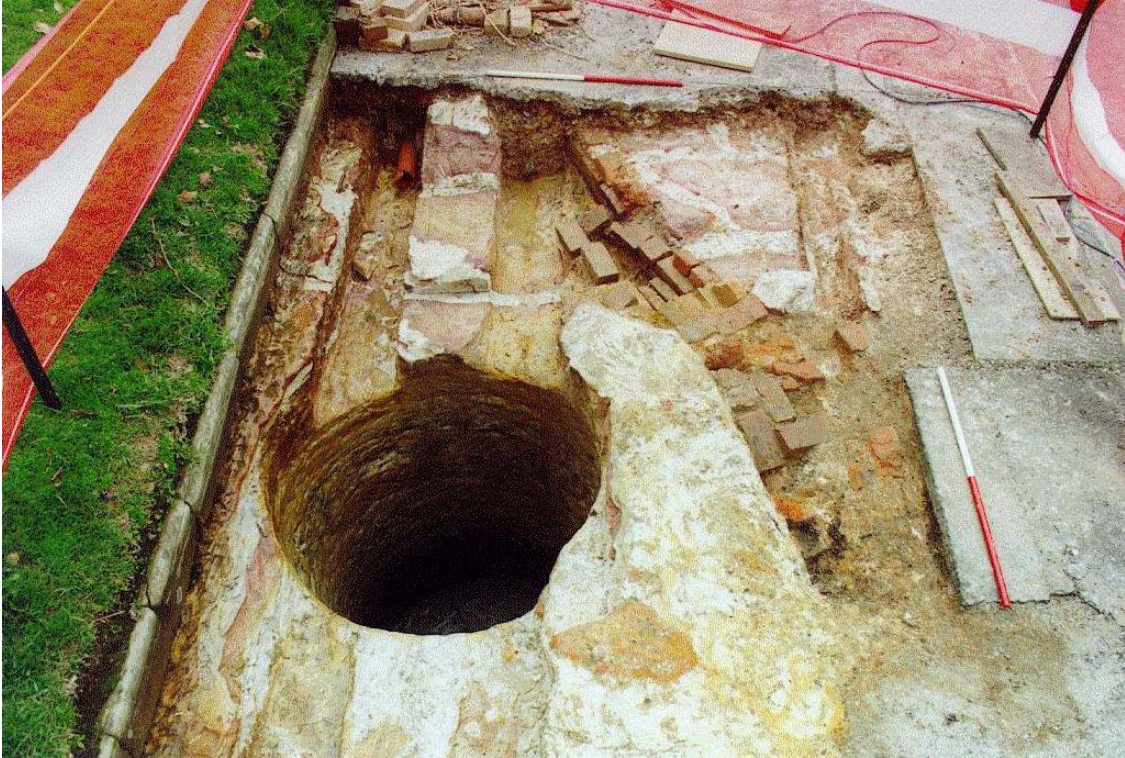
**Photo 5.6:** View to west showing cistern and adjacent section of underground drain. CP 3/30.

The cistern (#654) was a sub-circular hole cut into sandstone bedrock on the southern side of the Stables Forecourt (Plan 2; **Photo 5.6**). The east-west width was 2.3 m and at its deepest point it was 2.5 m (Chapter 8.4). The cut for the cistern was quarried with a small pick with most of the marks cutting downwards from right to left (**Photo 5.7**). The fall of the pick marks suggests that the cutting was done by a right-handed person moving from right to left around the circle of the cistern.<sup>21</sup>

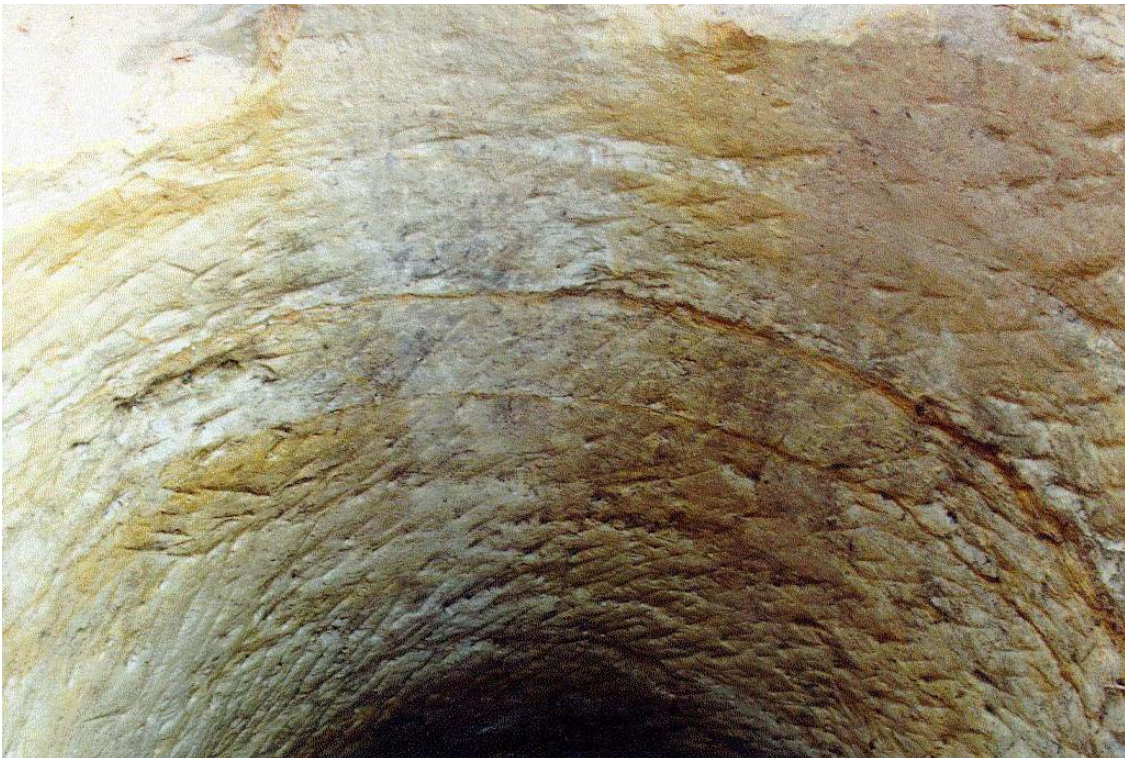
**Photo 5.7:** Eastern face of inside of cistern with pick marks. The marks were mostly made from right to left. CP4/22.
