Archaeological Excavation

Barangaroo South

Preliminary Results

Report to
Lend Lease (Millers Point)

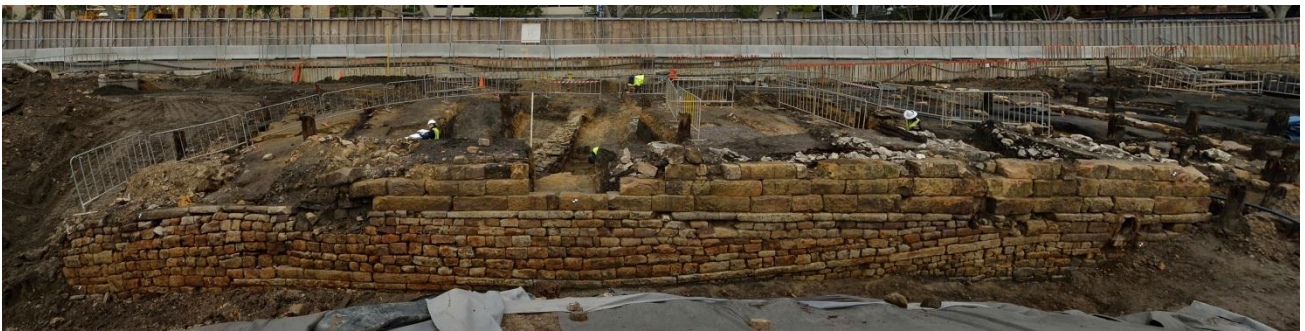
Sanstone seawall constructed in the 1840s. Phil Noller, The Moment It Clicks Pty Ltd

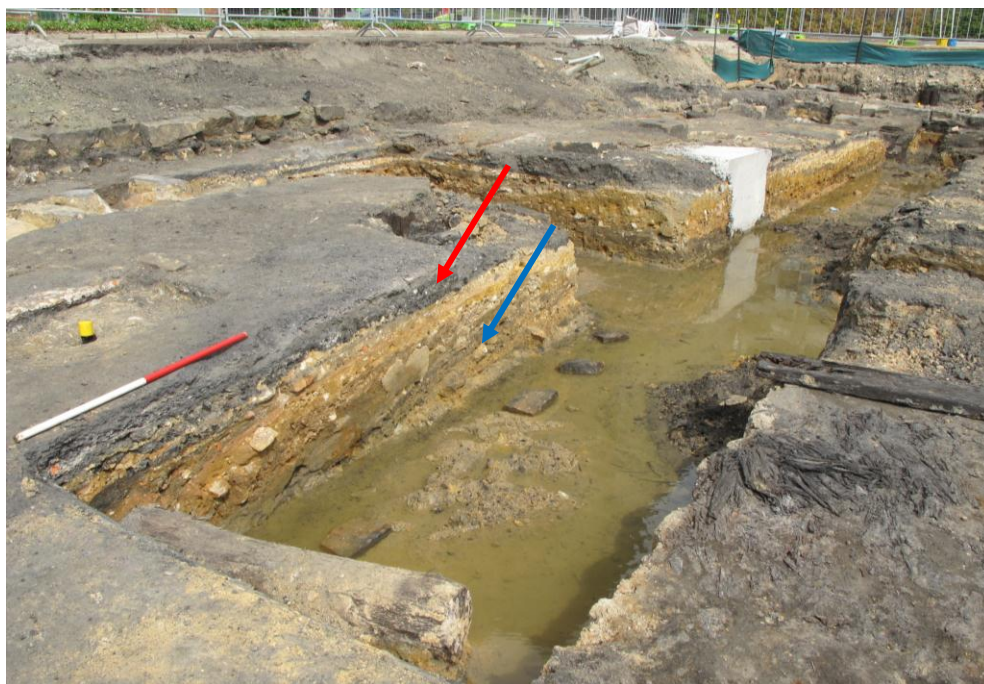
Figure 3.4: The land was reclaimed using bulk fills of clays and sandstone rubble (blue arrow). The ground above this was built up with thinner bands of levelling fills, surfaces and accumulations (red arrow). The water in the trench represents the high tide level at c.0.5RL. Scale 1m. Looking southeast.

Girard reclaimed a large parcel of land during the 1830s. The reclaimed land jutted out into the harbour from the natural shoreline. It was a roughly rectangular piece of land aligned with the northern boundary of lot 20. An 1834 plan showed that with the exception of a small area in the south, the land was not wharfed or substantially walled against the tide. On this plan a loosely drawn line represented the high water mark. It probably described land sloping into the harbour (Figure 3.3). The reclamation consisted of bulk fills of sandstone rubble followed by clay-rich fills to raise the new ground above the high water mark (Figure 3.4).

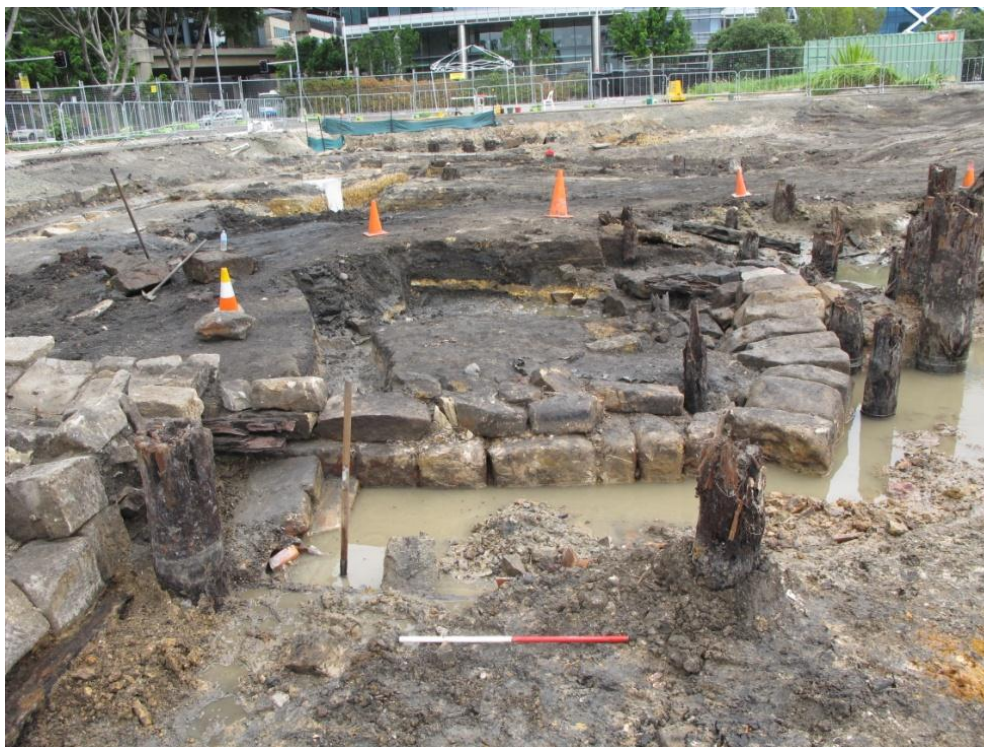
Figure 3.5: The second phase of reclamation extended slightly to the north. It was retained by a sandstone seawall. The water in the photo is the high tide mark. Scale 1m and looking south.

At the northwest corner of the reclaimed parcel of land were the remains of a sandstone retaining wall (Figure 3.5). The remains of the wall were not present along the entire northern limit of the reclaimed land. Timber piles were found along the western and northern edges and may have functioned as part of the retaining of the reclamation fills, or parts of the wall may have been robbed as reclamation progressed. Along the western edge was the remains of what was probably a small jetty associated with this early phase. It did not appear on any historic plans but it would have probably been necessary to access deeper water beyond the sloping fills. There was significant slumping and sloping of the fills into the harbour to the west and north.

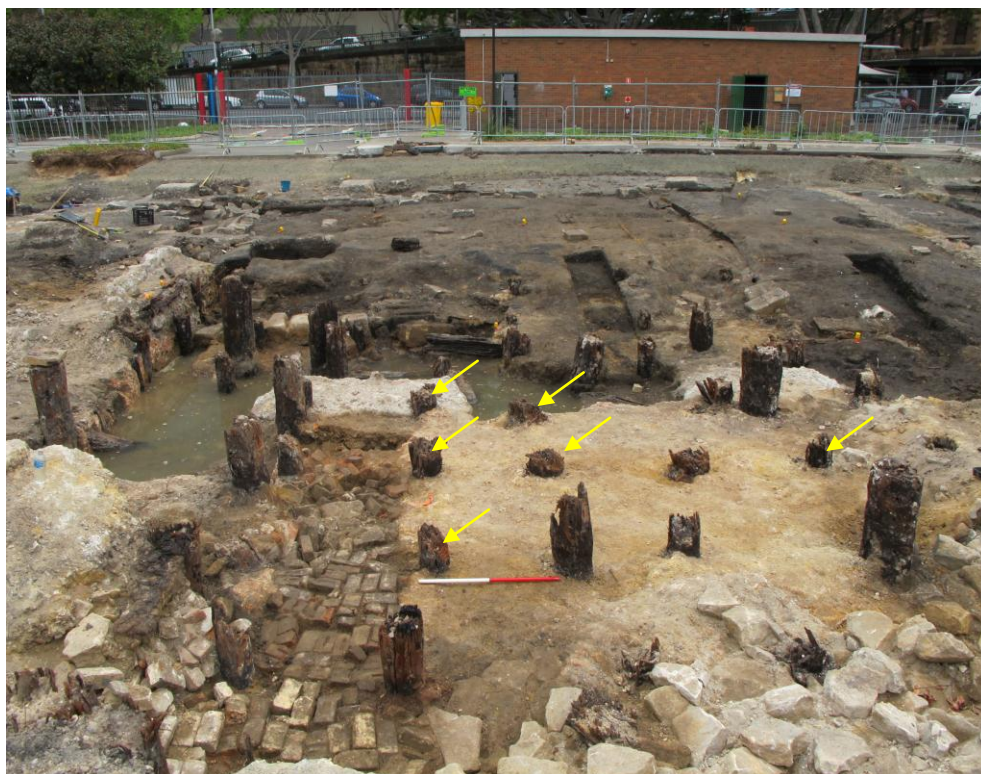
Figure 3.6: Remains of two sets of timber piles that would have supported two phases of timber wharf attached to the reclaimed land. The smaller piles (several are indicated with yellow arrows) are from the first phase (likely up to c.1870s) and the larger ones from a second phase of wharf and were probably associated with the raising of the ground level c.1880. Scale 1m and looking east.

A series of piles that did not share characteristics with any others were found close to the northwest corner of the reclaimed land (Figure 3.6). They were small in diameter and closely set. It is likely that they belonged to Girard's wharf. When Breillat and the H.R.S.N.Co. began using the land, the wharfage was improved and included the construction of two long jetties. The surface of the landform was built up with several fills and temporary working surfaces developed during construction.

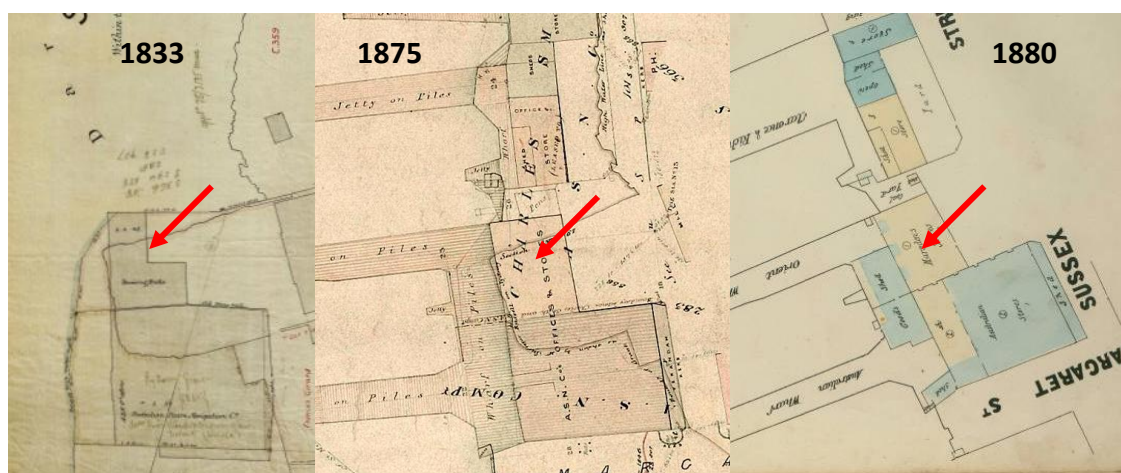
Figure 3.7: The 'Receiving Shed' (arrowed) added to the 1833 plan (left), had changed to a rectangular building by 1875 (middle plan) and recorded as 'Marsden Stores' on the 1880 plan (right). 1833 and 1880 plans, City of Sydney Archives Online; 1875 plan, AO 4775 SRNSW.

During the 1850s or early 1860s, a receiving shed was built on the edge of the wharf (Figure 3.7). There was some evidence found for the upright supports of this structure. The remains of the first phase of the shed consisted of postholes, timber base plates, and sandstone pier bases (Figure 3.8). To the east of the shed was a yard surface constructed from sandstone sets (Figure 3.9). The shed was later extended to partially encompass the yard area.

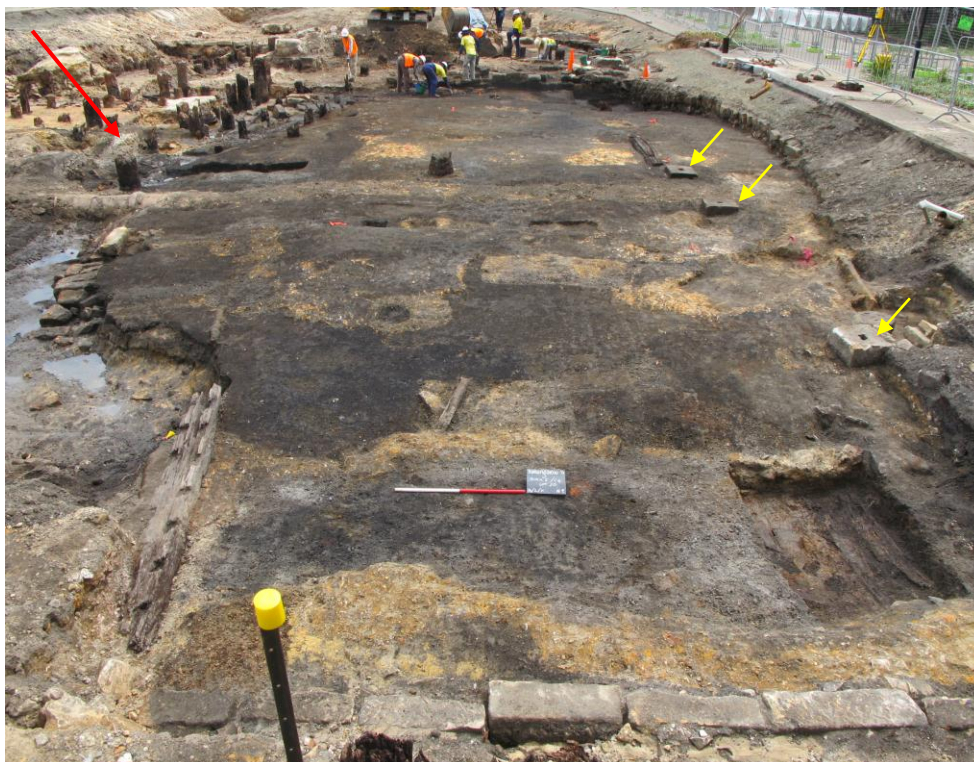
Figure 3.8: The sandstone wall in the foreground, the sandstone pads (yellow arrows) and several postholes formed the surviving remains of the 'Receiving Shed'. Scale 1m and looking north.

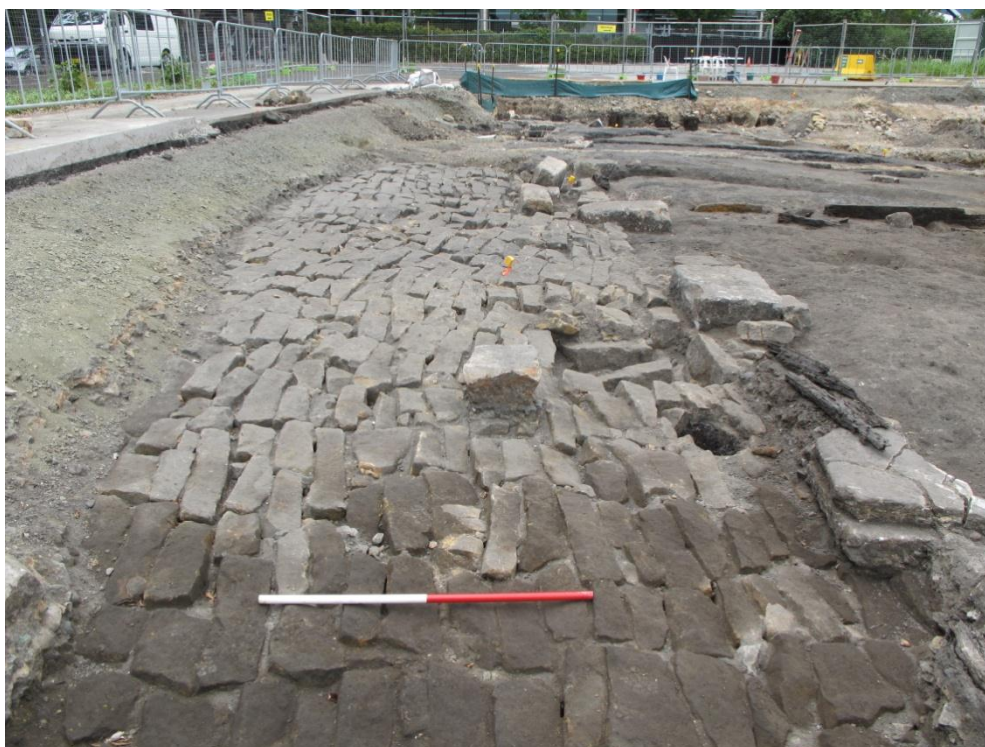
Figure 3.9: Sandstone sets associated with the yard area of the early version of the 'Receiving Shed' prior to reconfiguration after 1865. The sandstone pads on the right are part of the later level raising and resurfacing. Scale 1m and looking south.

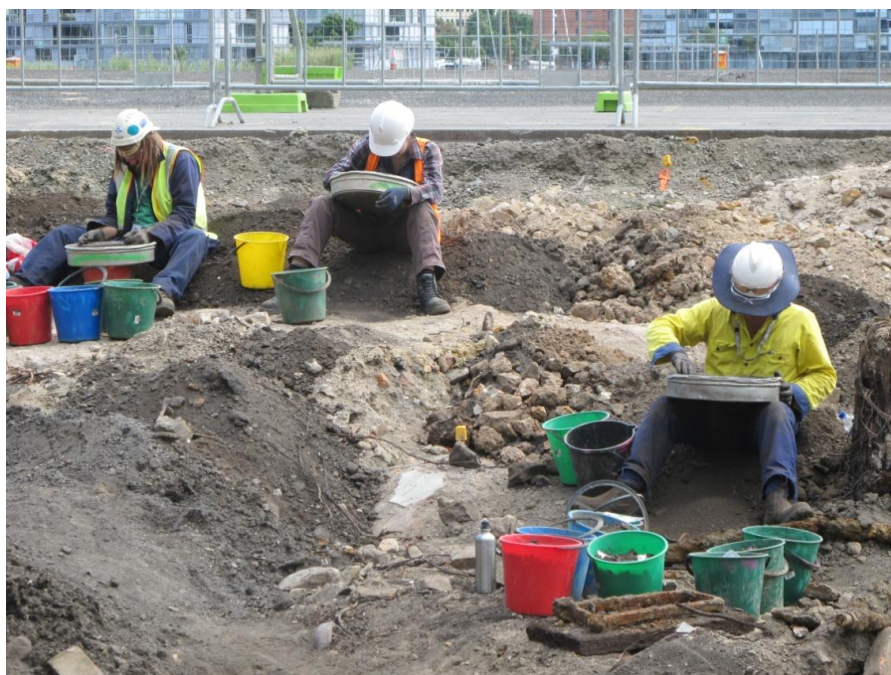
Figure 3.10: Sieving and artefact collection from the occupation deposit that accumulated below the last floor surface of the 'Receiving Shed', named 'Marsden Stores' on the 1880 plan.

During the mid to late 19th century an accumulation of underfloor material built up beneath the timber floor of the shed. This deposit contained a number of artefacts associated with the use of the shed, such as oyster shell and butchered animal bone (probably sheep) and nails. Occasional buttons and coins were also found. This material was sample sieved to demonstrate the range of artefacts and inclusions associated with this wharfage (Figure 3.10). At the end of the 19th century, the wharf areas were resumed and the cavities beneath were filled in and the wharves were upgraded. Sheet piling and bulk fills were associated with this late phase.

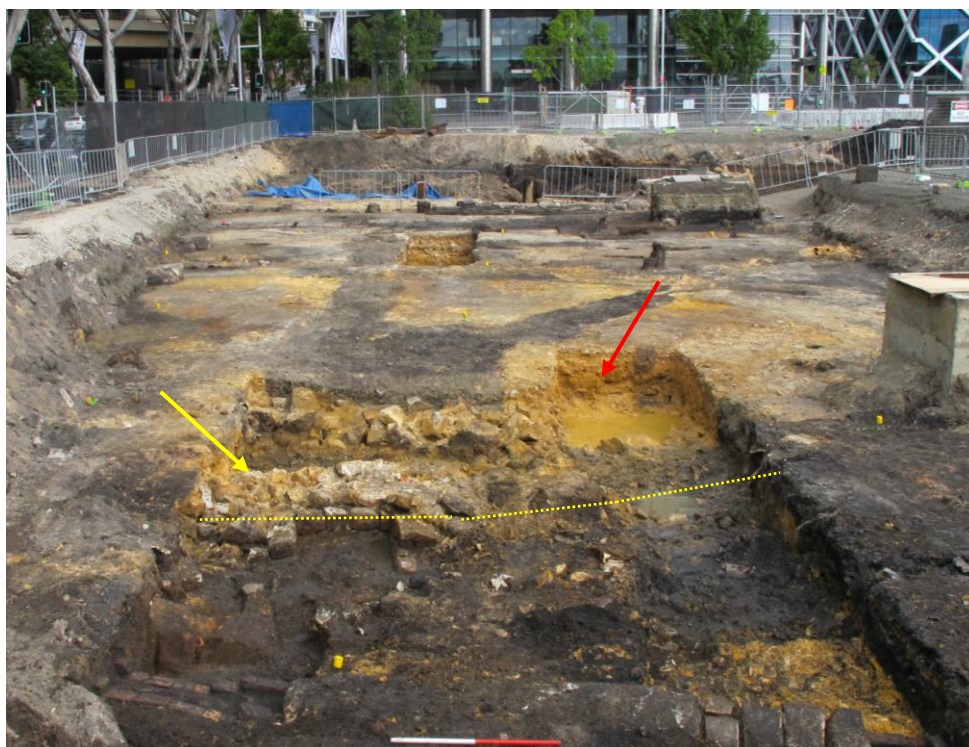
Figure 3.11: The yellow crushed sandstone deposits (red arrow) that formed the early reclaimed land. These abutted a sandstone rubble breakwater along the northern edge (yellow arrow and dashed yellow line). Photo taken looking south with a 1m scale.

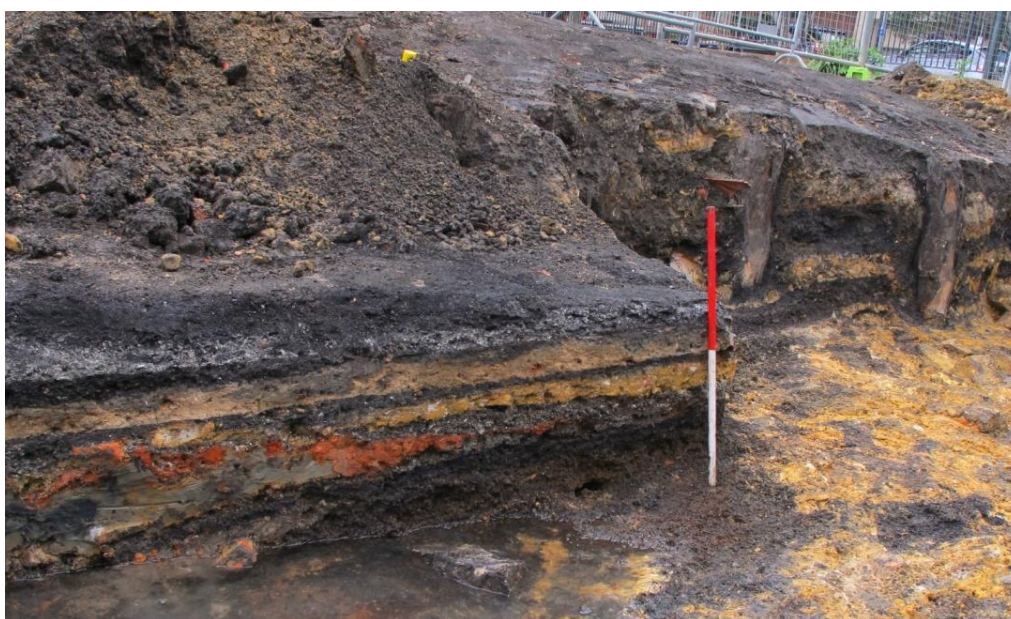
Figure 3.12: Bulk fills of the second phase of reclamation differed from the first phase as they also consisted of layers of industrial waste and clays. The water in the foreground is tidal water from the harbour. Photo is taken looking northeast with a 1m scale.

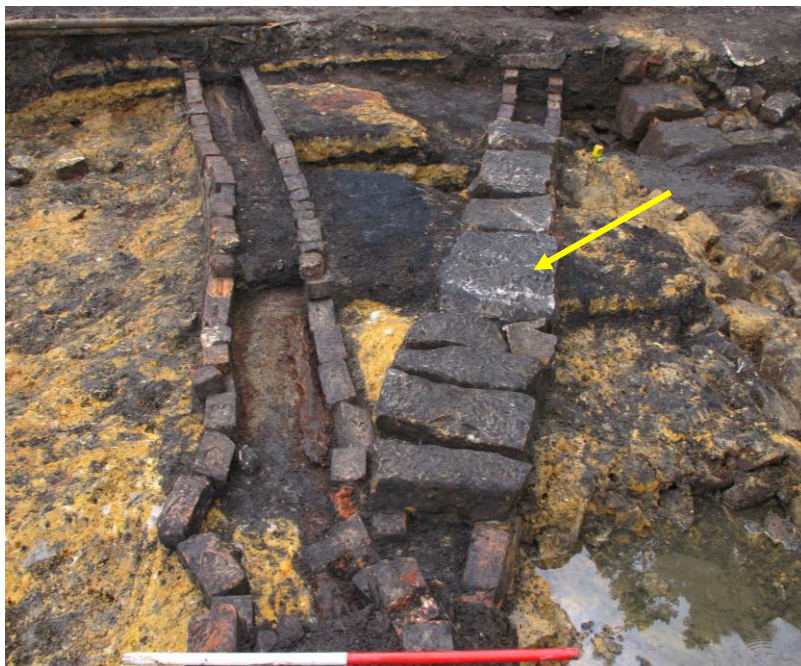
Figure 3.13: Remains of the stone-capped brick drain (yellow arrow) constructed during the second phase of reclamation to channel stormwater into the harbour. This was truncated by a later drain (to the left). Photo taken looking east with a 1m scale.

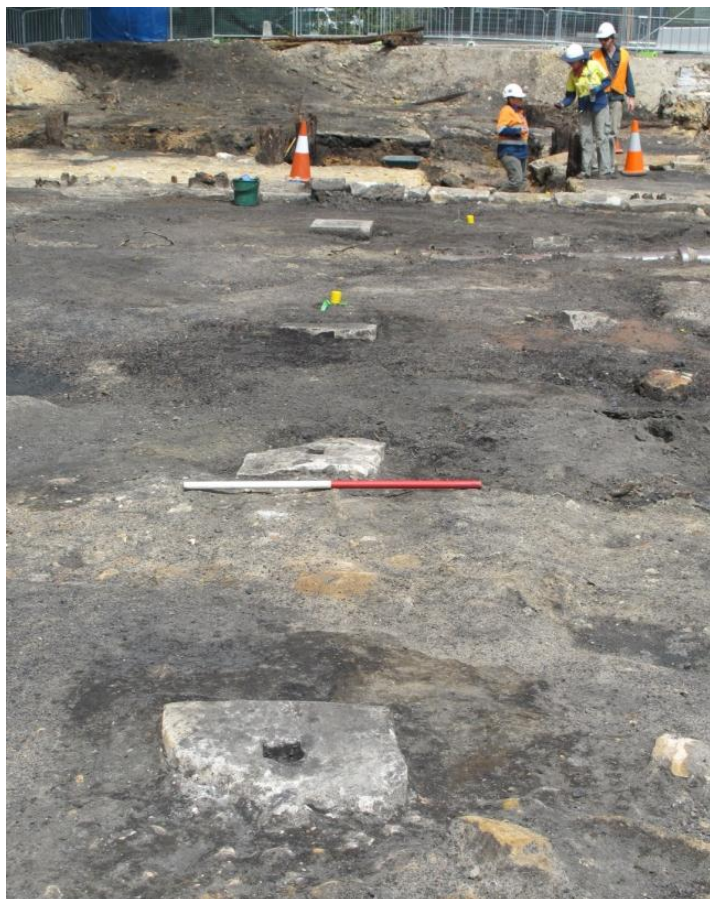
Figure 3.14: Alignment of sandstone pads associated with a mid to late 19th-century building, depicted as 'Marsden Stores' on the 1880 plan. Photo taken looking south with 1m scale.

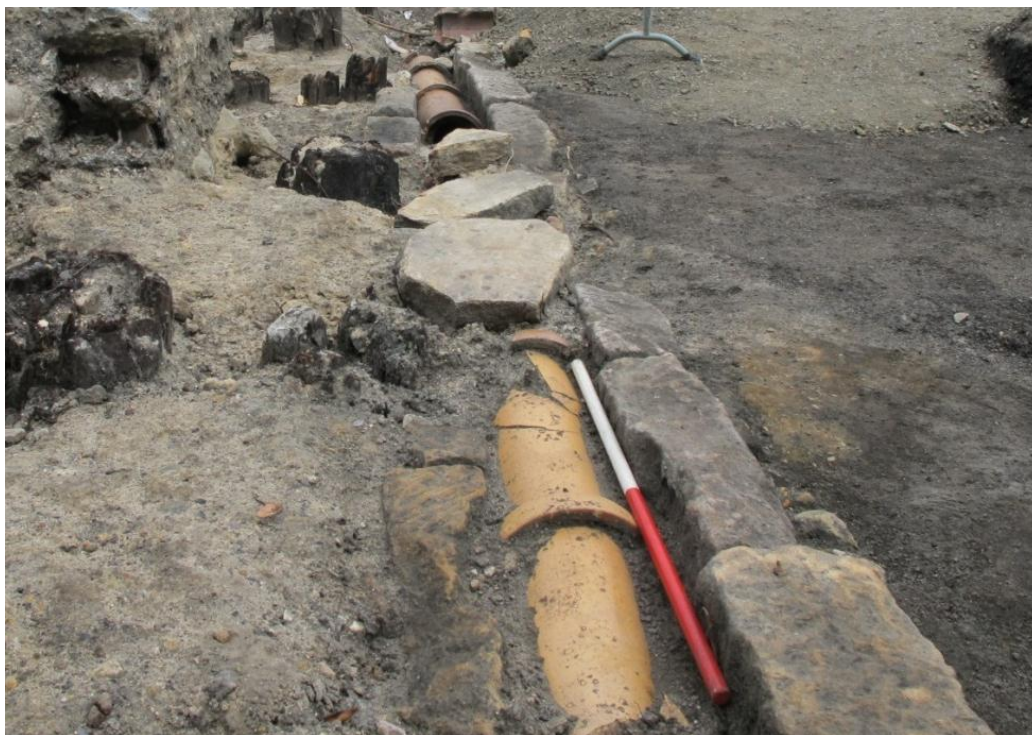
Figure 3.15: A mid nineteenth-century sandstone drain was later modified by the installation of ceramic stormwater pipes. Photo taken looking west towards the harbour with 1m scale.

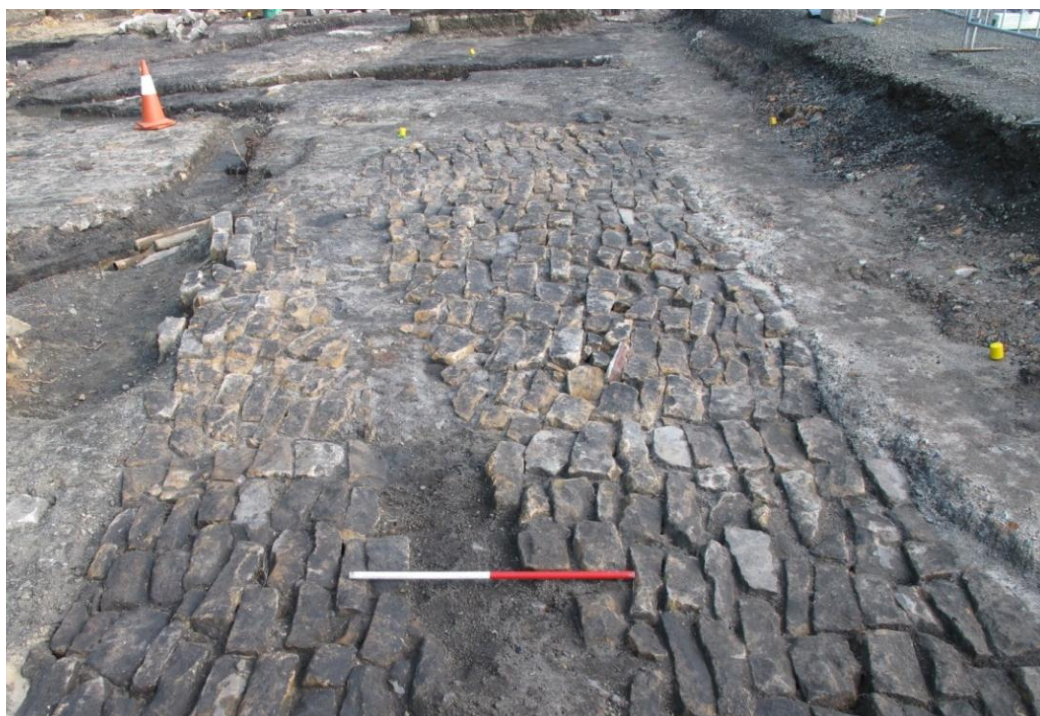
Figure 3.16: Sandstone sets formed part of the later nineteenth-century yard surface within Trench J. Photo taken looking south with a 1m scale.

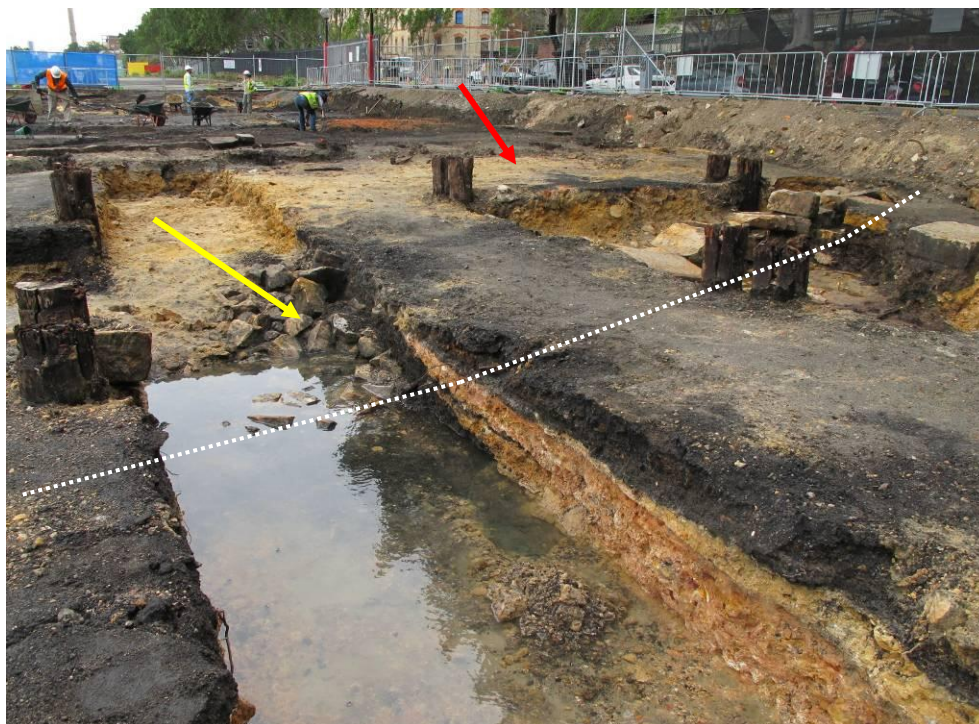
Figure 3.17: The southern edge of the early 1830s reclaimed landform (white dashed line) was within Area A. The surface of the reclaimed land (red arrow) was about 700mm above high tide level. The edge of the land was formed by sandstone rubble (yellow arrow). Photo taken looking northeast.

The western half of the reclaimed landform was within the development site. The remainder located below present day Hickson Road. The 1834 plan indicates that the northeast and southeast edges of the reclamation were formalised with walling. Archaeological remains of sandstone walling were found in the very eastern limit of Area A, corresponding to the depictions on the historic plans.

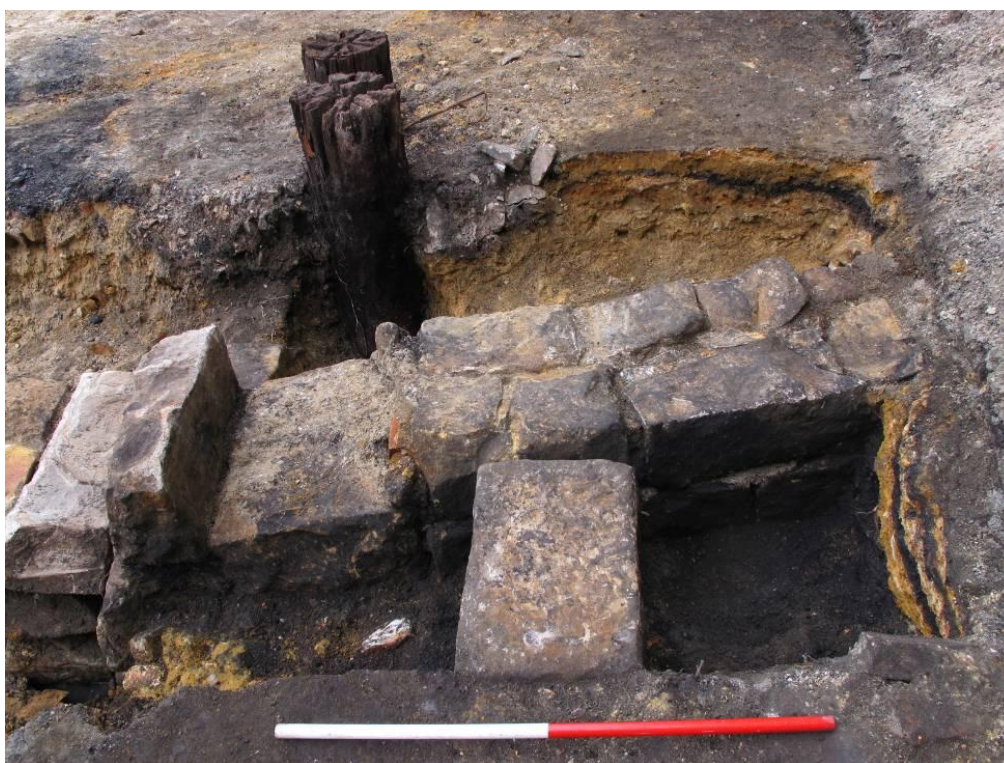
Figure 3.18: Formal sandstone walling forming the southeast edge of the 1830s reclaimed land. Scale 1m. Photo taken looking north.

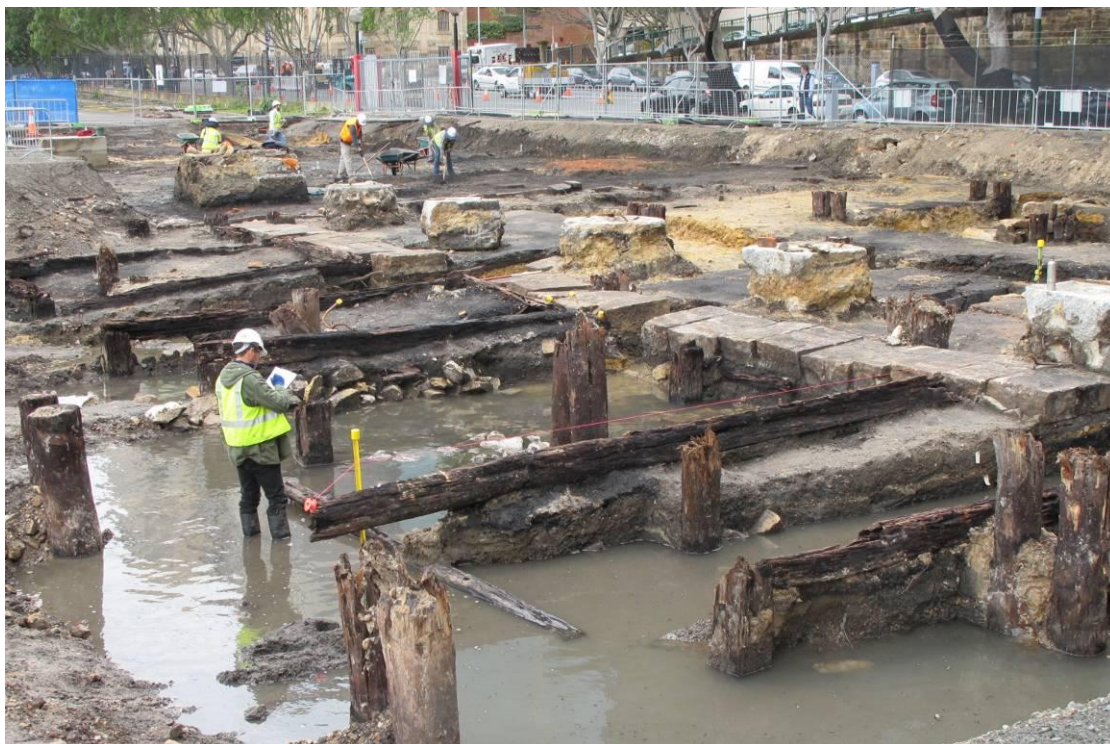
Figure 3.19: Remains of the mid 19th-century timber wharf in Area A being recorded by archaeologist Mike Hincks at high tide. Photo taken looking northeast towards Hickson Road.

Evidence of an early timber wharf and possible slipway was found in Area A. This was insubstantial and probably represented a temporary structure that served the landform while the more substantial wharf was being built. By 1851 there was a large wharf and long jetty and a three-sided shed at the wharf's edge. The timbers of the wharf and the footings of the shed were partially preserved (Figure 3.19). Surviving evidence of the shed consisted of lines of sandstone pads to support a timber superstructure (Figure 3.20). It was built on the first and second phases of reclamation. Later sandstone pads to support a floor indicate internal modification to the shed. A substantial sandstone wall formed the footings for the western or harbour frontage of this building (Figure 3.21). This building operated as a store for the Australasian Steam Navigation Co. throughout the mid to later 19th century, receiving goods transported to Darling Harbour.

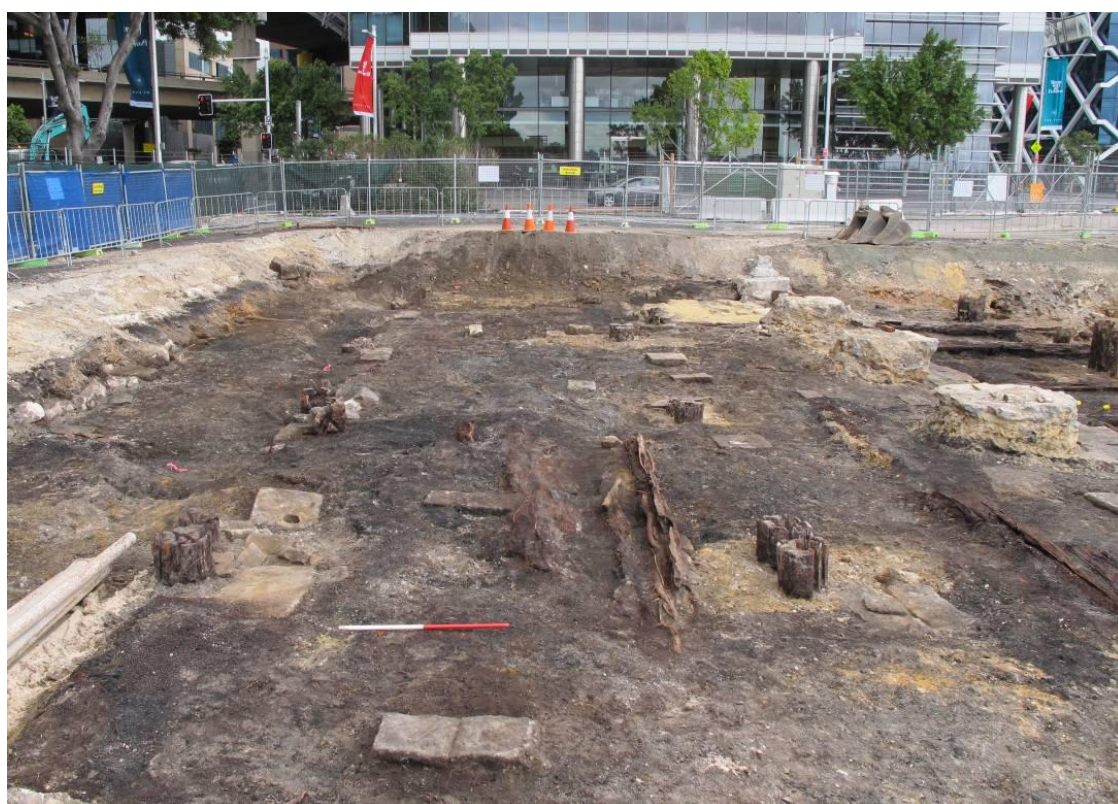
Figure 3.20: Line of sandstone pads that once supported the timber superstructure is all that survived of the large shed-like store building depicted on historic plans from the mid 19th century. Scale 1m and looking south.

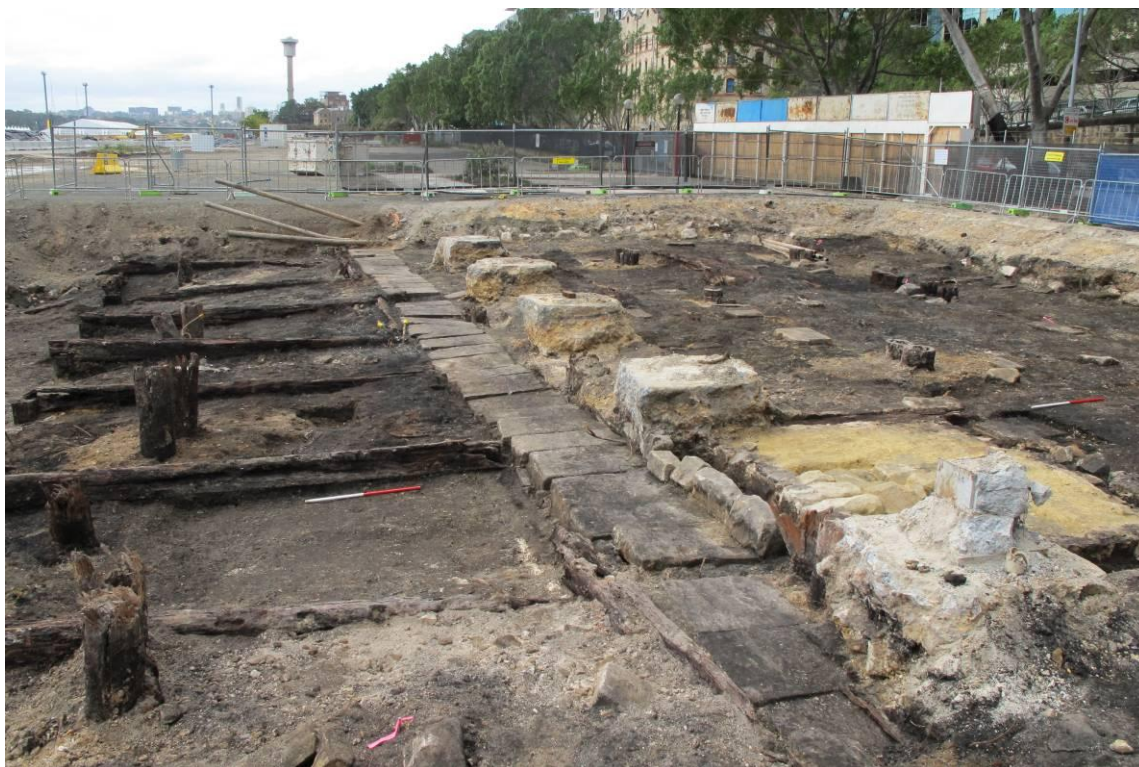
Figure 3.21: The large sandstone wall forming the footings for the large store also formed the boundary between building on reclaimed land (right) and timber wharf in the harbour (left). Scale 1m and looking north.

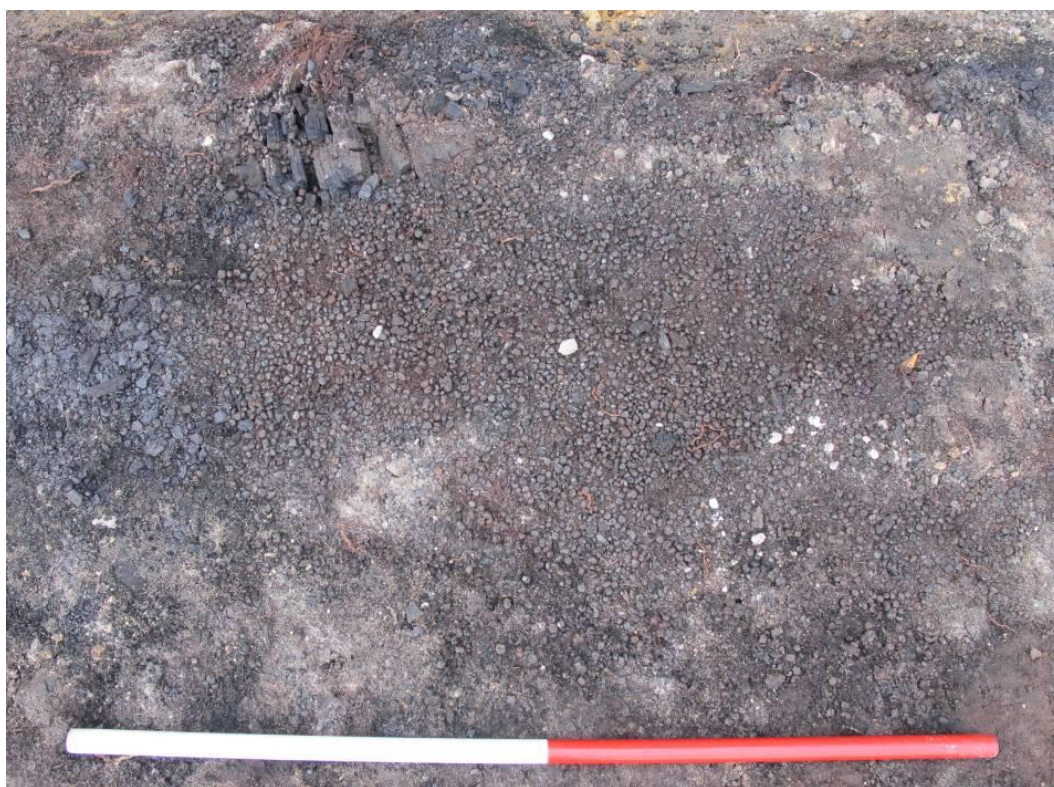
Figure 3.22: Detail of charred grains and corn resulting from a fire within the store. Scale 1m

In the later 19th century, this structure and the goods within it burnt down, leaving an extensive layer of burnt material, charcoal and charred grains covering the area (Figure 3.22). *In situ* burning of the timber wharf was also noted. This event led to the levelling of the site and the re-establishing of the store building. The new store building was constructed on the levelling fills and the superstructure was supported by double timber piles. This fire and rebuild was likely to have occurred before the resumptions in 1900. During the 20th-century there was consolidation and rebuilding of these premises.

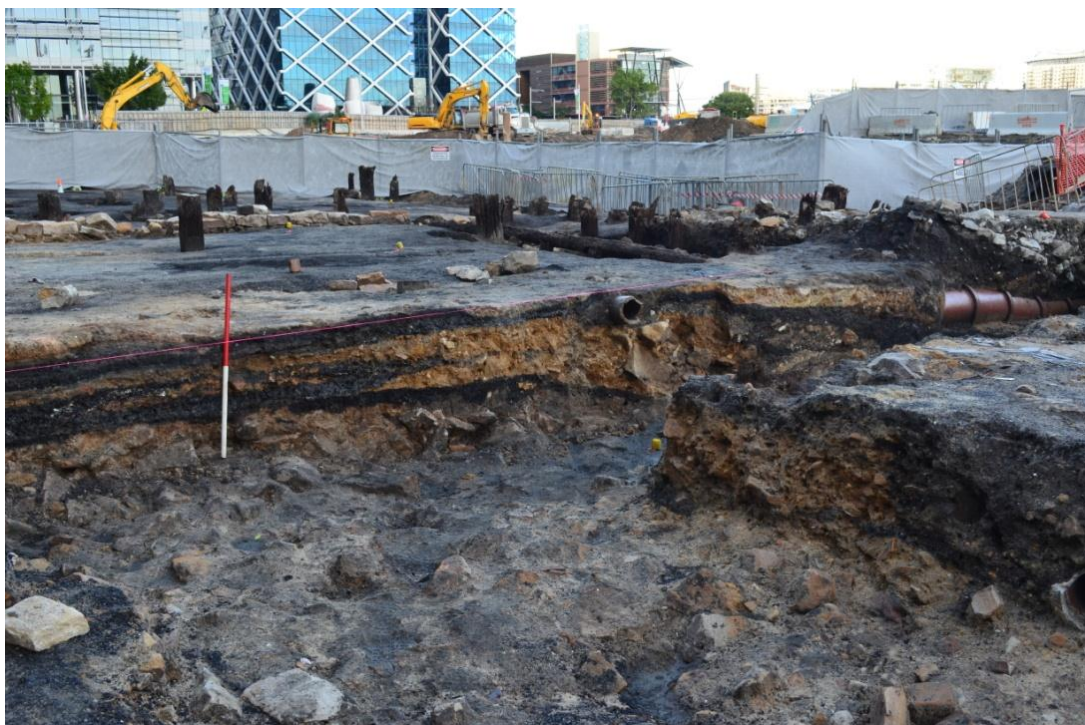
Figure 3.24: Test trench through the reclaimed landform showing bulk rubble sandstone fill followed by thinner bands of compacted fills. Photo taken looking southwest with 1m scale.

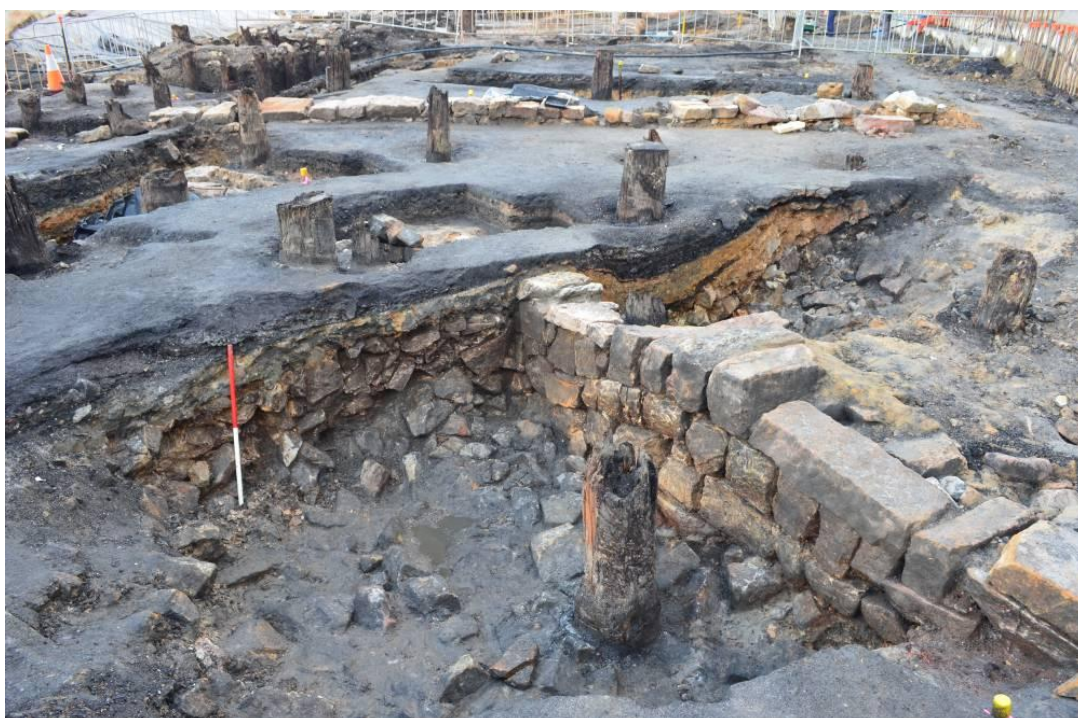
Figure 3.25: Roughly built sandstone wall that acted as a retaining structure during the reclamation process. It was built on rubble reclamation fill and the fills either side of the wall are different. Photo taken looking northwest with 1m scale.

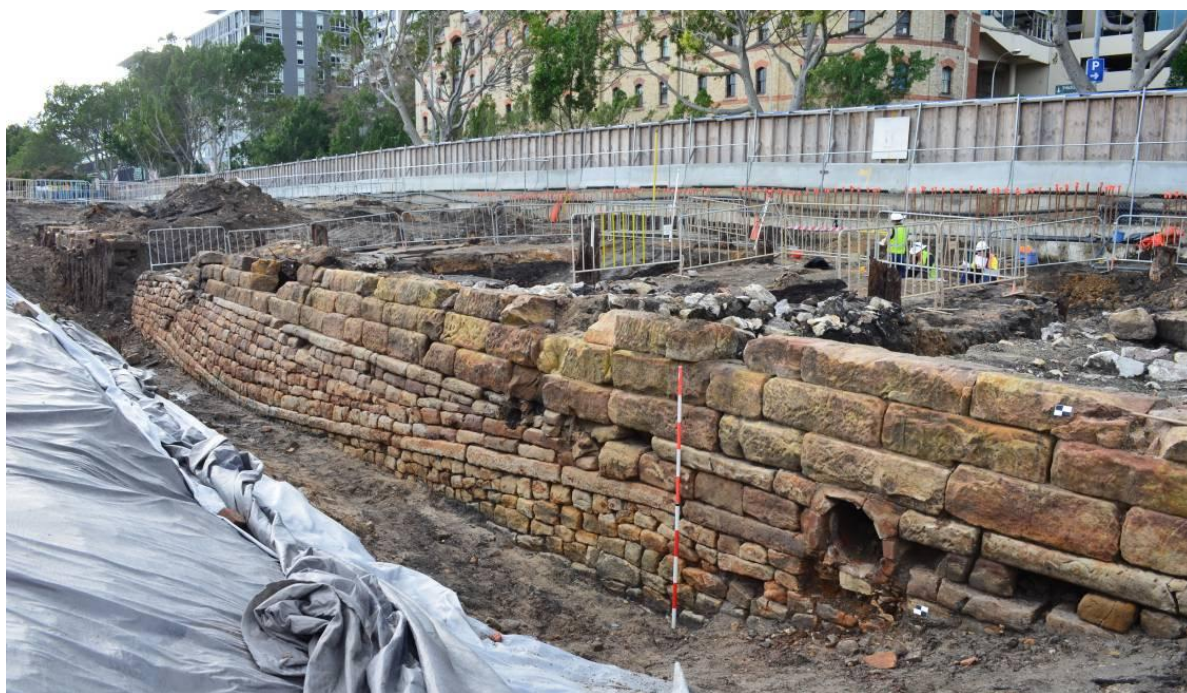
Figure 3.26: A substantial sandstone seawall dating from the 1840s retained the reclaimed land and provided berth for boats. The lower courses were constructed from below the low water mark using small and elongated blocks. The upper three courses using larger sandstone blocks were added in the 1860s. The base of the wall was at least 500mm below the base depicted in this photo. Photo taken looking northeast with 2m scale.

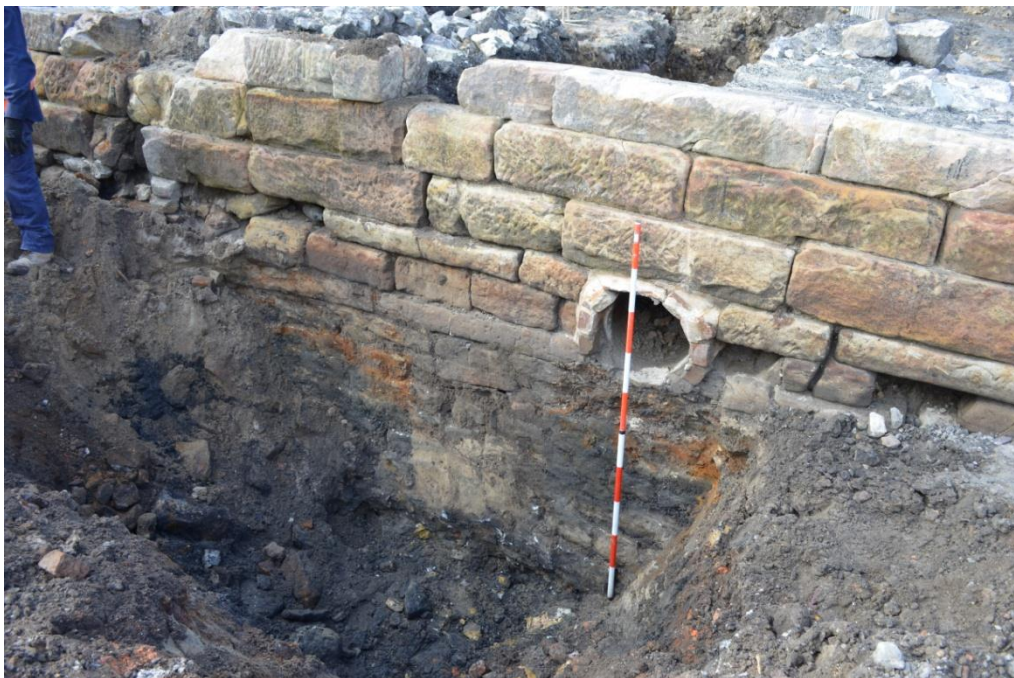
Figure 3.27: At the southern end of the seawall a machine trench was excavated to the base located at - 1.2m AHD, or 700mm below the low tide level. Note the upper three courses are a later addition. Scale 2m.

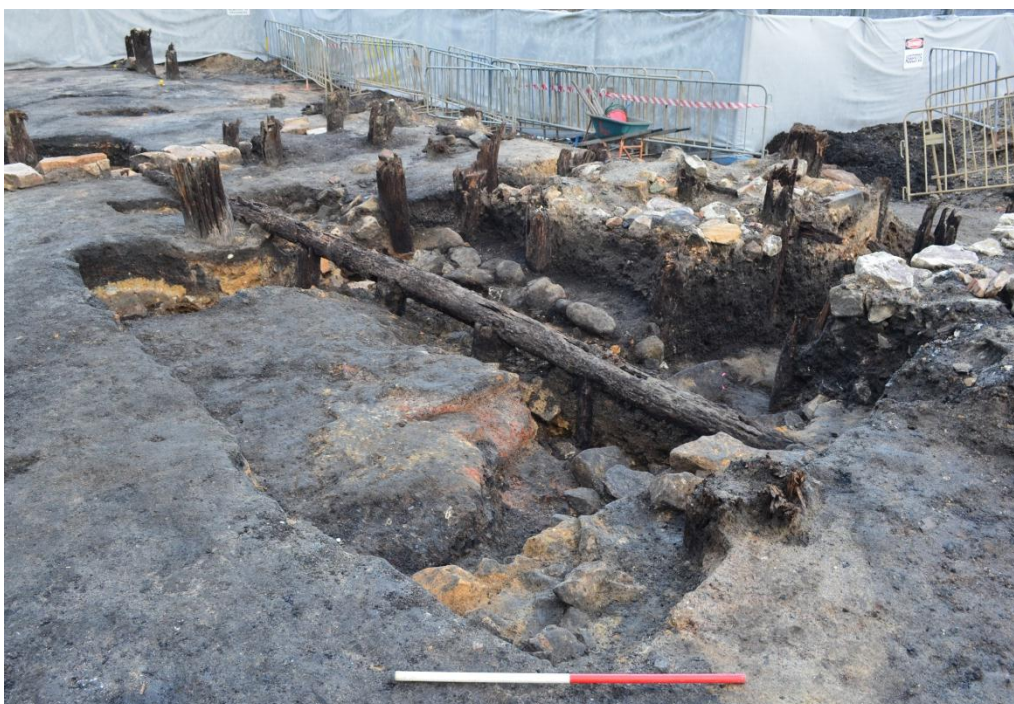
Figure 3.28: Remains of the c.1840s jetty included piles and one horizontal element. The pile in the background are part of later modifications to the jetty when the surface level and seawall was raised. Photo taken looking southwest with 1m scale.

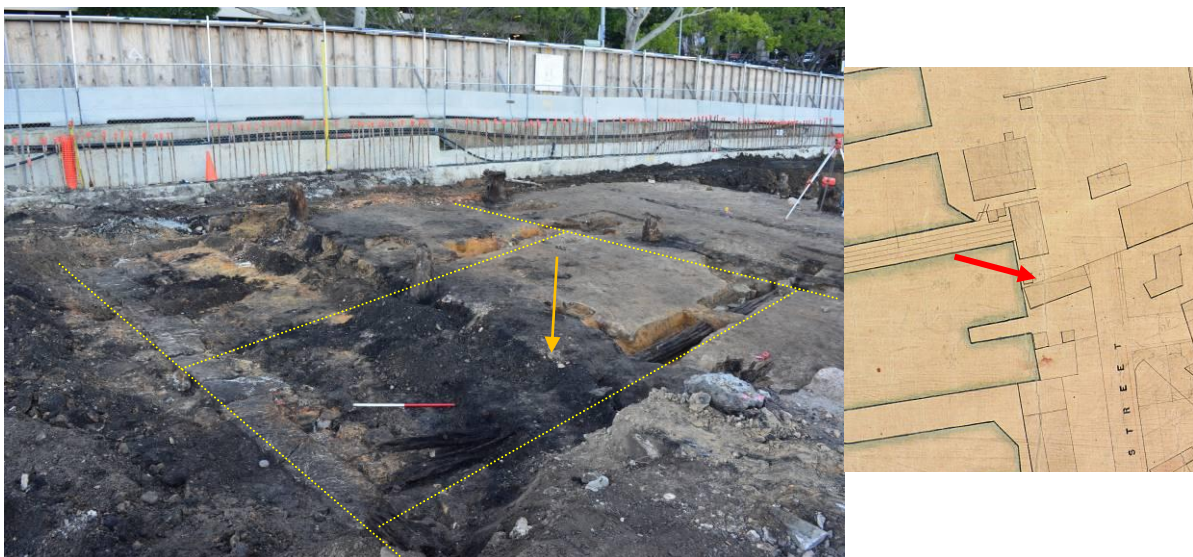
Figure 3.29: Remains of a building recorded on the 1865 plan (map and red arrow on right) were located at the northern end of Trench K and L. The remains consisted of sandstone and timber footings (dashed yellow lines) and postholes. The *in situ* deposit of slag (orange arrow) suggests this was a blacksmith's workshop. Photo taken looking southeast with 1m scale.

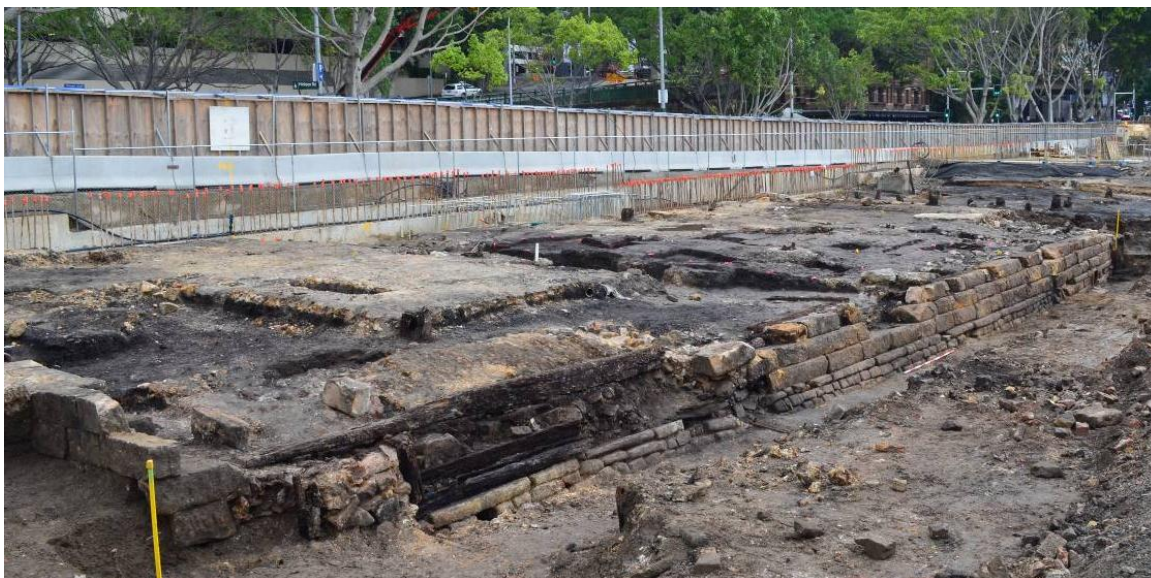
Figure 3.30: View of Area K following ground level raises dating to the 1860s or 1870s (blackened surface level) and an additional three courses of seawall. Photo taken looking southeast. 2m scale.
