Archaeological Excavation

Barangaroo South

Preliminary Results

Report to
Lend Lease (Millers Point)

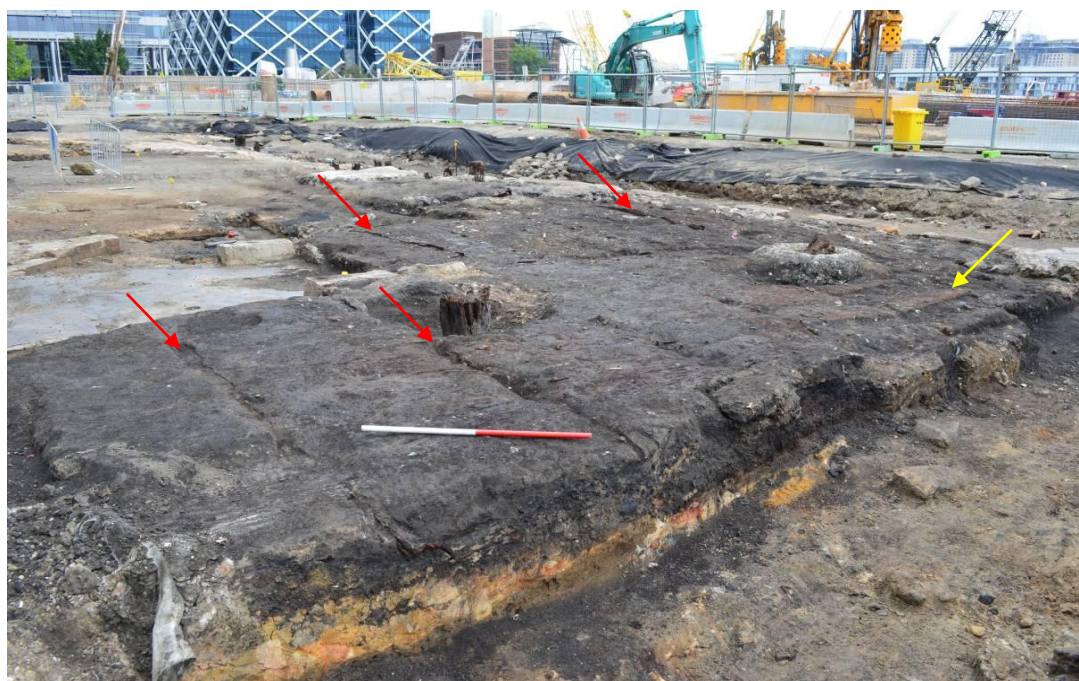
Figure 3.31: Remains of flooring and underfloor deposit within a large store building on the edge of the wharf in Trench L. The red arrows indicate some of the surviving joists and the yellow arrow the floorboards. Scale is 1m and the photo is taken looking southwest.

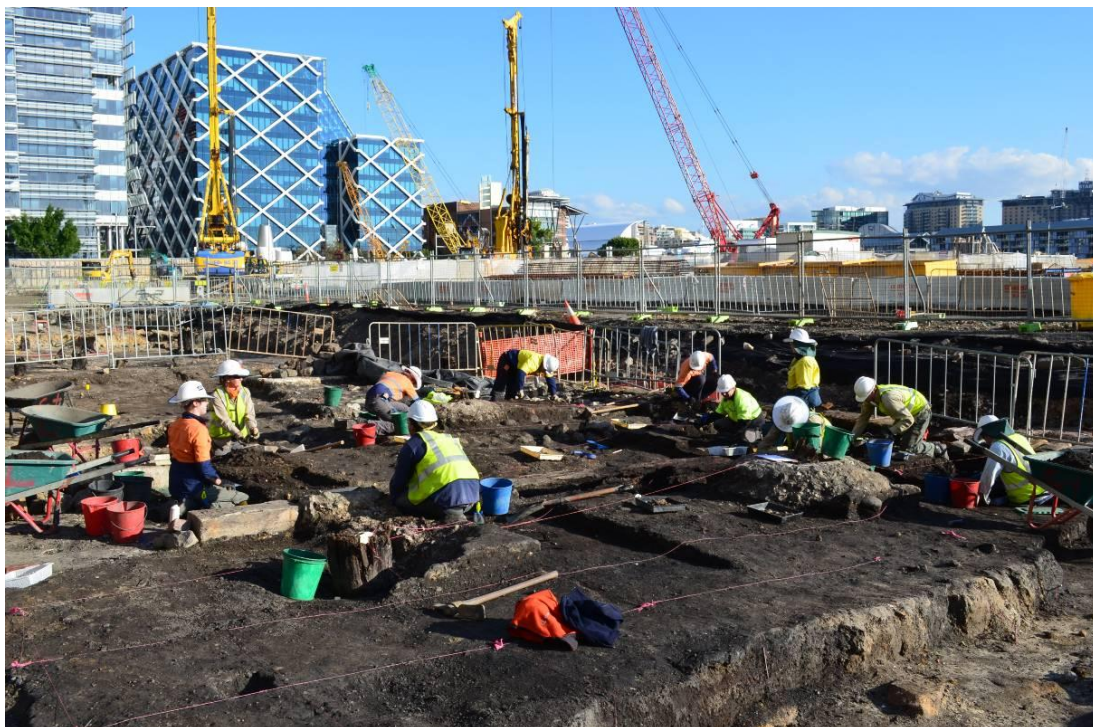
Figure 3.32: The underfloor deposit during excavation within a 1m grid system, outlined with pink string. Photo taken looking southwest.

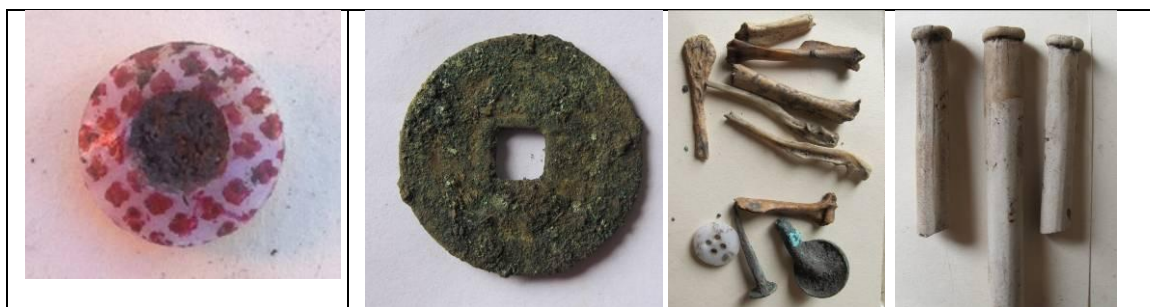
Figure 3.33: Selection of artefacts from the underfloor deposit. From left to right are a 'calico' button (1850s), a Chinese coin, rat bones, button and copper tacks, and mouthpieces of clay pipe stems.

Partial remains of a new building constructed during this redevelopment phase were present in the centre of Area K (Figure 3.31). Elements of the timber flooring and an underfloor deposit survived and were excavated. The deposit was gridded in 1m squares and sample sieved (Figure 3.32). Artefacts recovered include ferrous items, animal bone, bottle glass, some ceramic and a small number of buttons and coins (Figure 3.33). The artefacts relate to use of this wharf building and the men who worked there during this period. This is quite a rare type of deposit to find and we did not really expect to find one. It may relate to a room set aside for work breaks, for smoko and other similar activities. This building was demolished in the 1880s during the Grafton Wharf redevelopments.

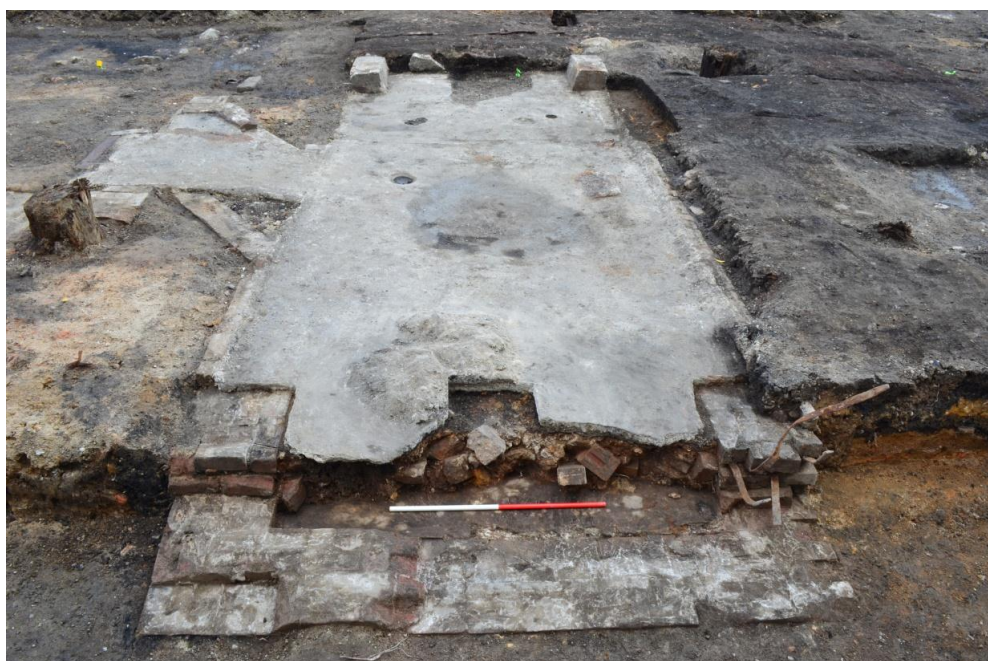
Figure 3.34: The concrete floor of the extended second phase of the weighbridge. The earlier phase of the weighbridge can be seen below the floor with an angled counterbalance annex to the left. Photo taken facing west with a 1m scale.

Early 20th-century archaeological remains were also present in Area K. Within the large warehouse, a concrete and brick weighbridge was constructed (Figure 3.34). This was later remodelled and extended. A partial brick and concrete structure found beside the weighbridge may represent a second weighbridge or possibly a crane base. To the south a second likely crane base was found, the base of which was lined with reused blue stone pavers. During this period a series of concrete and bitumen surfaces overlying levelling fills were formed within the warehouse.

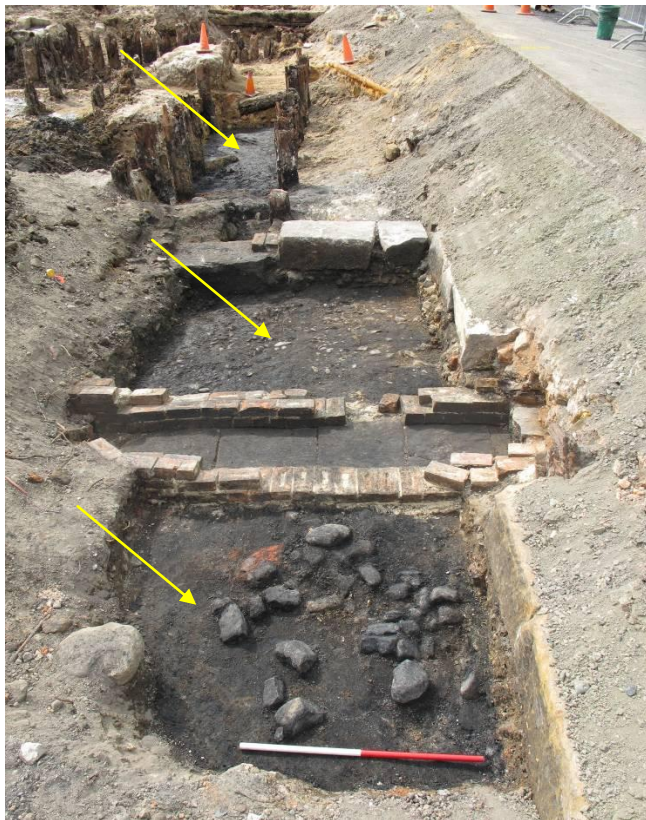
Figure 3.35: Blackened working surface (yellow arrows) located above the bulk reclamation fills dated to the mid 19th century. This photo shows the very western limit of this surface which continued east under the batter. The surface was later cut by wharf piles, sandstone footings and a drain. Photo taken looking north with 1m scale.

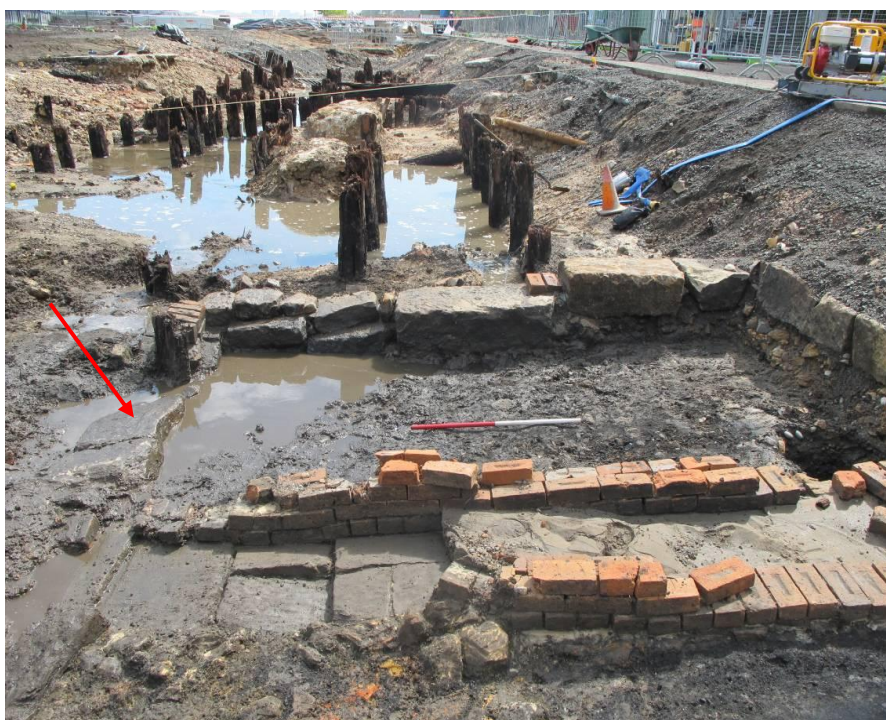
Figure 3.36: Sandstone footings of a store building recorded on plans from the 1860s. This cut the first working surface after reclamation and was later cut by a brick and sandstone-floored drain. View to the north with 1m scale.

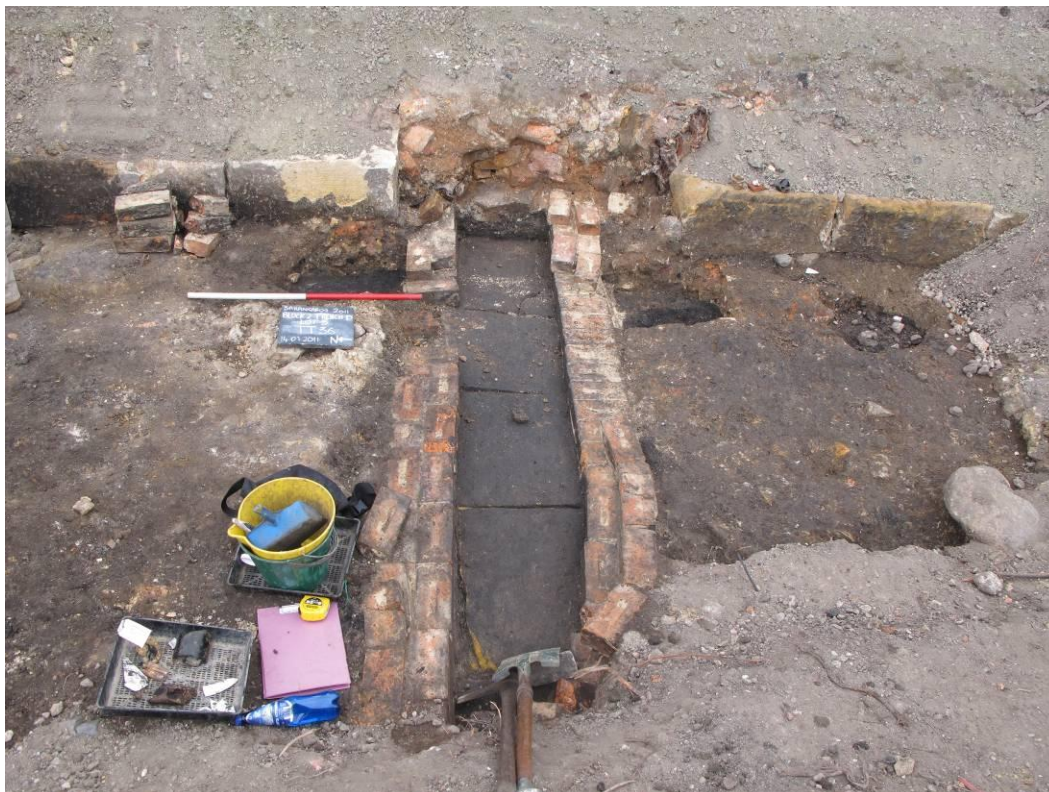
Figure 3.37: Brick drain cutting through sandstone footings. View to the east with 1m scale.

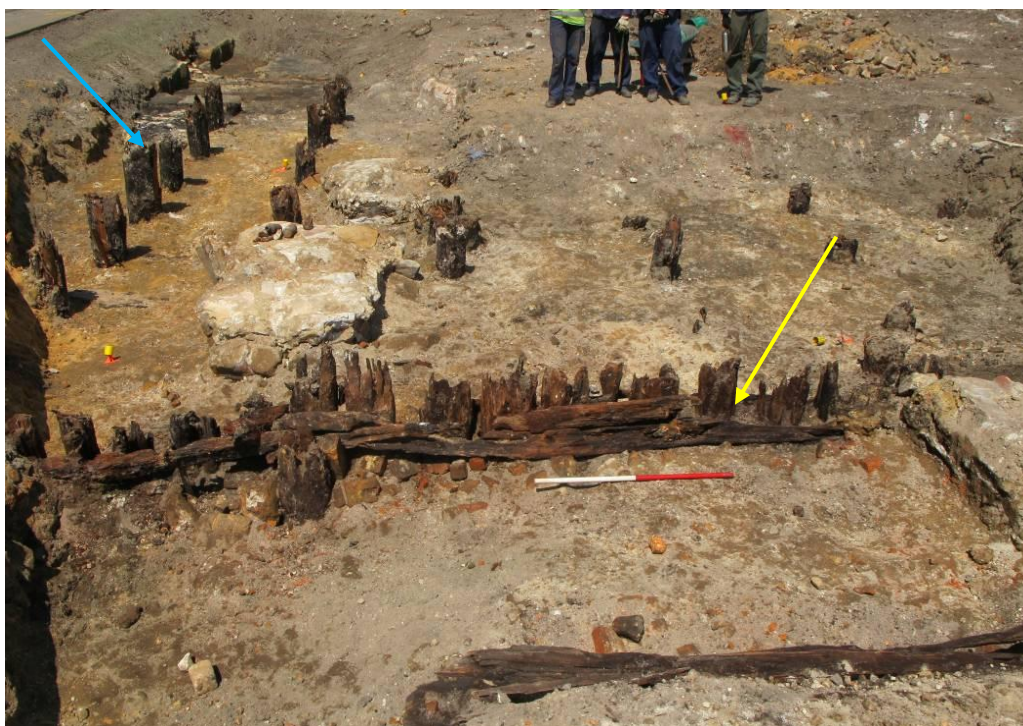
Figure 3.38: Set of piles associated with the jetty (yellow arrow) and wharf (blue arrow) depicted on the 1875 plan (Figure 3.39 below). View to the south with 1m scale.

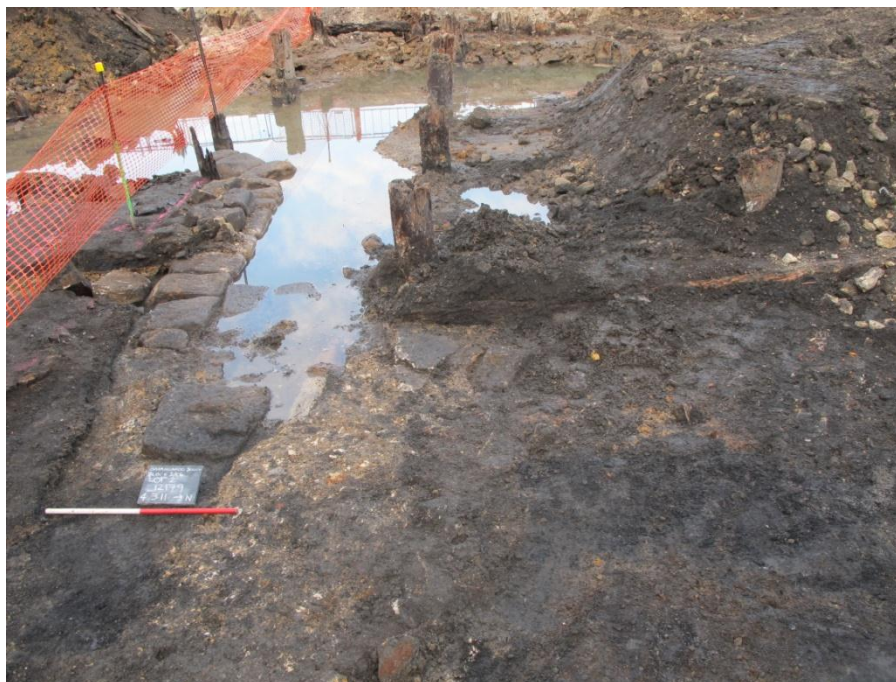
Figure 3.40: The working surface above the bulk reclamation fills in Area C4 (5) was created by accumulations of silt, soot and localised dumps of industrial waste containing coke and cinders. The water represents the high tide mark. Scale 1m and looking west.

A thin strip of Breillat's waterfrontage was excavated in Area C4 (Lot 5). This area is located to the south of the seawall and jetty recorded in Area K. The edge of the initial reclaimed land extended further west than the seawall and was not formally retained. The blackened working surface recorded in Areas K and D was also noted in this trench (Figure 3.40, Figure 3.35). Over this surface was a compacted stone layer that formed the first formal yard surface.

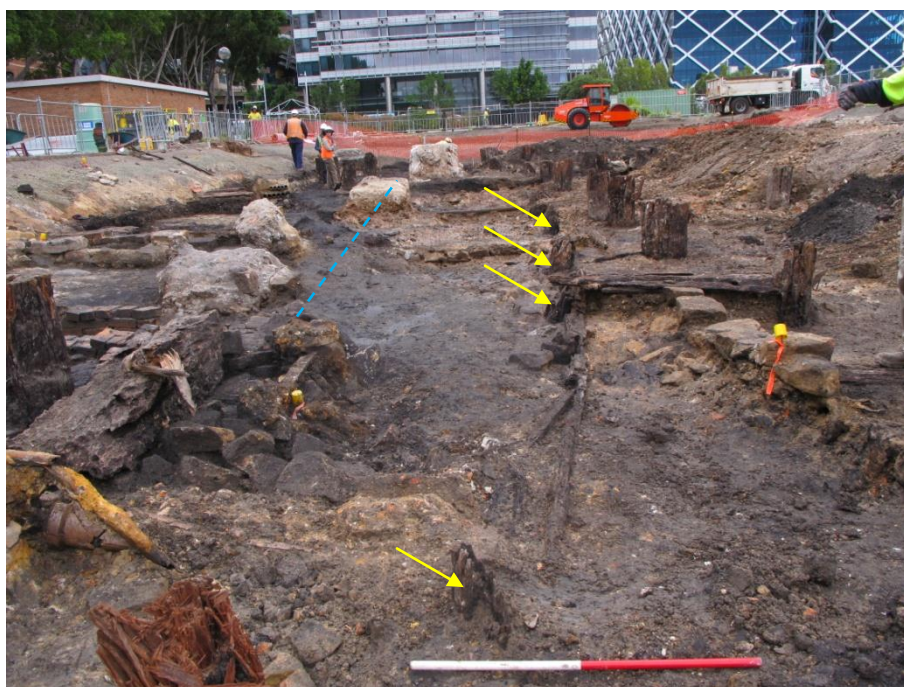
Figure 3.41: The remains of the first wharf constructed c.1840s were found below later reclamation fills. The level of the timber piles (arrowed) was related to the first yard levels built after reclamation. The blue dashed line represents the extent of the c.1840s reclamation associated with the first timber wharfage. Scale 1m and looking south.

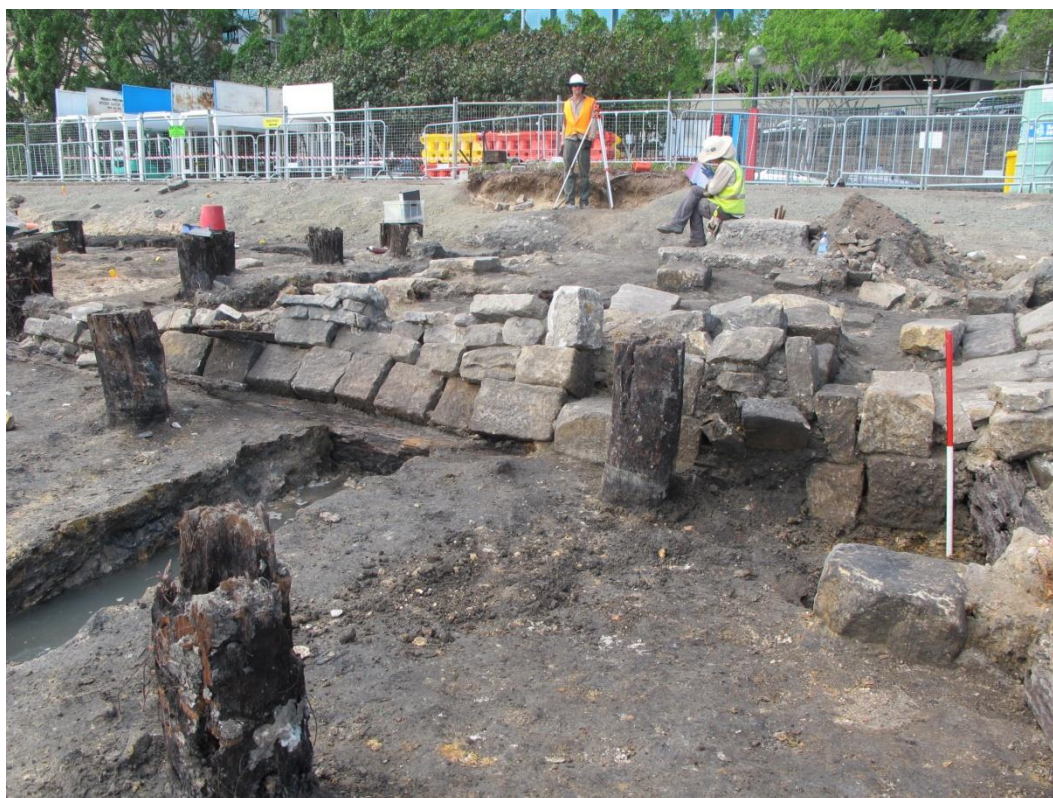
Figure 3.43: Roughly built sandstone retaining wall and larger timber piles associated with the c.1880 redevelopment of the wharf and raising of ground levels. Excavation behind the wall found that there had been attempts to prop up the wall suggesting it was designed as an upright structure rather than a wall with a battered angle. Scale 1m and looking northeast.

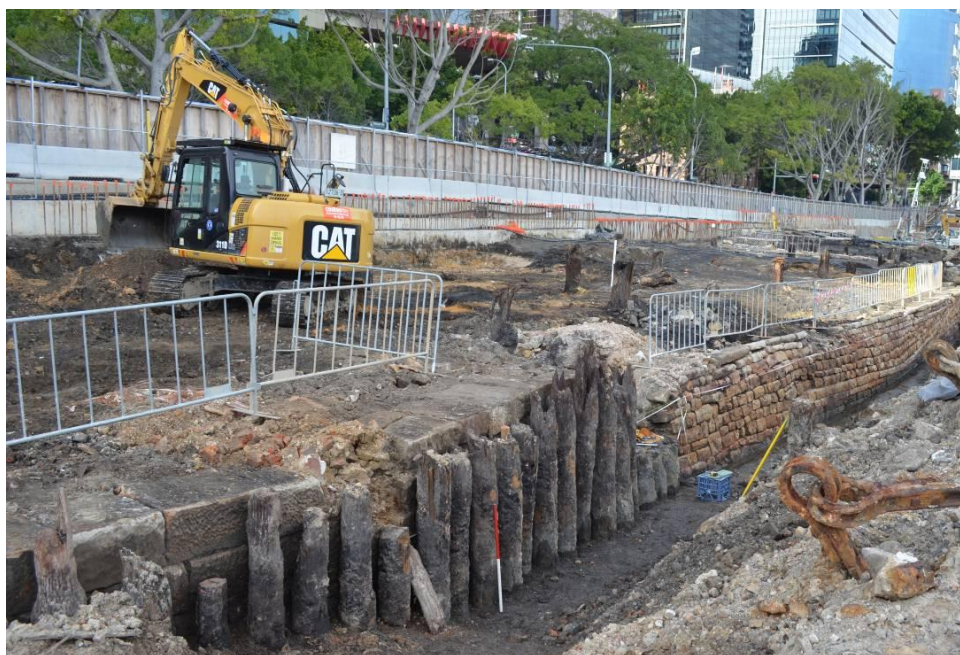
Figure 3.45: The sandstone seawall in Area L contained two main phases of construction. The original wall was a continuation of the seawall in Area K (right of photo). Larger sandstone blocks and timber piles were part of mit to late 19th-century redevelopment and modification. Photo taken looking southeast with 1m scale.

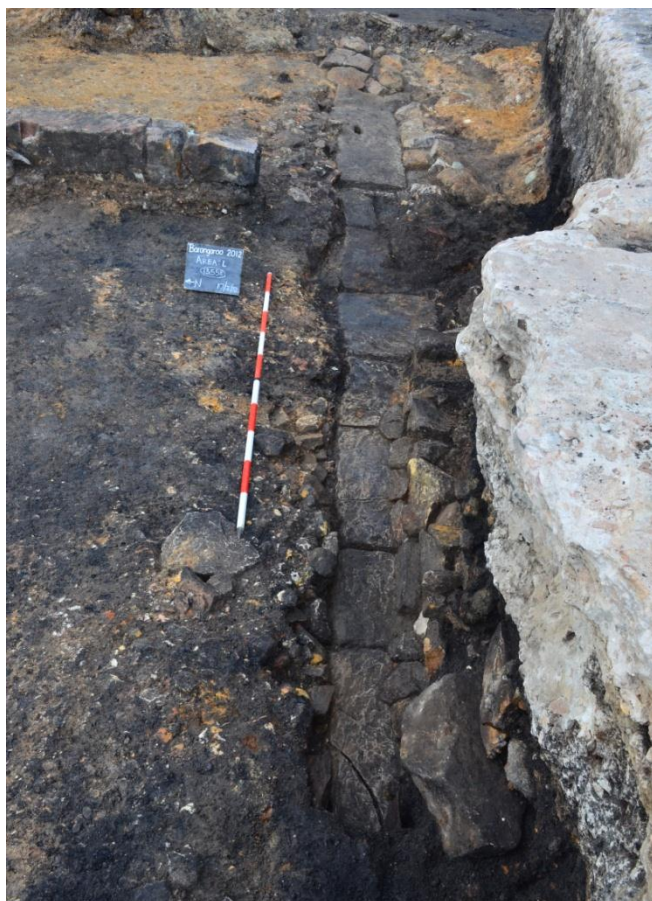
Figure 3.46: Sandstone footing that forms the northern wall of the structure depicted on the 1865 plan. The rest of the building was excavated in Area K. Scale 2m. Photo taken looking east.

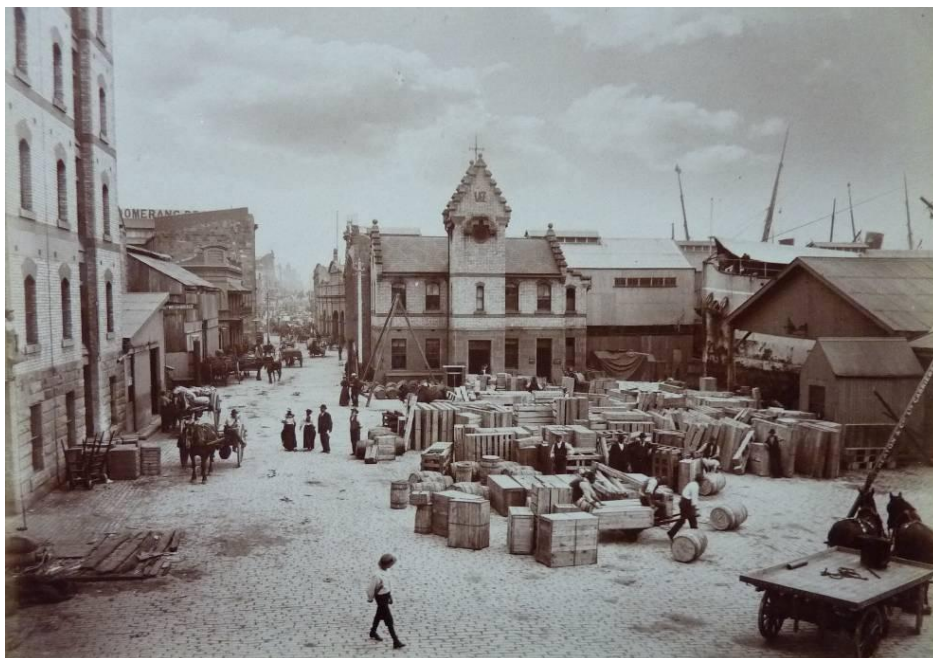
Figure 3.47: Historic photo taken looking south down Sussex Street with the Grafton Bond building to the left and the Flemish-style sandstone and brick building within Area L in the middle. Photo: Kerry & Co. ML, SLNSW, PXA 449.

The remains of the Flemish-style building with a clock tower built by Watson & Evans by 1883 consisted of substantial concrete footings of the southern wall (Figure 3.47, Figure 3.48). No floor level was found in association with this structure, instead a series of later 19th and early 20th – century ceramic service pipes. These services were cut through the seawall (Figure 3.49). Dead-man anchors were also installed, also cutting through the seawall, during this period of redevelopment. These were a continuation of the series of dead-man anchors recorded in Area K to the south and were part of the wharf modification of the later 19th century.

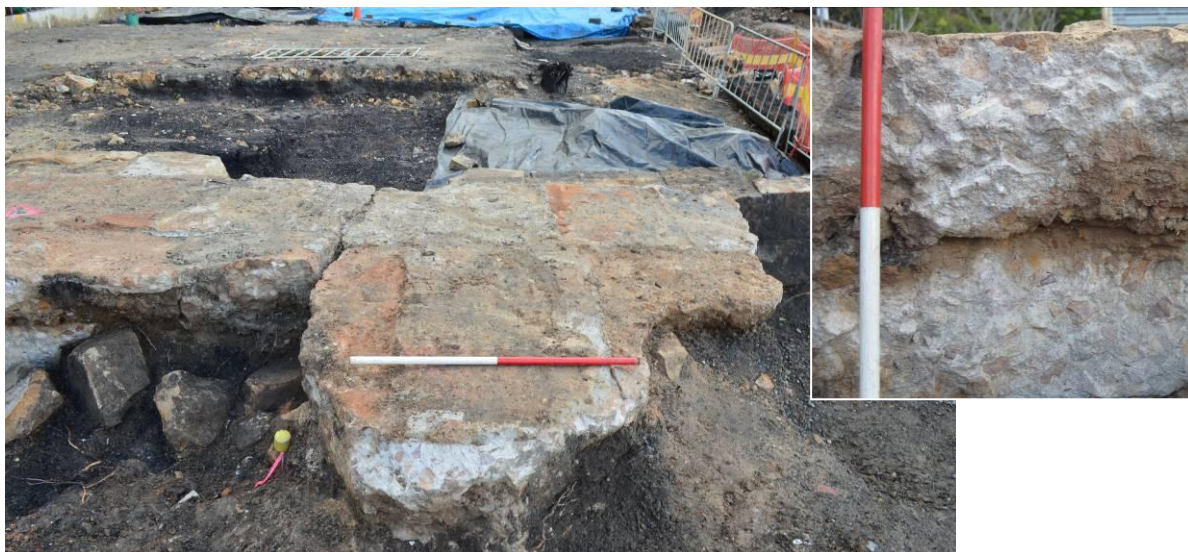
Figure 3.48: Part of the c.1880 concrete footing for the Flemish-style building in Area L with an inset detail showing the sandstone fragment aggregate. Scale 1m and photo taken looking south.

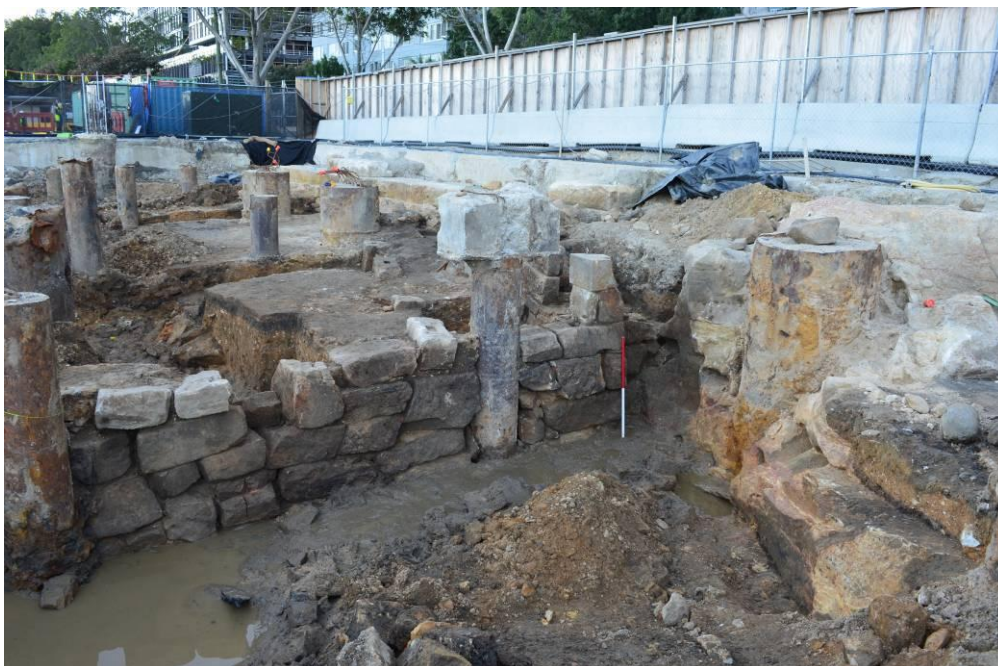
Figure 3.52: Sandstone seawall forming the southern edge of Bass' wharf. It was keyed-in to the rocky shoreline. Photo taken looking northeast with 1m scale.

Part of the reclaimed land and wharf recorded on the 1834 plan was within Area P. The reclamation consisted of bulk fills of sandstone rubble followed by layers of coarse sand and stone fill. To the south, a roughly built sandstone seawall retained the reclamation (Figure 3.52). The wall was keyed-in to the bedrock and was built from below the high water level (0.5m) to a height of around 1.4m AHD. Shortly after it was built the seawall was buried below reclamation fill following Bass' purchase of the property to the south in 1836 (Area M). The surface of the newly reclaimed land was informal and consisted of several bands of silt and sand accumulations (Figure 3.53). Some woody detritus and copper flecks were the only inclusions noted. The land displayed an obvious gradient from east to west toward the water.

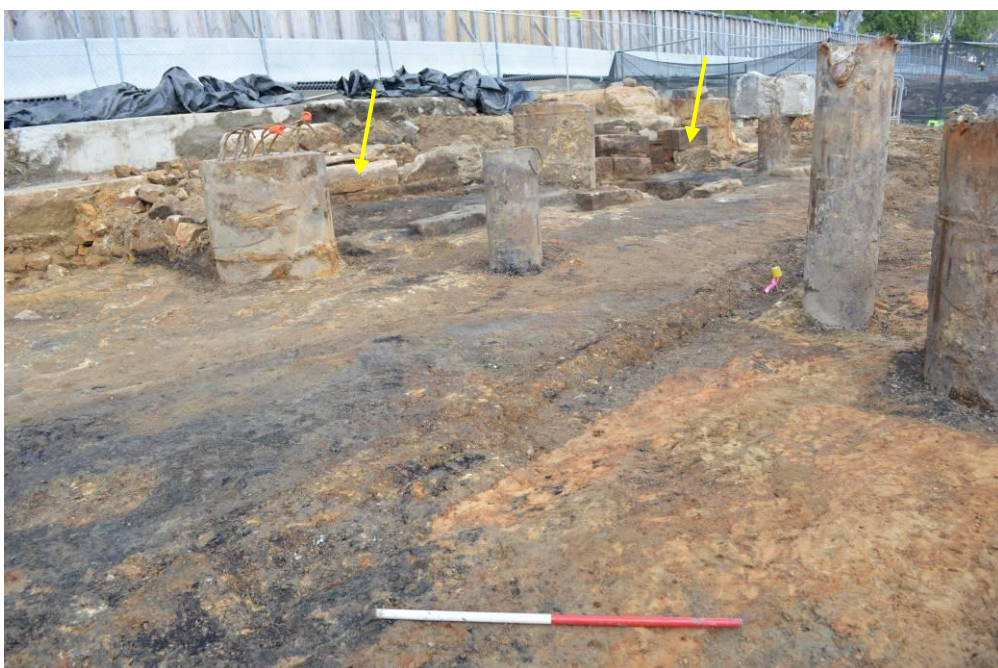
Figure 3.53: General view of the sands and silt accumulations that formed the informal surface of Bass' shipyard after reclamation in the 1820s/1830s. This photo also shows the cottage remains in the background (yellow arrows) and the modern piles truncating the area. Photo taken looking southeast with 1m scale.

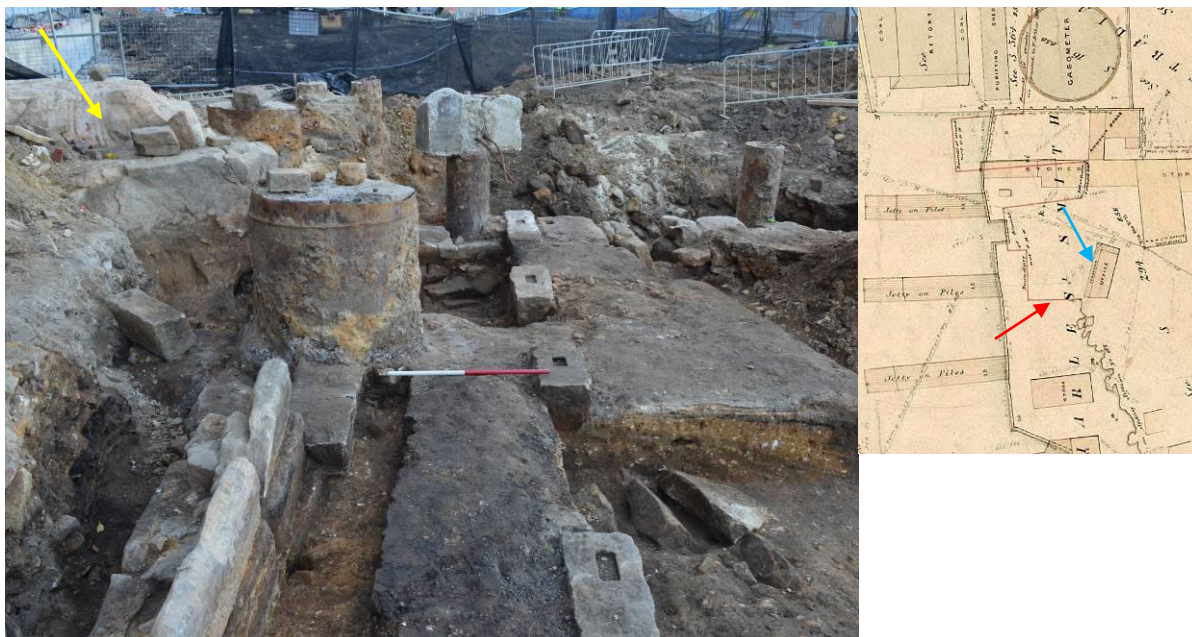
Figure 3.54: Remains of the wall and footing, and the sandstone verandah pier pads of a building constructed on both the natural sandstone outcropping (yellow arrow) and the reclaimed land. The inset is the 1875 plan that records the shoreline and Bass' Wharf as it was by the 1830s (red arrow) in relation to the later mid 19th-century wharf expansion. The cottage (blue arrow) is recorded on the 1875 plan and plans dating from the 1850s. Photo taken looking south with 1m scale.

The remains of a building were located along the eastern edge of the trench (Figure 3.54). Notably the building was orientated northeast to southwest, an alignment that reflects the original shoreline. This building is recorded on plans from the 1830s to 1880. Only part of the front wall and verandah were within Area P. The remains consisted of sandstone footings with one to two courses of walling, also of sandstone. Remains of the verandah consisted of sandstone base pads for timber posts. Within the footprint were the remains of an internal storage space constructed with sandstock brick. The front wall and verandah were both constructed on the newly reclaimed land with the southwest corner of the building on the seawall. The rest of the house was built on the bedrock with the ground floor level being higher than the reclaimed land surface.

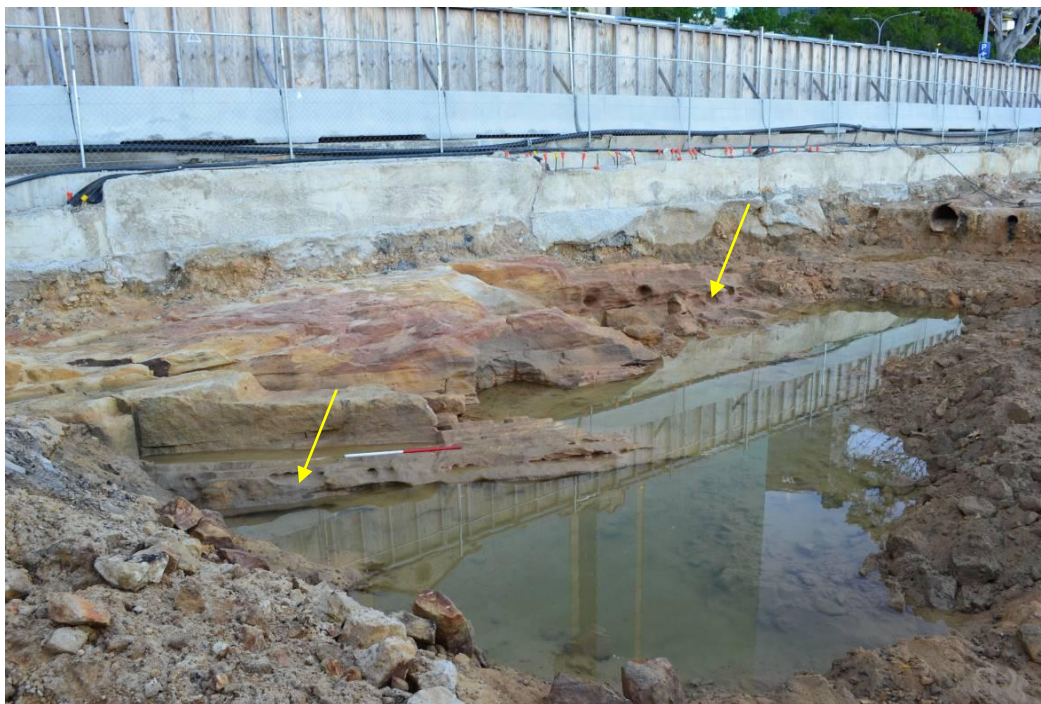
Figure 3.55: The original shoreline in Area M displayed natural erosion patterns (arrows) below the high tide level. The water is at c.-0.2m. Scale 1m. The photo is taken looking southeast.

Most of Area M would have originally been below the high water mark, except for an outcrop of natural bedrock in the northeast corner of the area. The bedrock showed evidence of water erosion in the intertidal zone and weathering above the water line (Figure 3.55). Higher up on the bedrock were several triangular quarry marks that were part of later 19th-century modifications to the natural landscape. A series of mid 1830s reclamation fills abutted the bedrock. No natural or aboriginal occupation deposits were found.

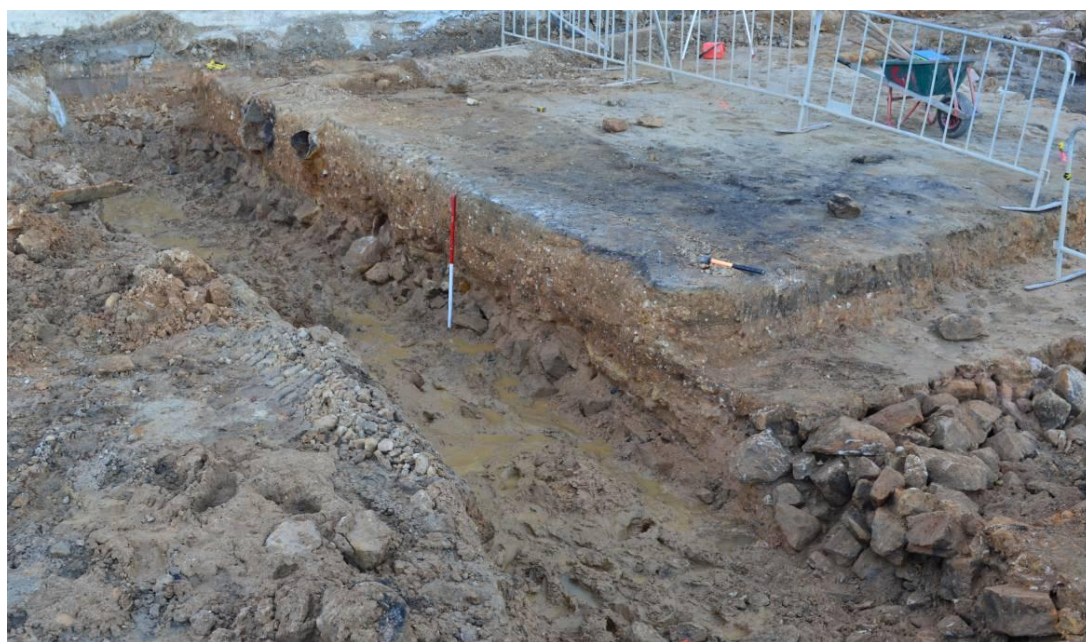
Figure 3.56: Trench excavated through the 1830s reclamation. At the base is the rubble platform below the high water level with compacted sands and clay above. The surface level was created by trampled silts and other accumulations. Looking southeast, 1m scale.

The reclamation process included the deposition of rubble sandstone to form a platform to the high water level. This was then consolidated with compacted sands and clays to form new ground about 1m above high tide level (Figure 3.56). Parts of the southern and western edges of the newly reclaimed land were within Area M. The edges of the reclamation were informal and consisted of rubble sandstone that acted as a seawall to prevent slumping and erosion. It may not have been successful as there was archaeological evidence for consolidation with a second phase of rubble along the periphery quite soon after the initial reclamation.

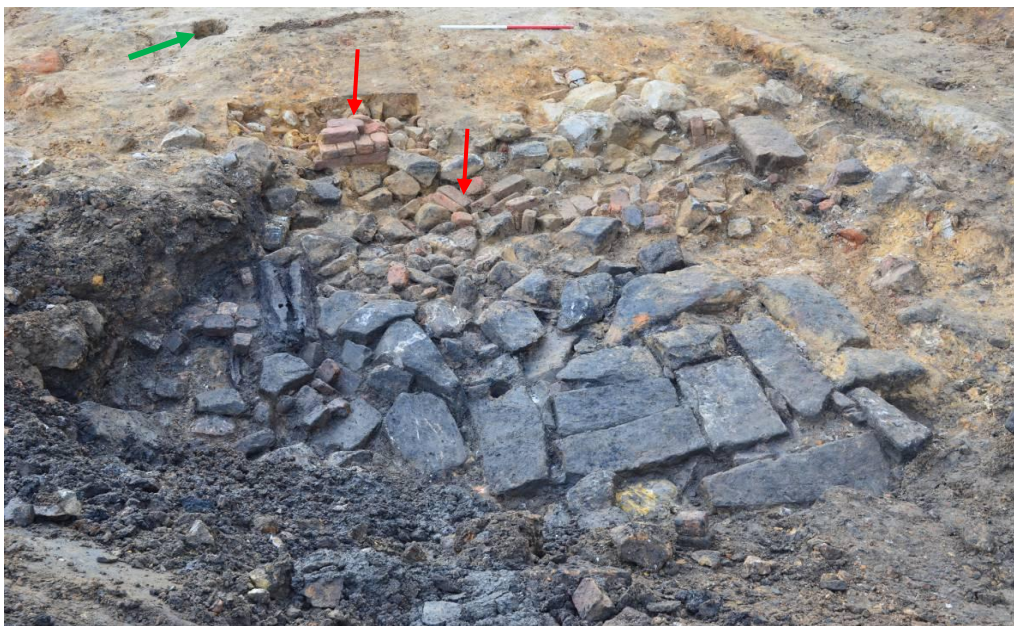
Figure 3.57: Remains of the boat ramp on the southern edge of Area M. At the water's edge were flat sandstone pavers and further up the bank were the remains of a timber structure supported by a brick pier (red arrows) and postholes (green arrow). Looking north, 1m scale.

On the southern edge were the remains of a boat ramp or skid (Figure 3.57). This feature consisted of a series of sloping sandstone pavers at the high tide mark. Sandstock brick piers and postholes further up the slope indicated that there was also a small timber superstructure component. This was a very rudimentary arrangement that would only have been suitable for very small vessels, however it is a good example of early access to the harbour (Figure 3.58).

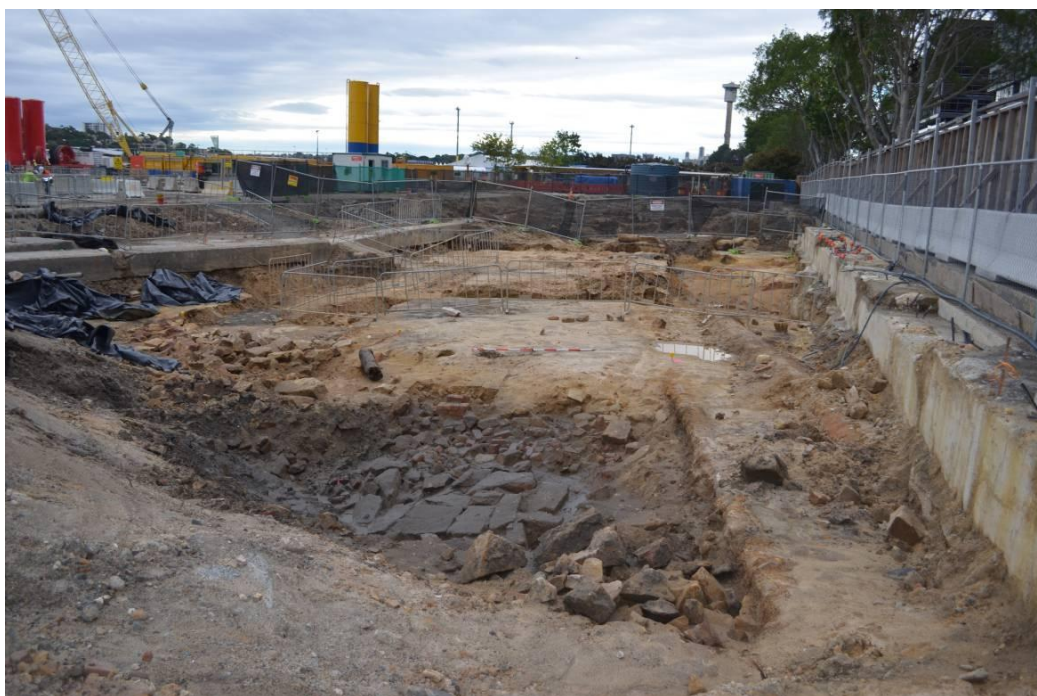
Figure 3.58: Area M looking north at the completion of the archaeological investigation of above the high tide level. This shows the 1830s reclaimed level with sandstone rubble forming the edges and the remains of a stone boat ramp. 2m scale

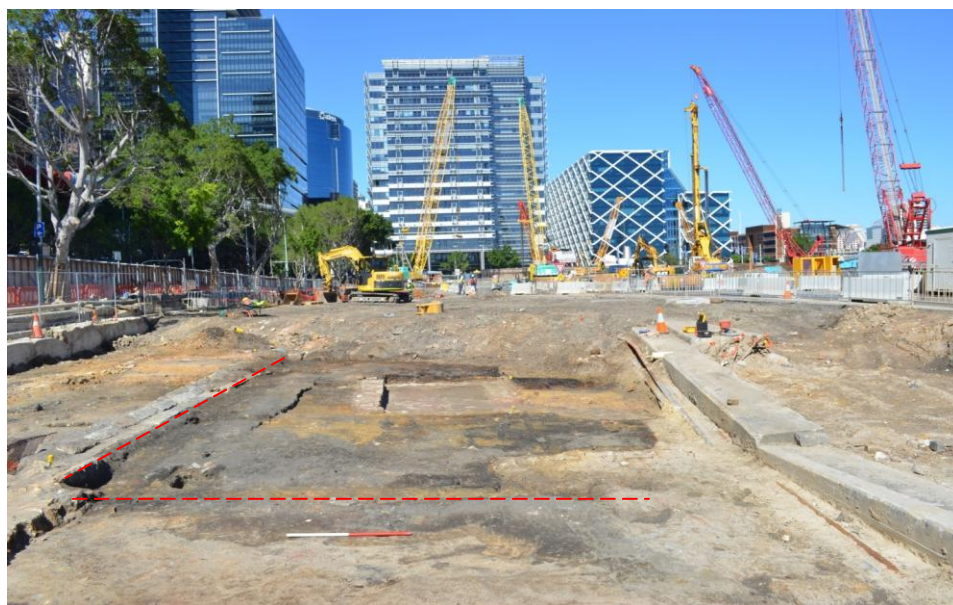
Figure 3.59: Remains of the building consisted of wall trenches (dashed red lines) and an occupation deposit (dark material). The sandstone gutter is visible on left. Photo taken looking south with 1m scale.

When Smith & Challis bought the lot in 1854 they redeveloped and consolidated the reclaimed land and wharf. Sand and clay-rich fills were imported to raise the level of the land. The levelling fills were capped with a formal metallised surface. This new surface still had a notable north-to-south slope. Following the formation of this new surface level a large shed or warehouse was constructed (Figure 3.59). Consisting of the northeast corner of the building, the archaeological remains included postholes, wall trenches, a sandstone surface-gutter on the eastern exterior and an

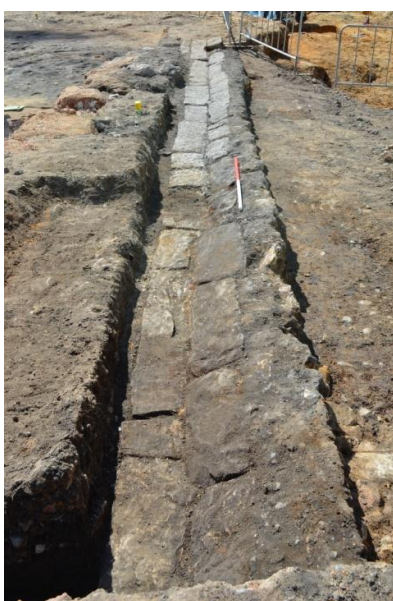
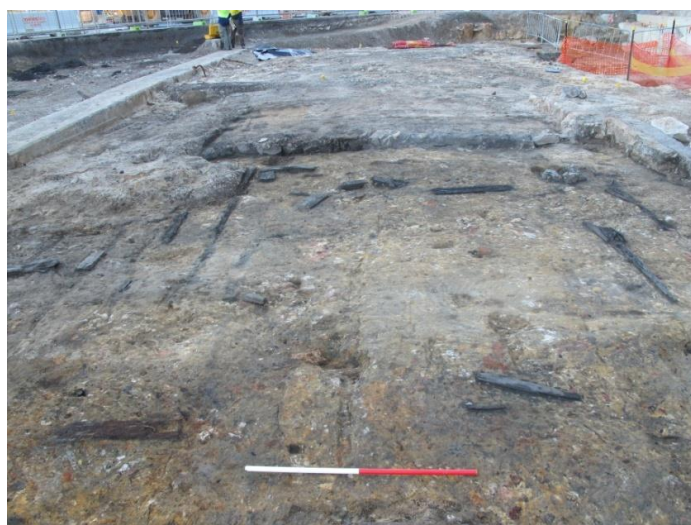
Figure 3.60: Detail of the sandstone surface-drain on the left, and the timber floor elements within the building. Both photos are taken looking north with a 1m scale.

occupation deposit surrounding decayed flooring elements (Figure 3.60). A patchy occupation deposit was present around the floor elements that contained a low frequency of artefacts, such as ceramic pipe stems, glass fragments, fruit stones, fragments from a coconut shell and an unusual timber pipe bowl carved in the shape of a man's head.

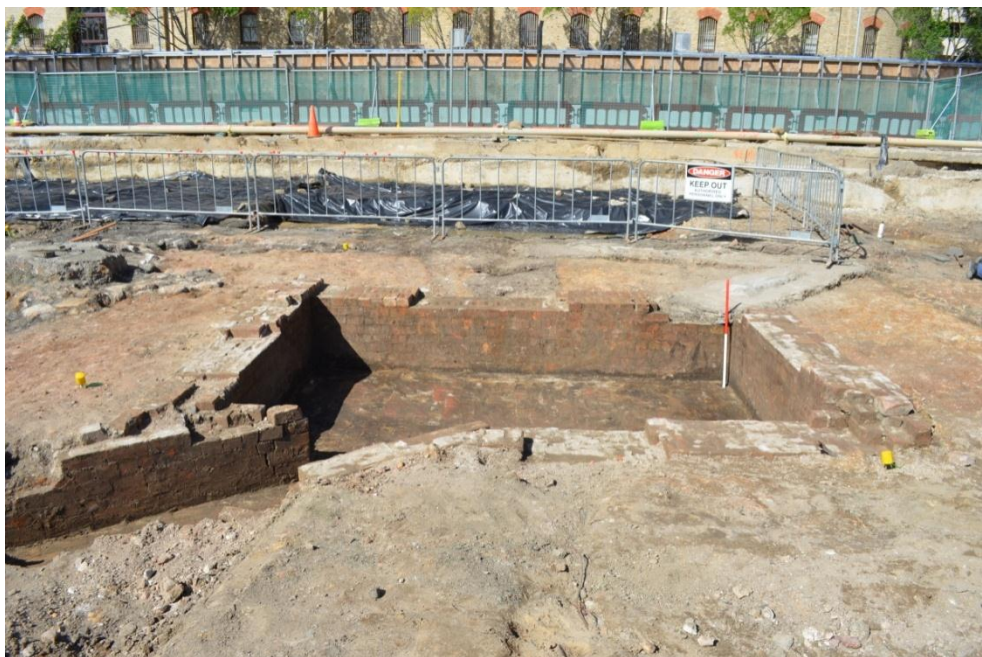
Figure 3.61: 1880s weighbridge structure. The goods would have been suspended in the rectangular central space, while the weights would have been attached to a counter-balance arm in the smaller channel in the bottom left corner. Photo is taken looking east with 1m scale.

During redevelopment in the 1880s the ground level in Area M was again raised and consolidated. The earlier building was demolished and the area became part of a yard. There was no intact archaeological evidence for the yard surface as it was removed during 20th-century redevelopment. Associated with the later 19th-century phase of use were the remains of a weighbridge (Figure 3.61). It was constructed from machine-made, purple shale bricks and hard lime mortar/cement. The weighbridge would have contained an in-ground set of weights and scales to weigh goods either arriving or leaving the docks.
