3.5 Barker's Mill, Jetty and Mill Pond 1825 to 1870s

3.5.1 Introduction

3.5.2 1825 Mill Development by Cooper & Levey

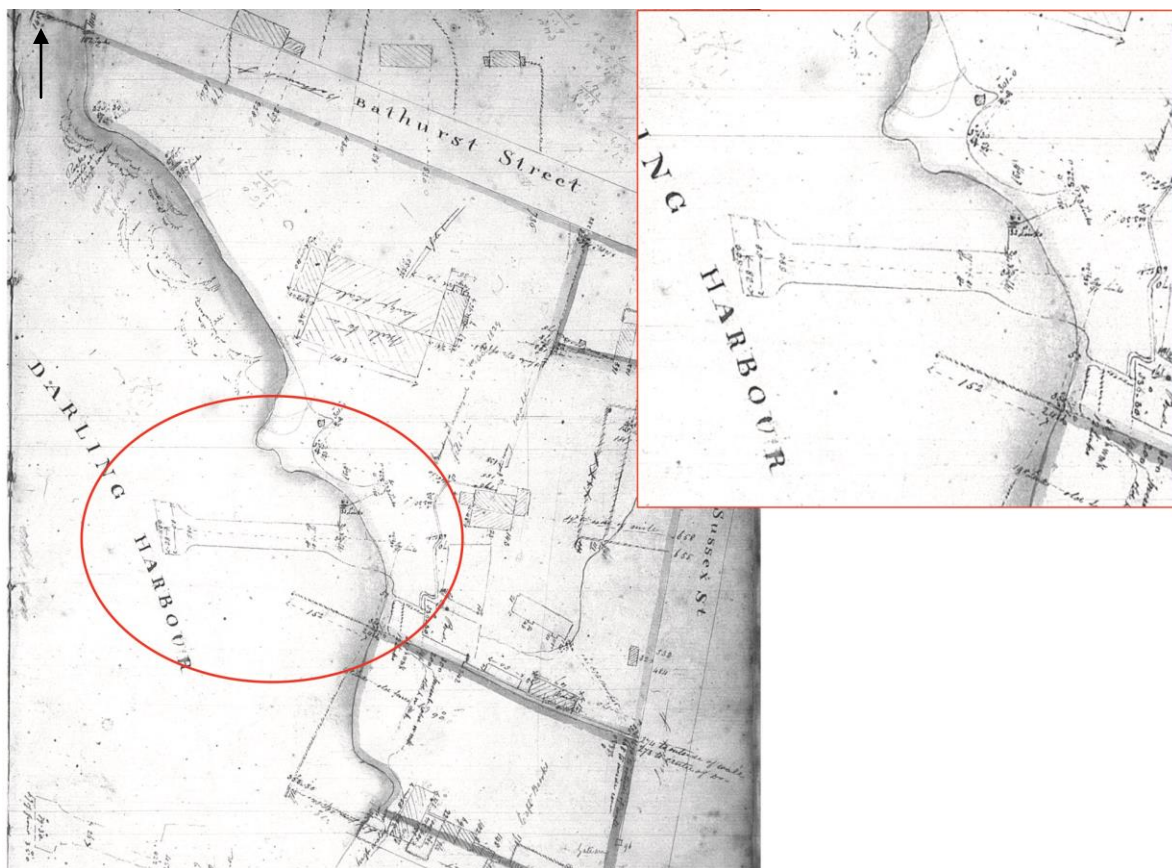
Figure 3.5.6: Ambrose Hallen’s sketch of the mill complex including the jetty dated to 1828-1830, when the mill was owned by Thomas Barker. The sketch notes survey details about the jetty and the mill buildings. Note that the building illustrated to the north of the jetty is an enlarged version of the mill that is actually located directly east of the jetty. The inset shows a detail of the jetty sketch. A Hallen 1828-1830 FB 347 Reel 2628 SRNSW.

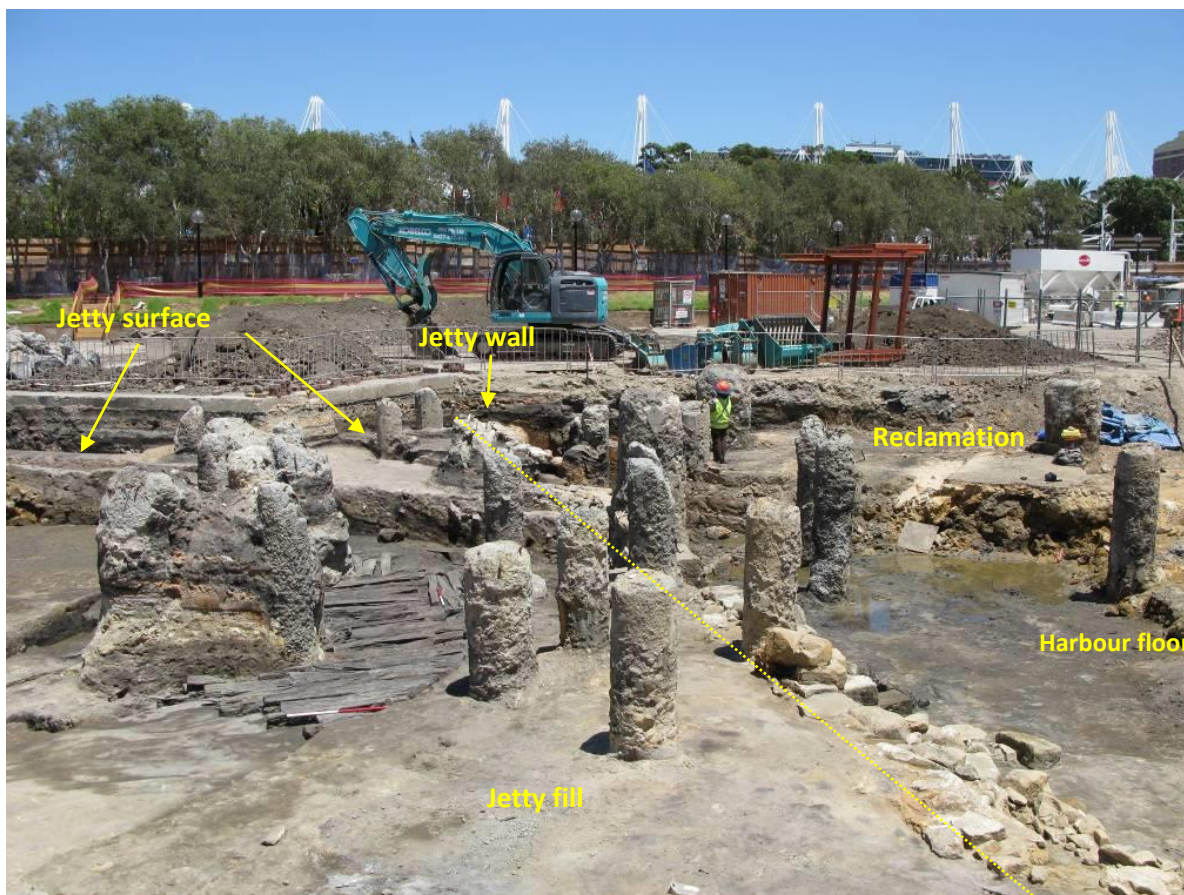
Figure 3.5.11: View of the jetty wall remains from the shore with remains of the jetty in-fill and surfacing. The timber slipway was revealed below the jetty fill. The harbour floor is to the right with reclamation (Phase 5) overlying. View to west. Scale 1m.

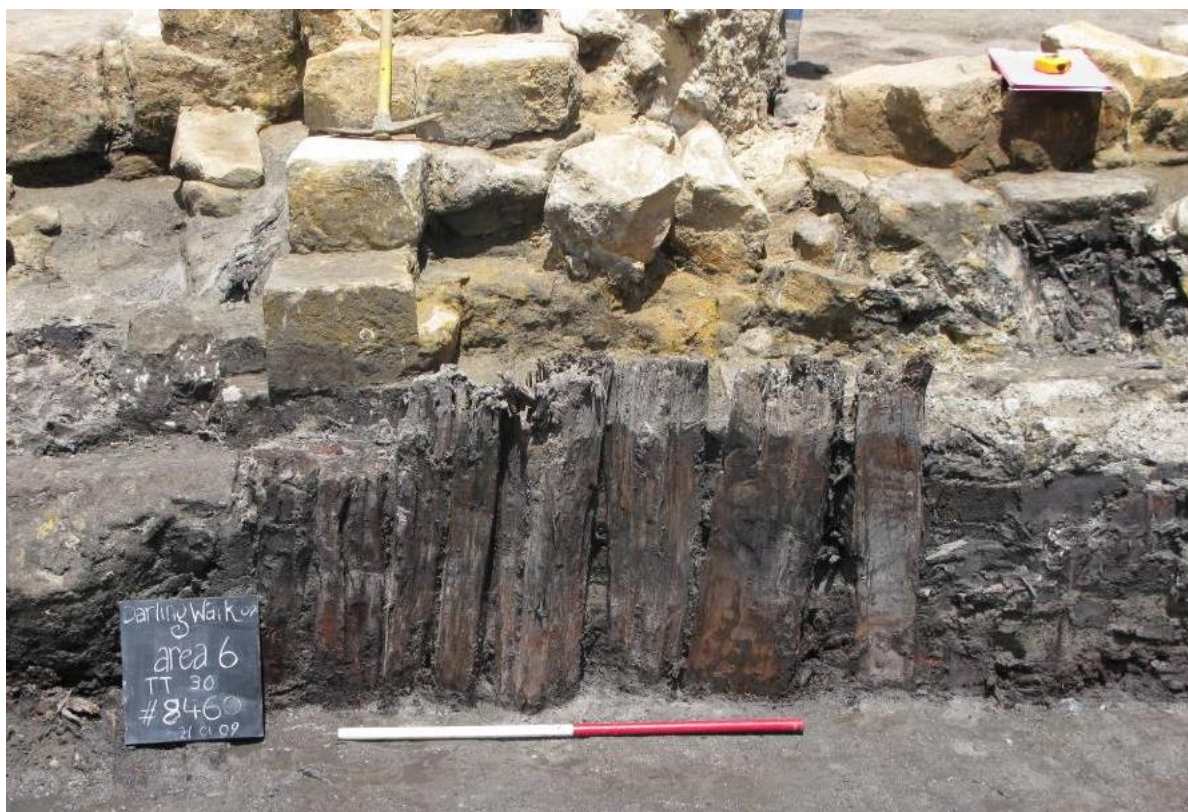
Figure 3.5.12: Exposed timber formwork (context 8460) with the sandstone jetty wall (context 8366) beyond. View to the south. Scale 1m

Timber formwork (context 8460) was used in the construction of the northern sandstone wall of the jetty (Figure 3.5.12, Figure 3.5.13 and Vol 4: Plans 10.8, 10.12). Almost 20m of formwork was recorded in plan, and exposed in more detail in three test trenches (TTs 28, 29 and 30) along the northern side of the jetty wall (Locations of TTs in Vol 4: Plan 10.8). The formwork consisted of closely placed timber planks driven into the harbour sands (Figure 3.5.14). The planks were roughly formed by longitudinally-split logs up to 1.5m in length. Bark had been removed but otherwise the logs were not milled, and in section they were either rectangular or triangular. The base end of each piece of timber was roughly hewn and shaped to a point (Figure 3.5.16). Generally, the timbers were driven into the sand with the cut side facing towards the water. In TT28 there was evidence for horizontal brace timbers on the external face of the shoring (Figure 3.5.15).

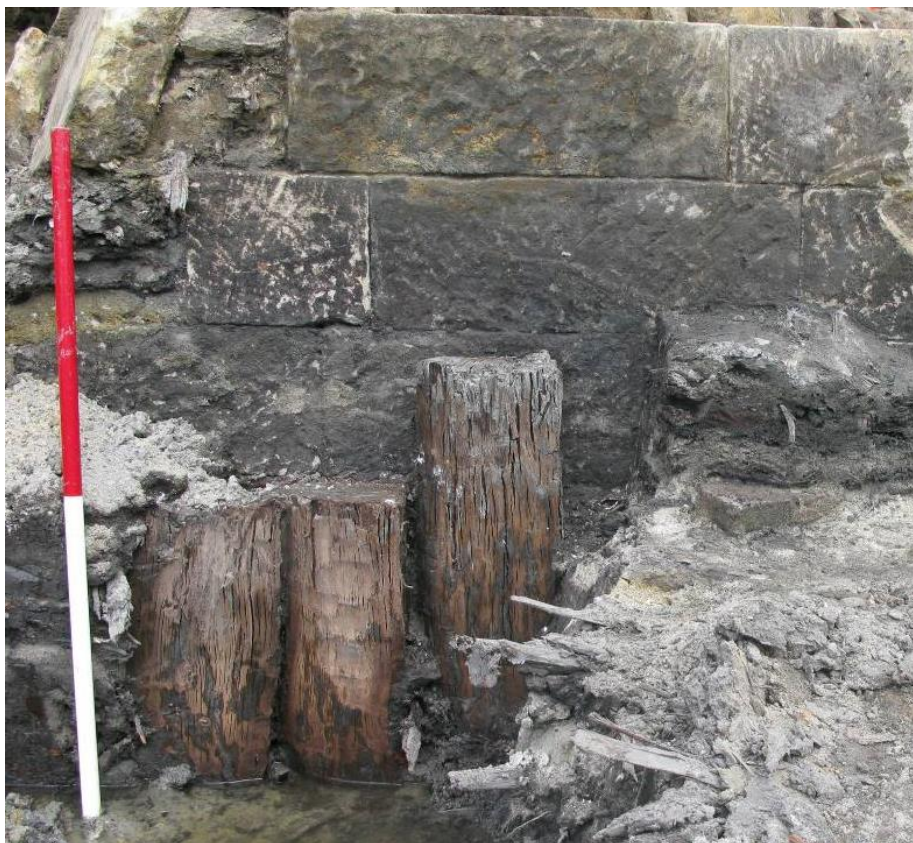
Figure 3.5.13: Detail of the top of the formwork (8460) and the stone wall behind. The right of the frame shows the amount of harbour deposits and accumulation against the wall. View to the south. Scale 1m.

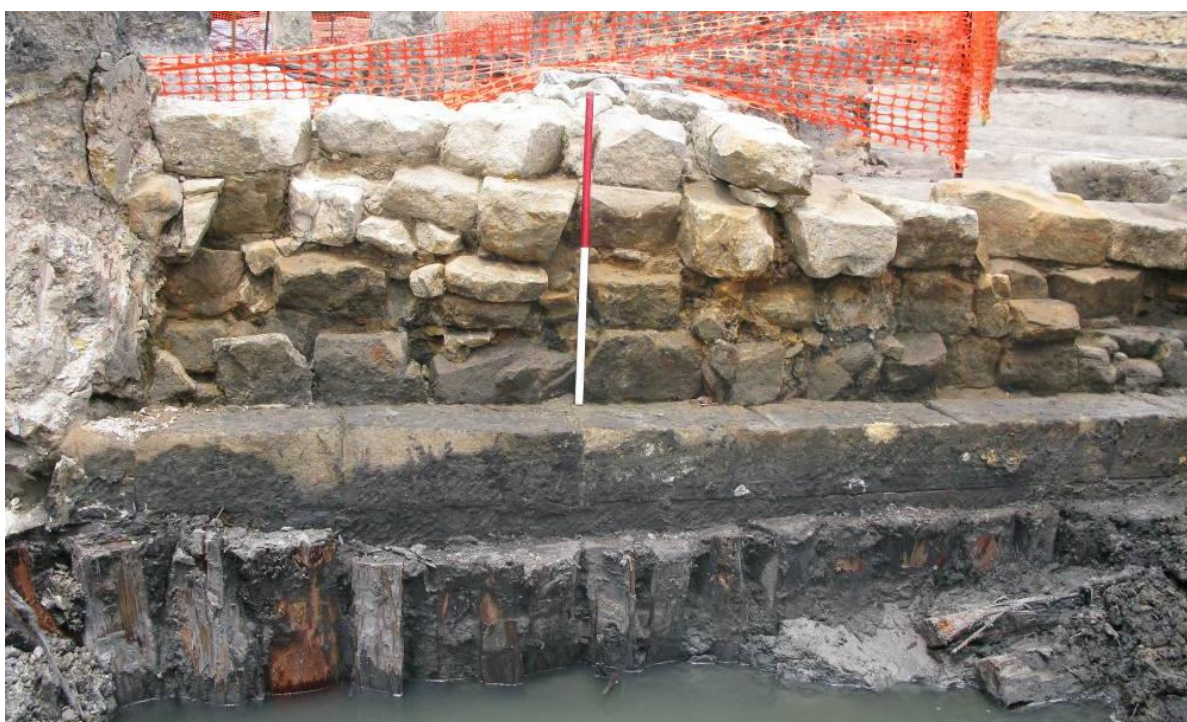
Figure 3.5.14: View of the harbour-side of the jetty wall with the top of the timber formwork exposed. The oyster shells adhering to the stone just above the top of the formwork indicate that the high tide water levels rose to cover the formwork. View to southeast. Scale 1m.

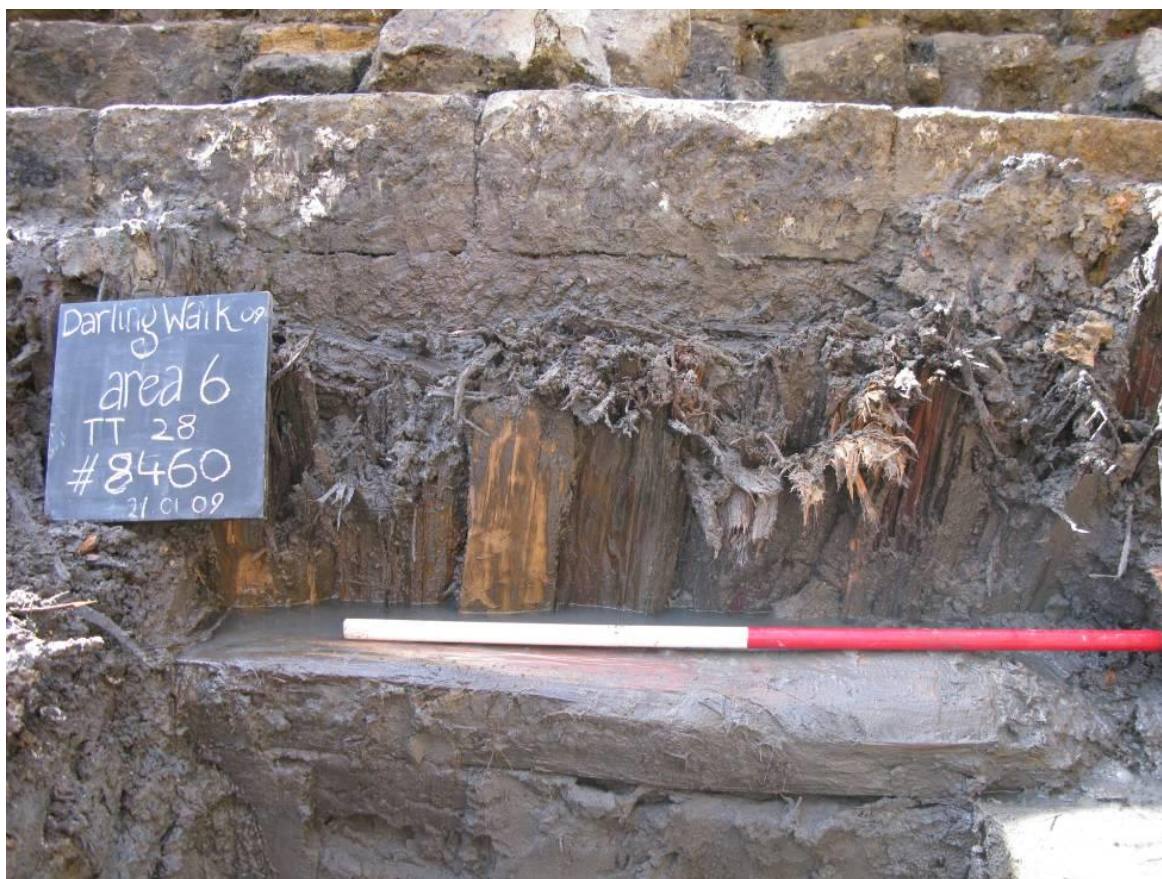
Figure 3.5.15: Horizontal timbers used as extra bracing on the outside of the formwork. These were revealed below some harbour sand in TT28. View to the south. Scale 1m.

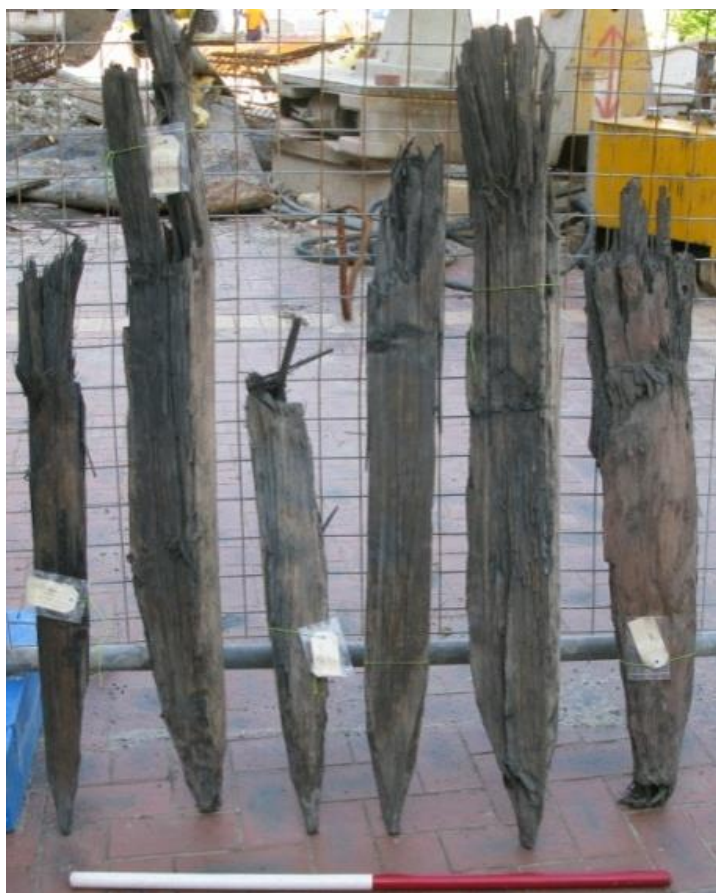
Figure 3.5.16: Group photo of the timber samples from context 8460 retrieved during bulk excavation. Note the pointed ends which would have aided the timbers to be driven into the sand. From left to right: sample #163 (24B), #162 (24E), #165 (24A), #164 (24F), #159 (24C) and #166 (24D). Scale 1m.

Three timber samples were sent for species identification.⁵⁴ Two of these (#162 and #166) were identified as *Eucalyptus pilularis*, or blackbutt. This hardwood was abundantly available in the early years of settlement, and is likely to have grown within one kilometre of the site.⁵⁵ The availability of this species at the time of the jetty construction suggests that locally sourced timbers are likely to have been used.⁵⁶ Also identified as part of the formwork was *Eucalyptus oblique* (#165), commonly known as messmate or messmate stringybark. Like blackbutt, messmate is a hardwood which is used today in construction and flooring.⁵⁷ Messmate does not naturally grow in the Sydney area, but is endemic to the Tablelands districts of New South Wales.⁵⁸

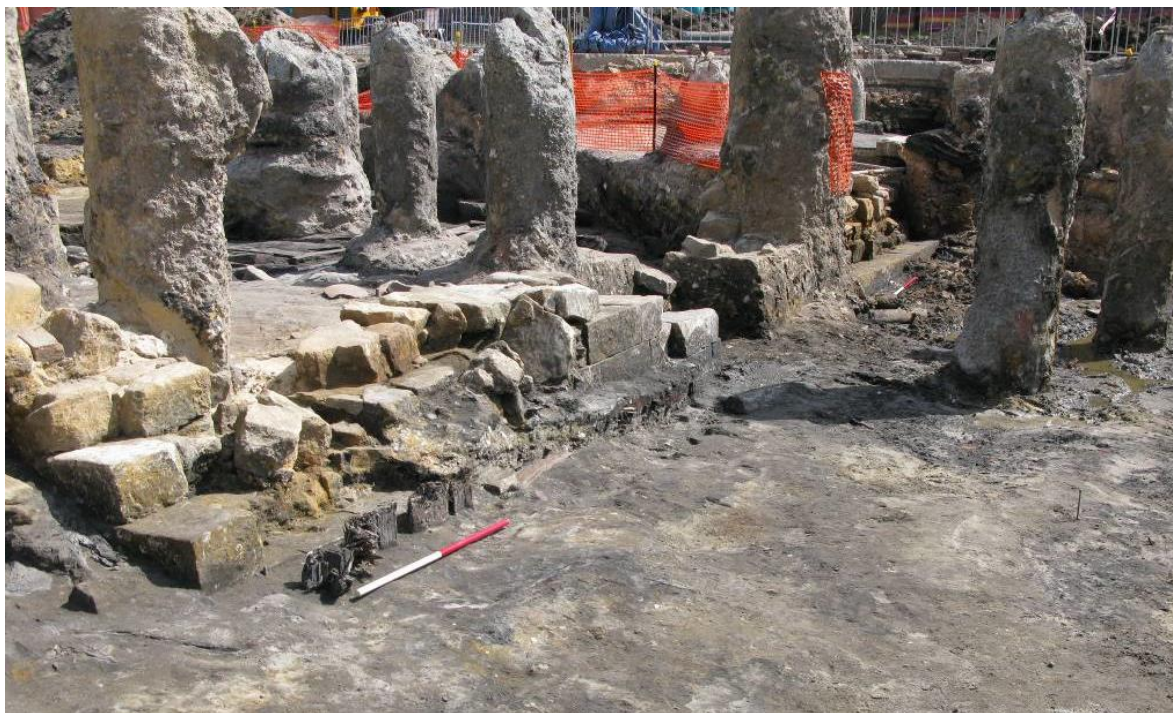
Figure 3.5.19: Remains of the northern jetty wall with ashlar stone construction on the harbour-face and rubble sandstone on the interior, visible in the background. View to west. Scale 1m.

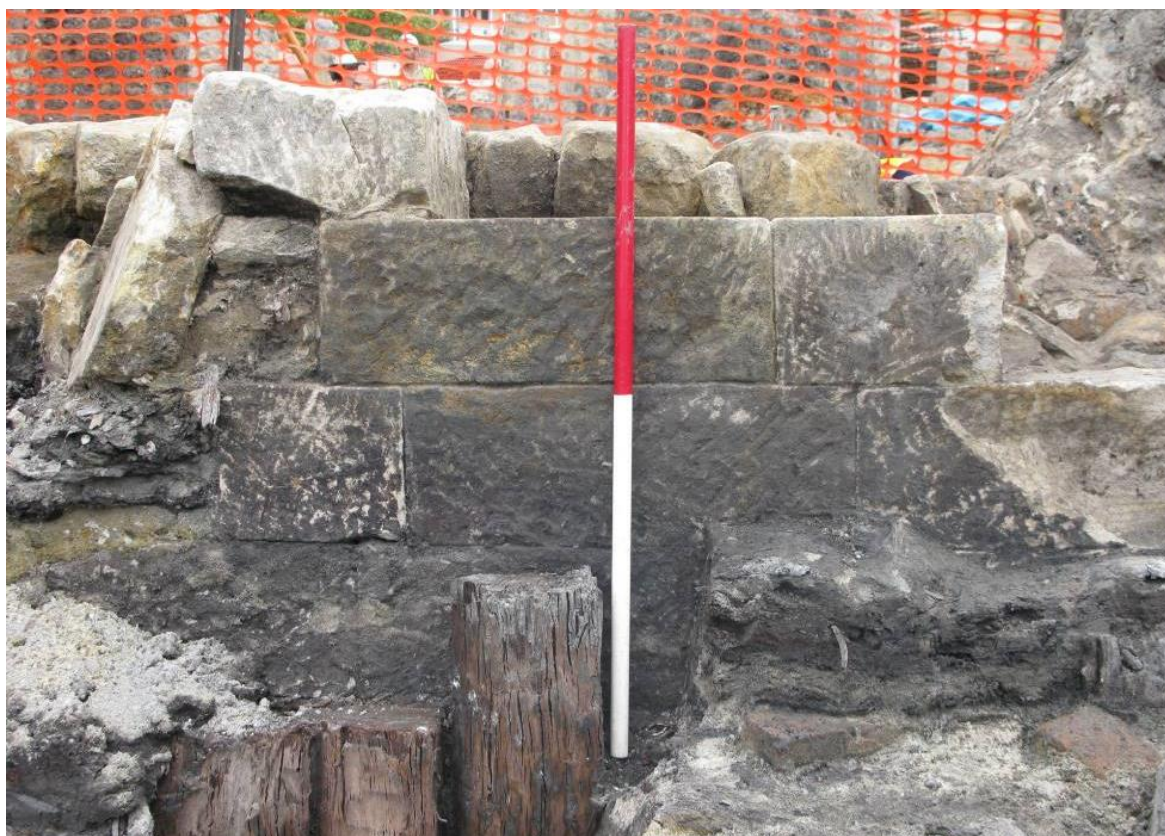
Figure 3.5.20: Detail showing the stones facing the harbour neatly cut and with chisel mark surfacing on the face. View to south. Scale 1m.

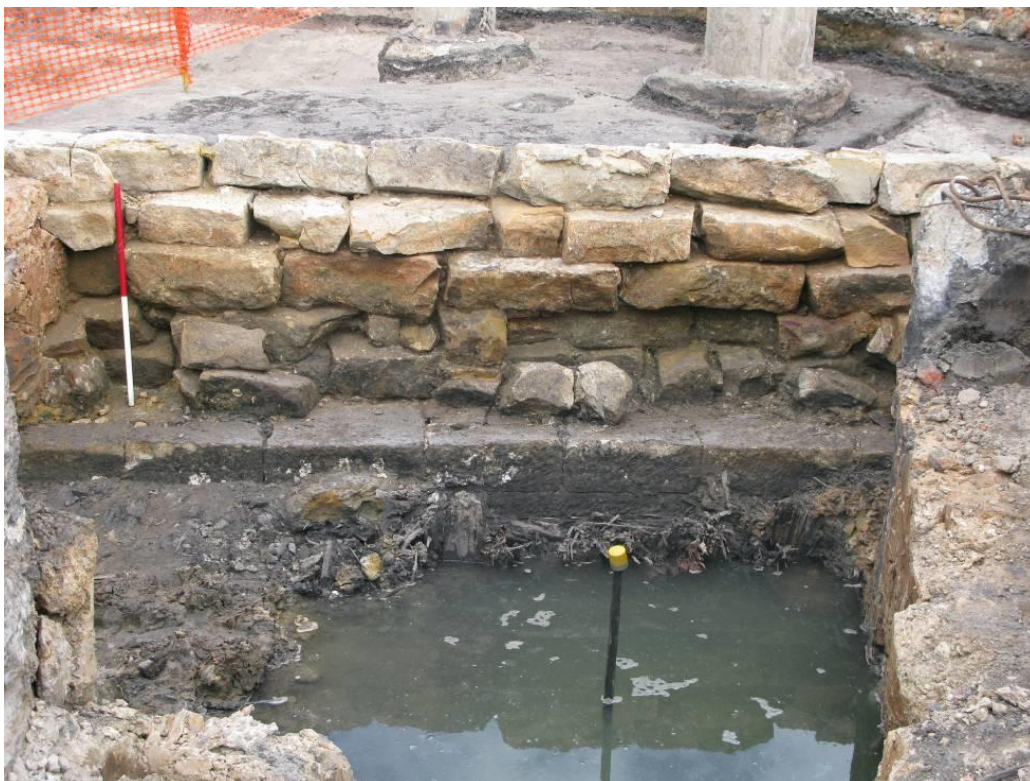
Figure 3.5.21: The jetty wall consisted of ashlar blocks on the harbour face. These were robbed-out before the wall was covered by the reclamation fills in the 1830s. On the internal side of the wall were large rough-cut sandstone blocks. View to the south. Scale 1m.

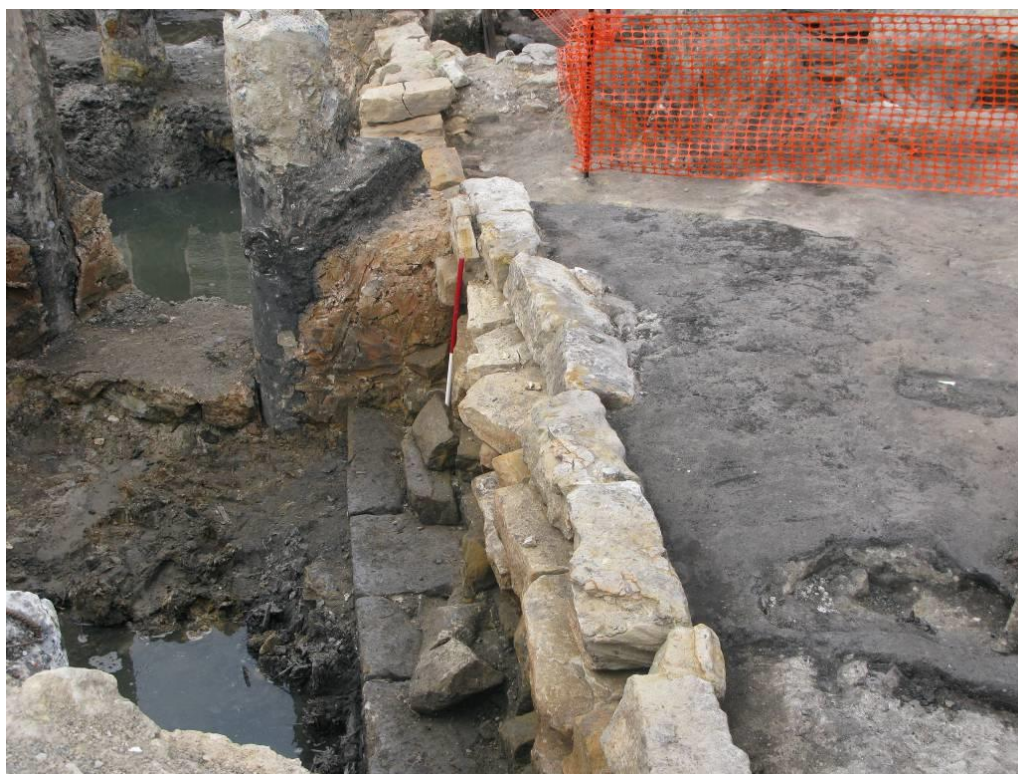
Figure 3.5.22: The remains of the jetty wall showing the rough-cut sandstone used in the interior abutted by the black occupation deposit over the jetty surface. The harbour-facing stones were robbed-out before being covered with the later reclamation fills, as seen in the section where orange clays cover the wall remains, behind the scale. View to east. Scale 1m.

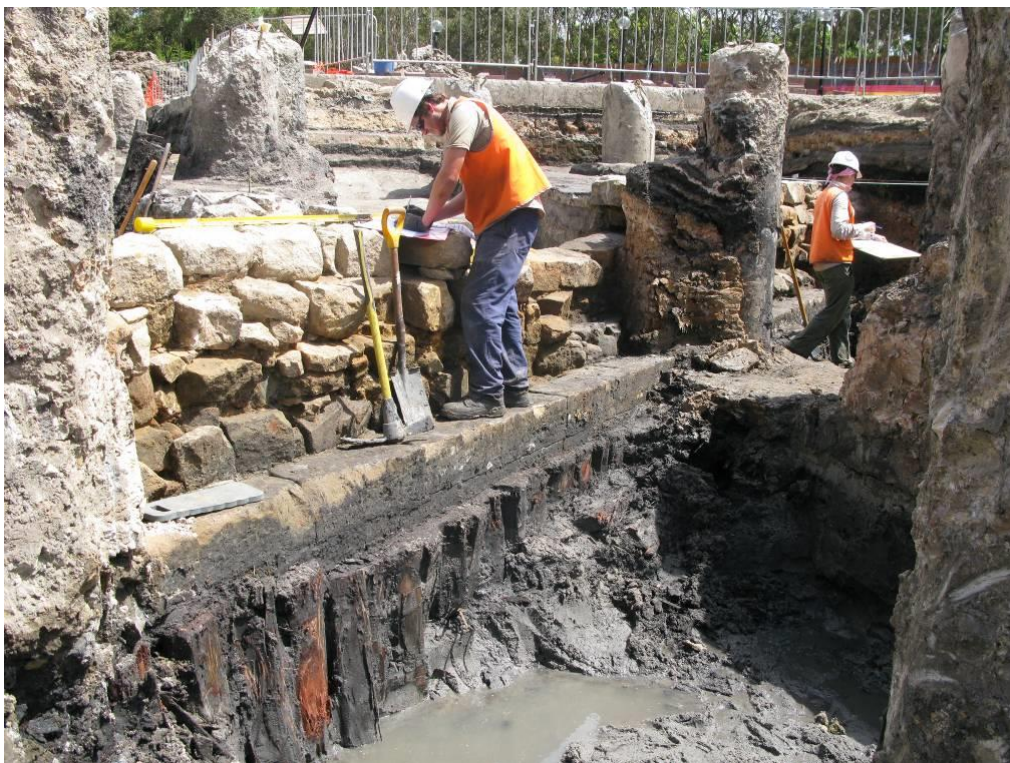
Figure 3.5.23: Recording the jetty remains. The jetty wall was solid sandstone with wooden timber formwork along the harbour side. Grey coarse sands formed the deposits on the harbour-side of the wall. This photo also illustrates the deepening wall courses further into the harbour zone. View to west.

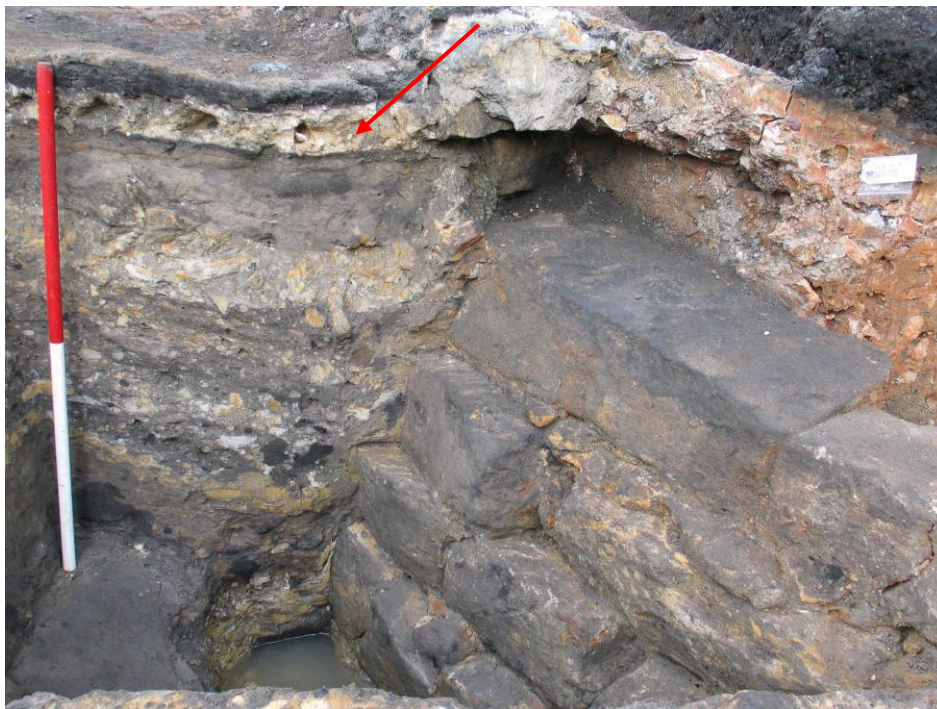
Figure 3.5.26: Detail of the east-facing section of TT21 (Section #21) showing the bands of sand mottled with decayed clay that formed the infill behind the jetty wall. The red arrow points to a band of crushed whitish yellow sandstone and shale (context 8439) that formed the raised surface of the jetty. View to west. Scale 1m.

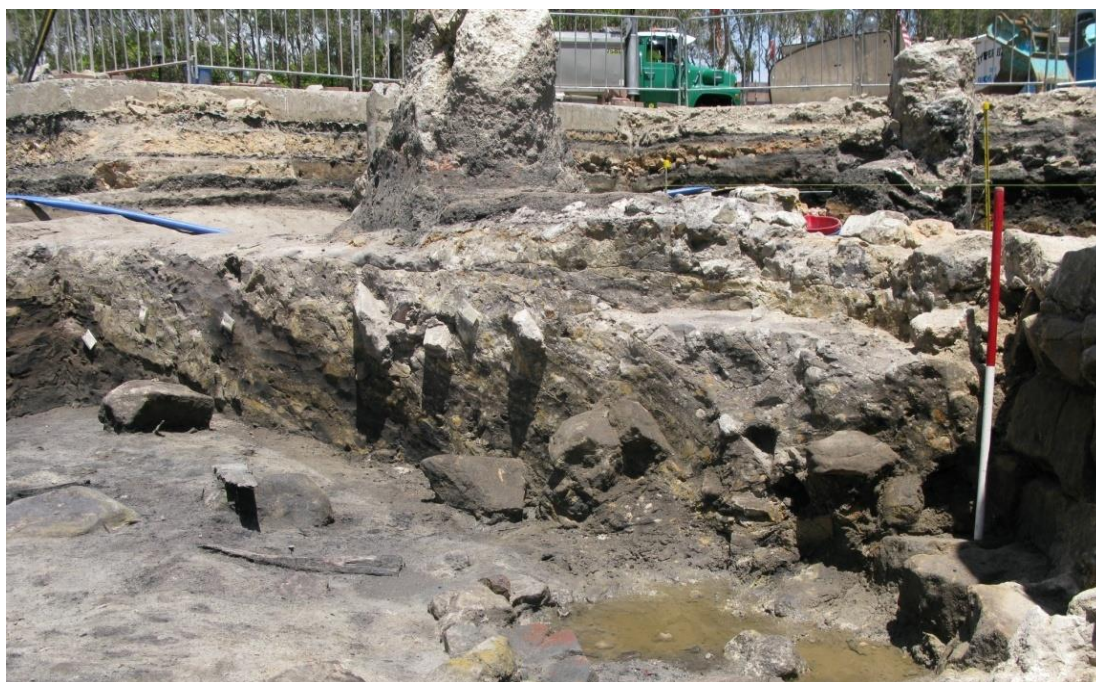
Figure 3.5.27: Section #24 through the redeposited grey harbour or foreshore sands used to fill-in behind the jetty wall and raise the ground level above the high water level. View to southwest. Scale 1m.

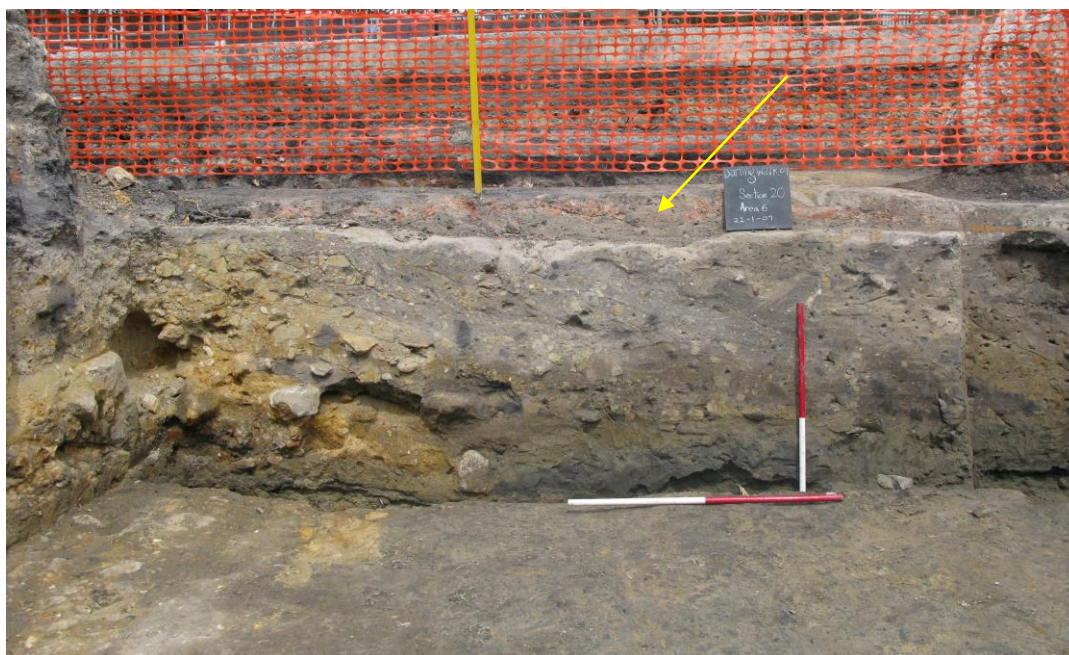
Figure 3.5.28: Southern end of Section #20 showing the grey sands and crushed sandstone fills used to raise the ground level within the jetty. The base of the section and in the foreground is the top of the naturally deposited sands of the foreshore just above the mean tide level (around 0.1m) and the yellow arrow points to the material that formed the jetty surface about 1.2m above. View to west. Scale 1m.

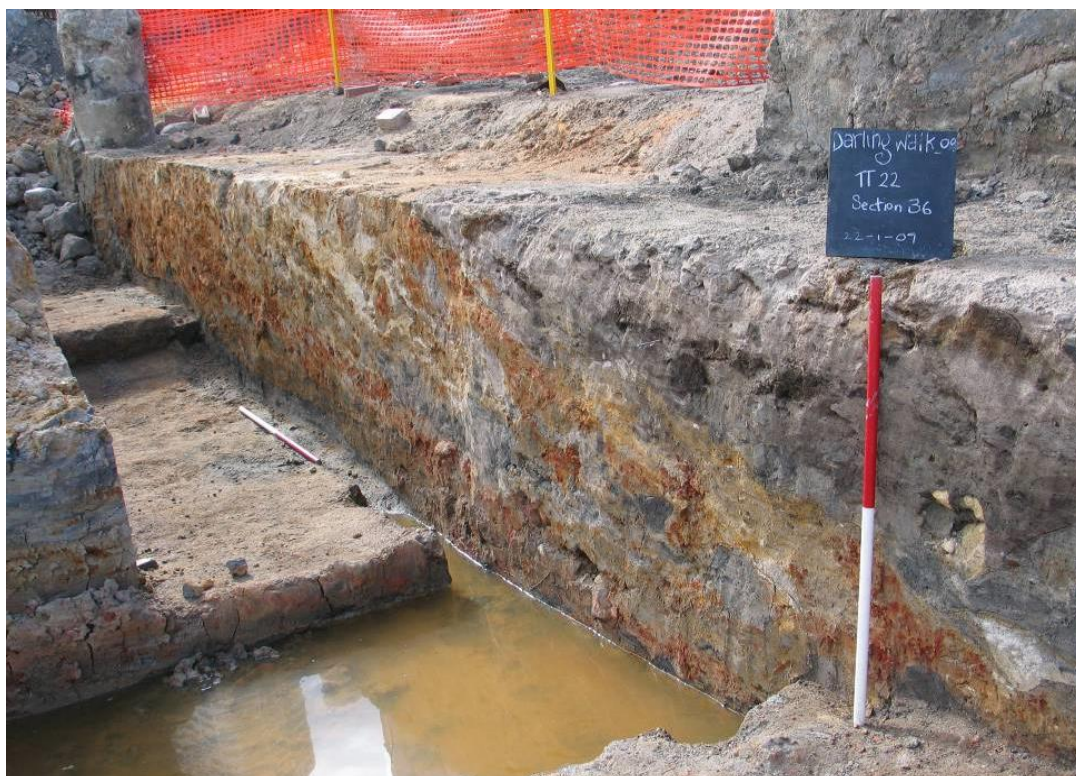
Figure 3.5.30: North-facing section (Section #36) of an east-west test trench (TT22) through the jetty infill showing orange clay-rich fills as well as grey sands. These fills were tipped from east to west. View to southeast. Scale 1m.

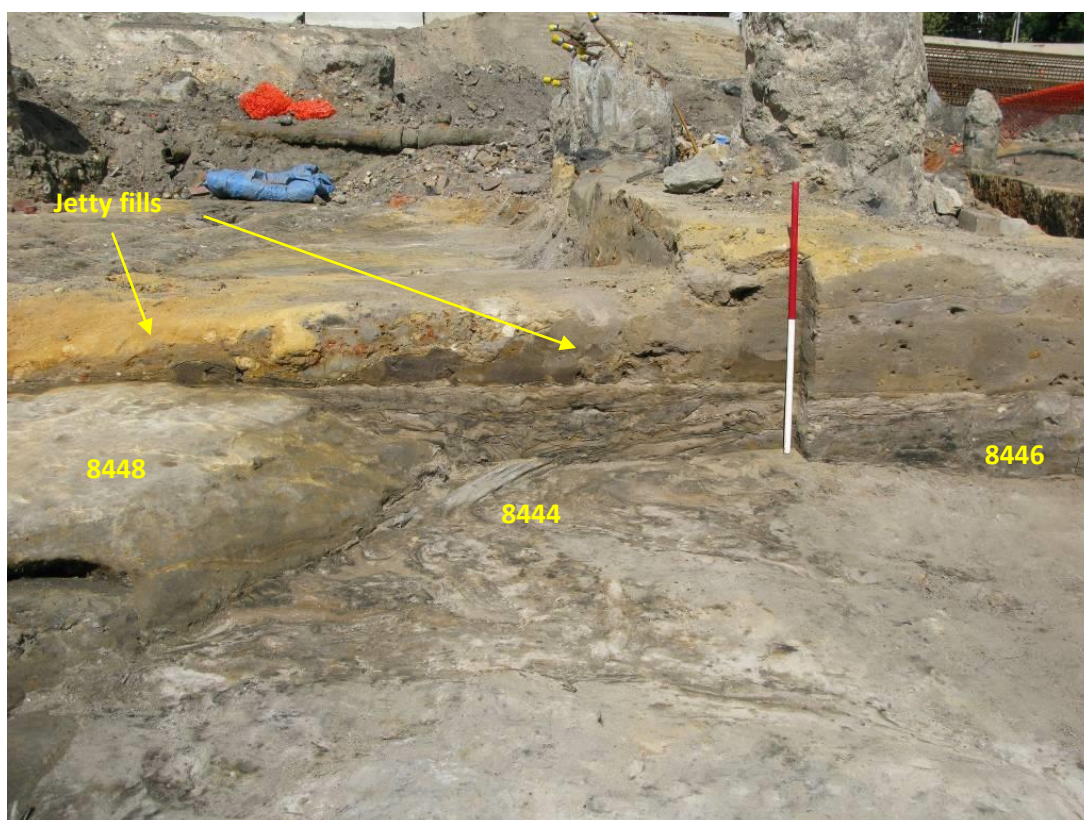
Figure 3.5.31: Crushed sandstone and coarse yellow sand was also used as jetty infill. Section #25, west-facing, with bedrock and naturally deposited foreshore sands below the jetty fill. View to east. Scale 1m.

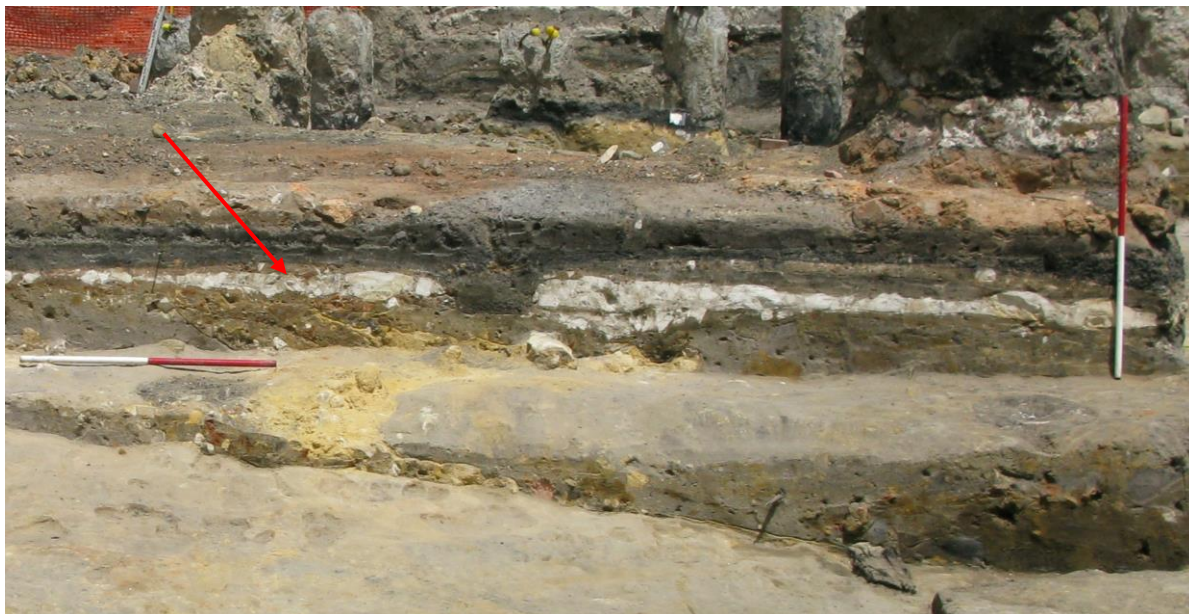
Figure 3.5.32: Compacted crushed white sandstone surface 8478 (red arrow) in Section 27. This was located on the eastern side of Area 6 where it joined with Area 9. In the foreground is the gentle sloping weather-eroded sandstone shore 8474. The sand and crushed sandstone fills below were deposited to 'fill in' behind the jetty wall and raise the levels above the high water mark. View to south. Scale 1m.

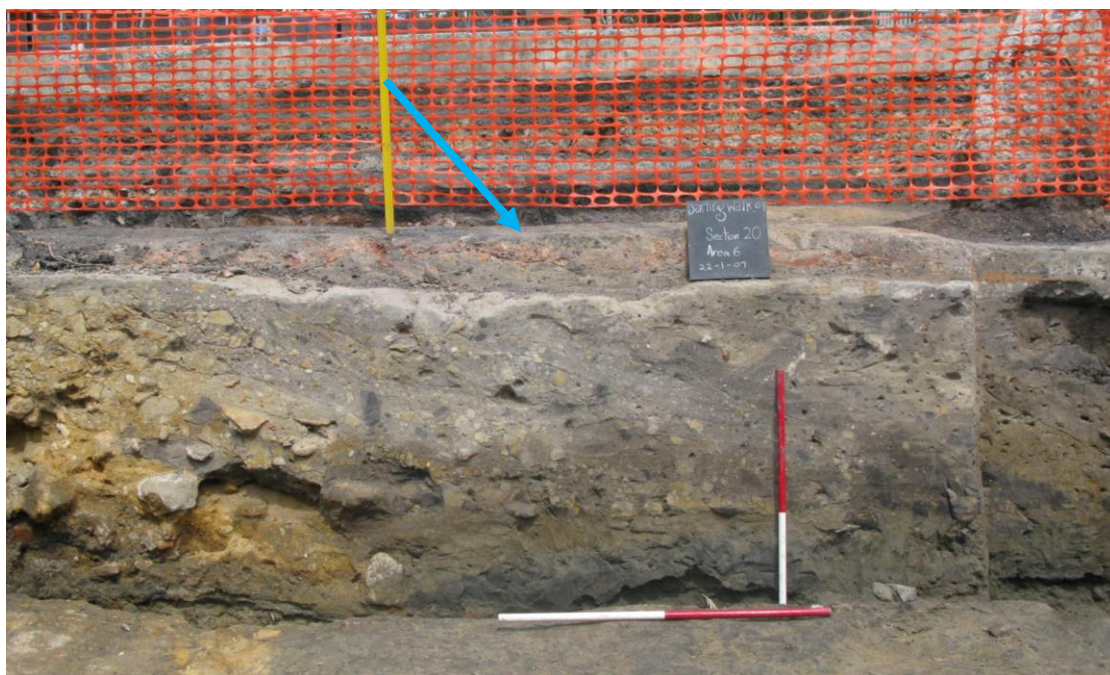
Figure 3.5.34: Section #20 showing a compacted layer of crushed pinkish sandstone (blue arrow), context 8435, that formed part of the surfacing of the jetty. It overlies deep sand and sandstone fills that 'filled in' the jetty and raised the surface above the harbour floor (foreground and base of section) and above the water. View to west. Scale 1m.

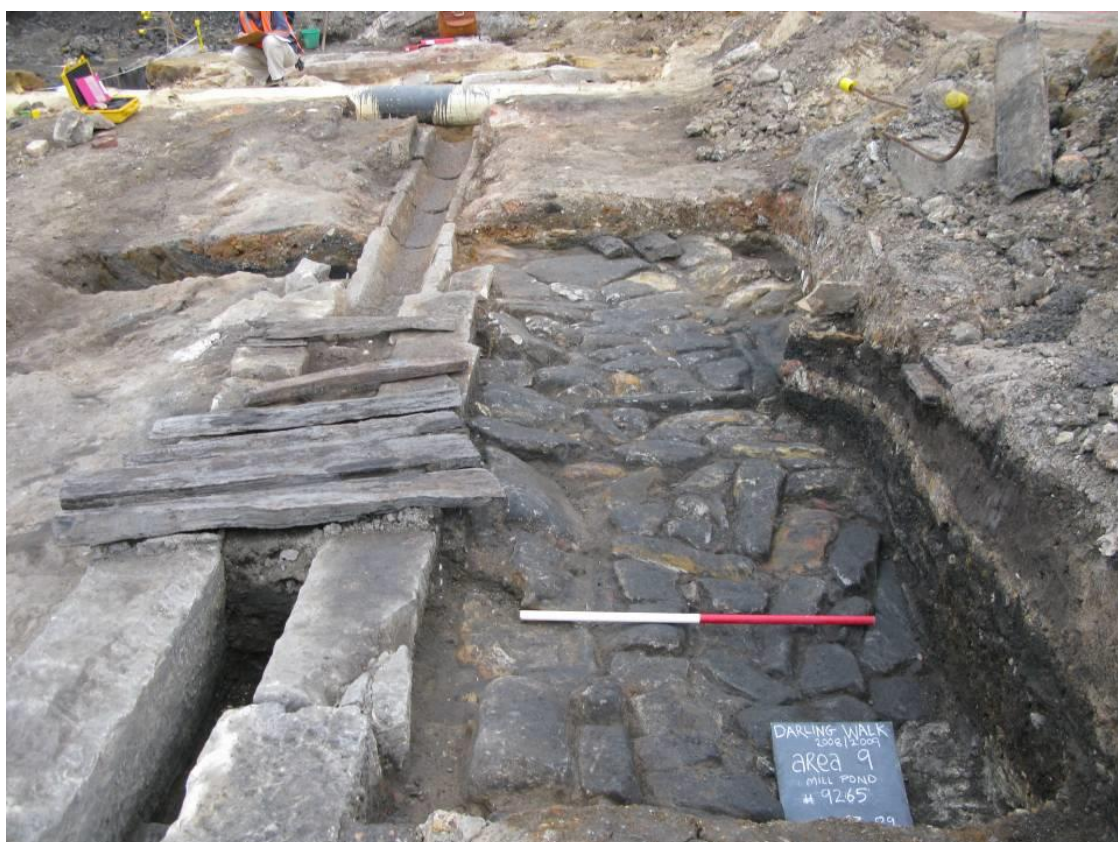
Figure 3.5.35: To the south of Area 6, near the boundary with Area 7, was a small area of rough sandstone paving 9265. This surface was located above redeposited sands, similar to the jetty fills recorded in the north of the Area associated with the jetty wall. It was cut by the mill pond overflow drain (1840s?) and sealed by levelling fills that were introduced to the area after reclamation works in the 1840s. View to east. Scale 1m.

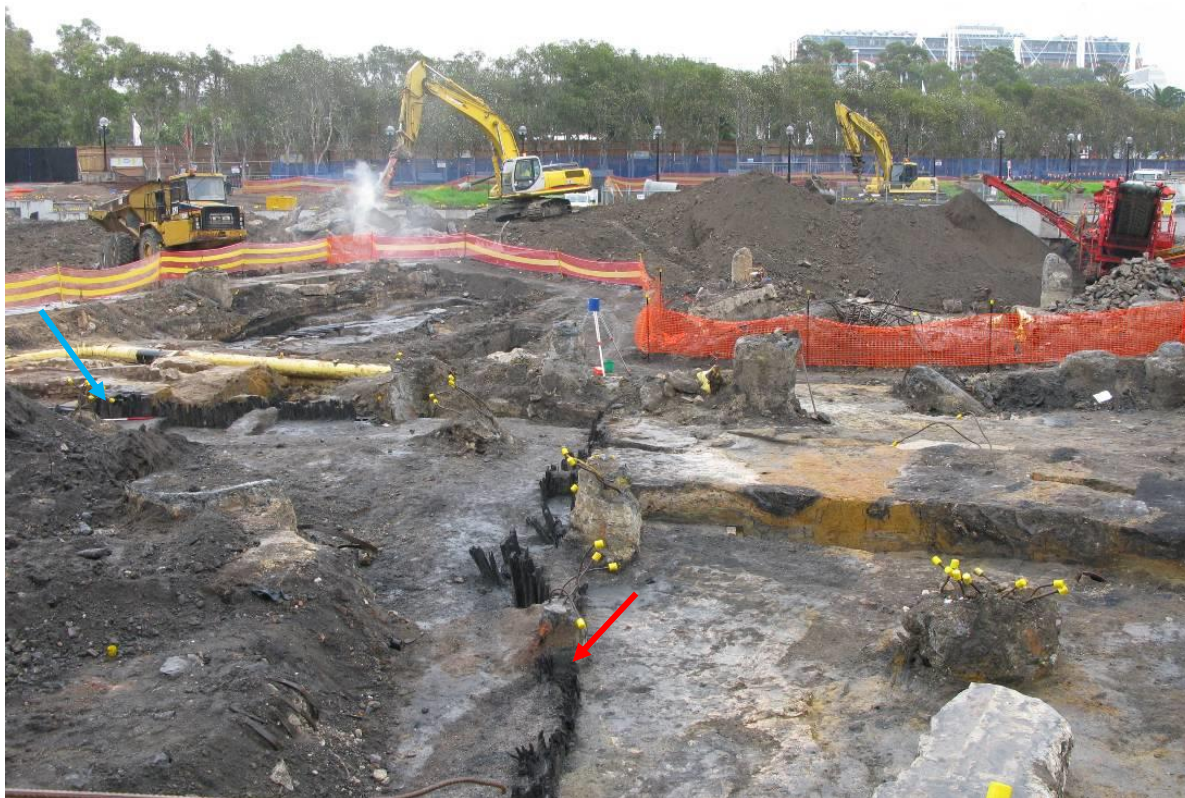
Figure 3.5.39: The timbers formed a revetment on the northwest corner of the mill pond, the red arrow indicates the north wall and the blue the west wall. View to west. Scale 1m.

The main structure of the mill pond consisted of timber walling (context 9251) (Figure 3.5.38, Figure 3.5.39). It was constructed with of a series of individual timber planks driven into the ground, as demonstrated in TT59 to the north (Vol 4: Plans 10.38, 10.39, 10.60). On the western side in TT69, it appeared that the timber planks were placed within a clay-lined cut (Vol 4: Plans 10.38, 10.40, 10.60). The timbers were placed quite closely together and were between 40mm and 60mm apart. The planks were between 1m and 2m in length and on average 200mm in width, and 100mm in breadth. The top of the timber walling was exposed between RL 1.4m and 1.6m, level with or about 200mm above the surrounding ground level. In TT69 the base of the timbers were recorded at around RL -0.7m.

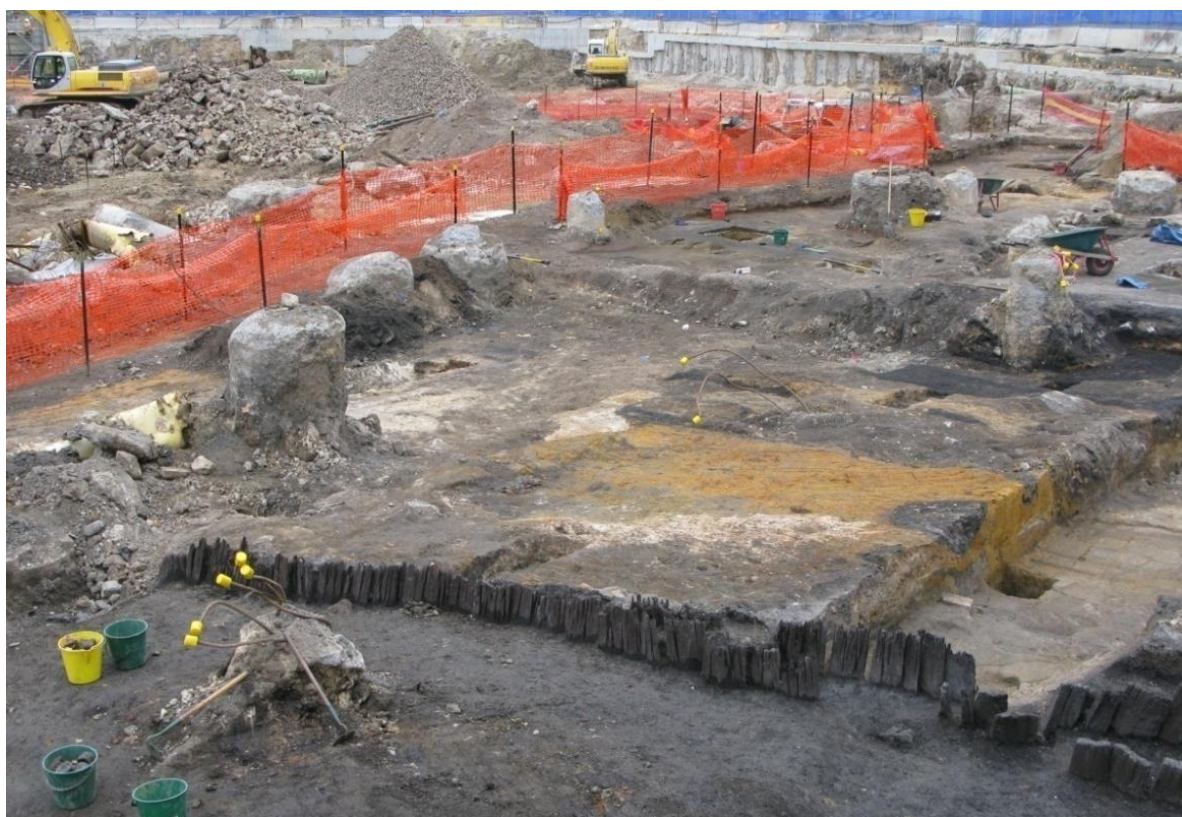
Figure 3.5.40: The timbers forming the northern part of the mill pond revetment looking towards the yard area of the mill. There was a double row of timbers along this section. View to northwest.

The secondary row found on the interior of the northern wall may be evidence of repair or consolidation work (Figure 3.5.40, Figure 3.5.41, Figure 3.5.41). Between the double row was a fine grey silty clay packing (context 9260) that may have acted as a waterproofing agent. The mill pond was constructed through ground that was created during the reclamation works for the jetty construction, and as such consisted of bulk fill material of varied stability; sands, crushed sandstone and clays. The timber walling therefore formed a revetment around the exterior of the pond that prevented the sides from collapsing

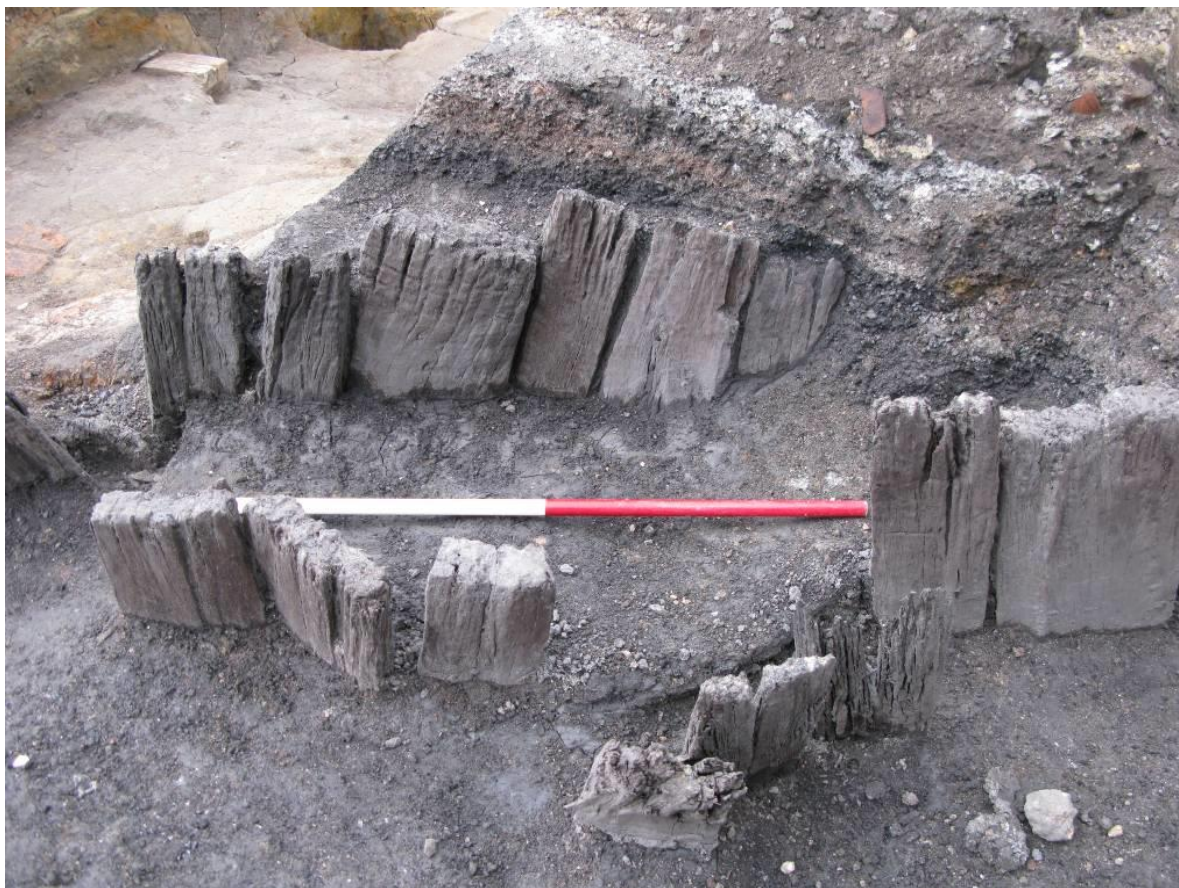
Figure 3.5.41: Detail of timbers within the northern wall showing the mix of cut and un-worked tops. View to north from within the pond. Scale 1m.

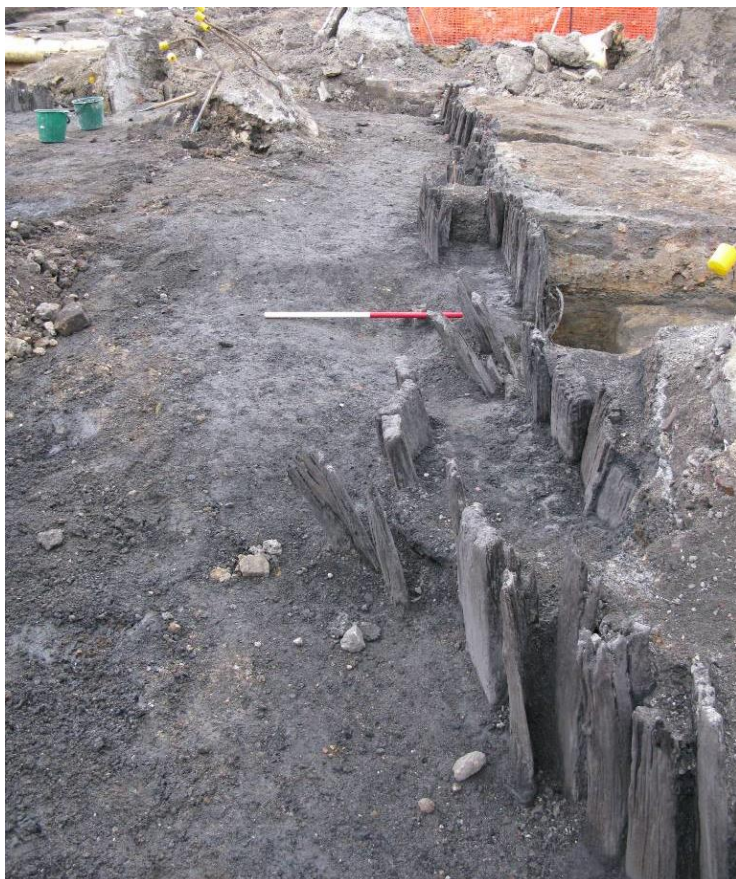
Figure 3.5.42: The row of timbers on the northern wall which had collapsed into the pond. View to west. Scale 1m.
