3.5 Barker's Mill, Jetty and Mill Pond 1825 to 1870s

3.5.1 Introduction

3.5.2 1825 Mill Development by Cooper & Levey

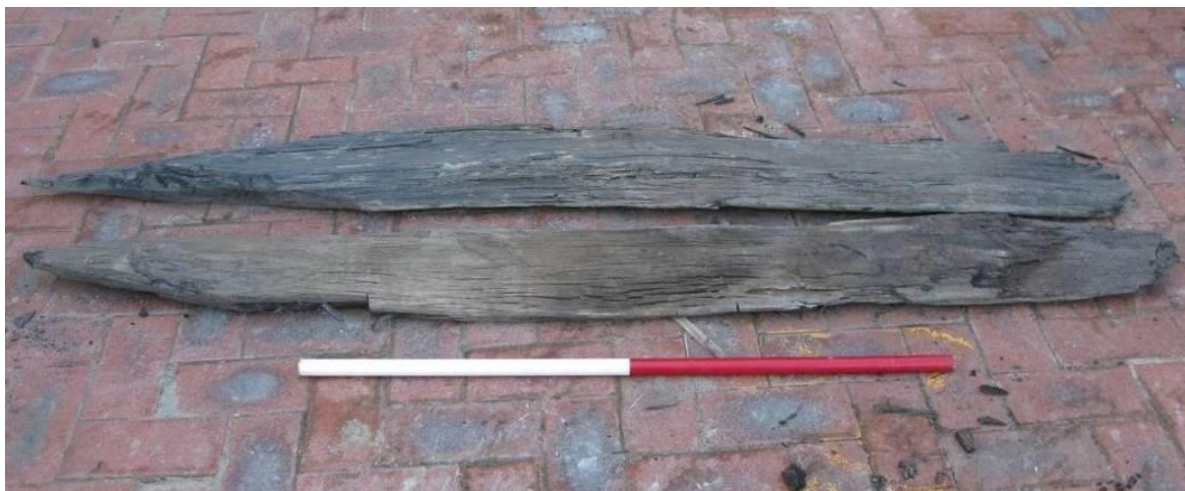
Figure 3.5.43: Timber samples from the mill pond revetment 9251. Note the pointed ends but otherwise unworked. These samples were identified as Blackbutt. Scale 1m.

Analysis of three samples taken from the timber revetment identified the wood used as *Eucalyptus saligna* (sample #134), *Eucalyptus siderophloia* (sample #147) and *Eucalyptus pilularis* (sample #171) (Figure 3.5.43). All tree species are hardwood eucalypts endemic to the Sydney region. *Eucalyptus saligna* or Sydney blue gum is common along the coast of New South Wales, as well as parts of Queensland.⁶⁸ It grew naturally in the Sydney area and was particularly heavily forested in the north western suburbs now known as Pennant Hills, Epping and Ryde from the first few years of European settlement, and by 1823 was being obtained from as far out as Annangrove and Kenthurst.⁶⁹ *Eucalyptus siderophloia* (grey ironbark) and *Eucalyptus pilularis* (Blackbutt) were also readily available in the Sydney area at the time of the mill pond's construction, and were particularly abundant in the Turpentine-Ironbark Forest, which is likely to have extended to within 1km of the site.⁷⁰

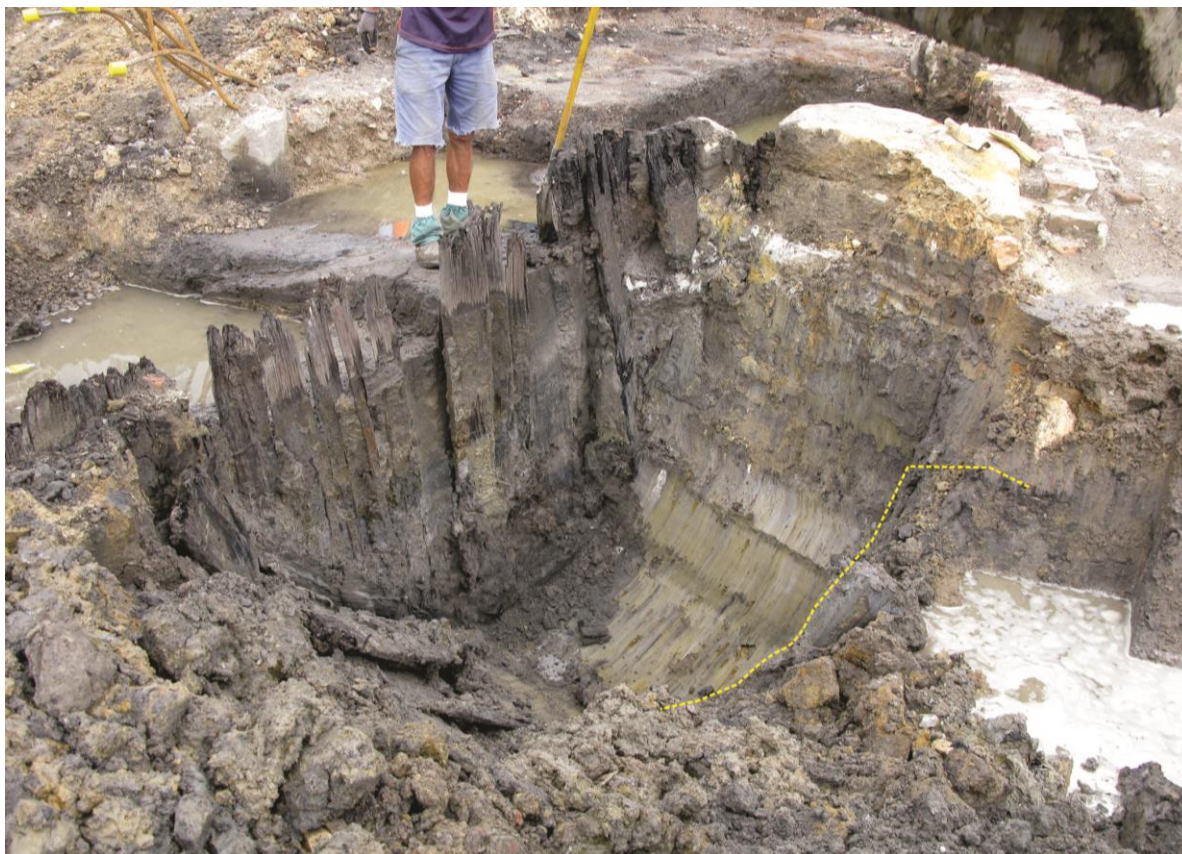
Figure 3.5.44: Machine-excavated test pit at the eastern end of TT69 to investigate the construction of the mill pond. Outside the timber planks forming the mill pond revetment wall was a clay-lined cut, indicated by the dashed yellow line. View to southeast.

The timber revetment on the western side of the pond was constructed within a cut that was clay-lined, as demonstrated at the eastern end of TT69 (Figure 3.5.44, Figure 3.5.45; Vol 4: Plans 9.7, 10.40). The ground on the eastern side was excavated, or cut to create the mill pond. The cut was at least 1m in depth and was through the surrounding sandy reclamation fills and natural foreshore sands. The side of the cut was then lined with grey and greenish-coloured clays with sand inclusions (contexts 9290 and 9296). The use of clay and clay-like material to line channels and reservoirs to make them watertight is known as 'puddling'. 'Puddled clay' is usually made by mixing heavy clay with some water to make it more malleable. Sand or grit can also be added to this mix. The puddled clay is then used to line the interior of the structure. The mill pond was excavated through ground that consisted of sandy reclamation fills with foreshore sand flat deposits below, and the clay lining recorded in TT69 illustrates this process of puddling.

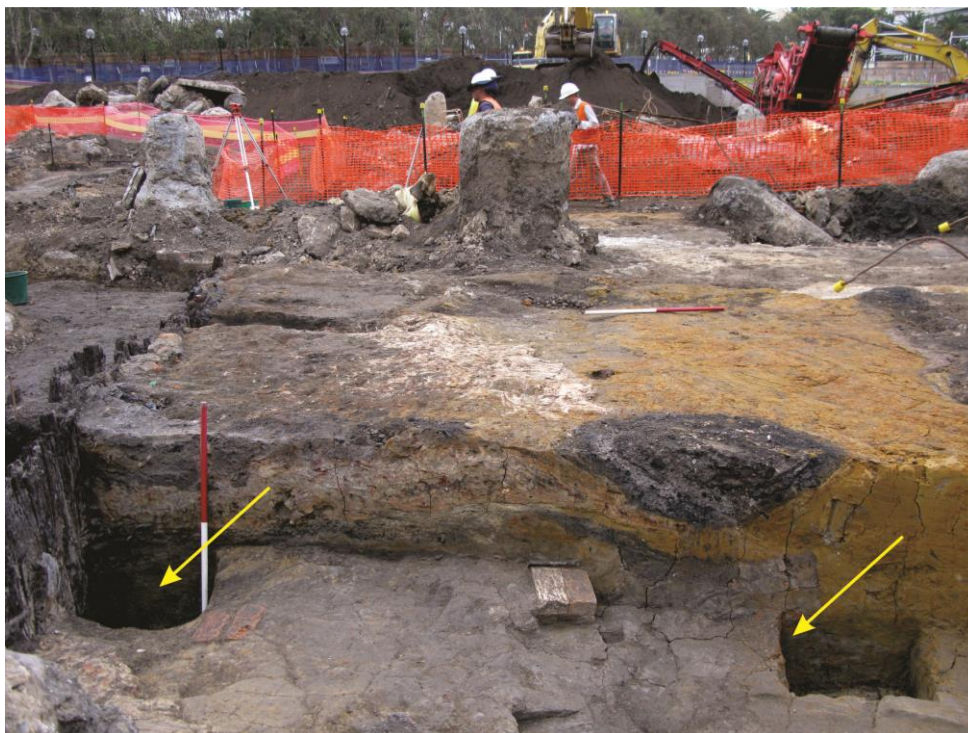
Figure 3.5.46: Detail of the east-facing section of TT59 located on the north side of the mill pond (left of picture). The arrows indicate the dense clay fill, context 9466, located above the natural harbour sands on this side of the pond. This material was an extensive deposit rather than the lining or fill of cut as seen in TT69 on the western side of the mill. This clay fill appeared to have been a temporary surface level, as indicated by the sandstock brick pads used prior to the formation of the clay bank (orange and pink clay above). View to west. Scale 1m.

There was no evidence for a clay-lining on the northern side. However in TT59, the natural sand flat level was sealed by an extensive deposit of dense greenish clay, context 9466 (Figure 3.5.46). This clay would have functioned in the same way and was likely to have been deposited as part of the puddling process.

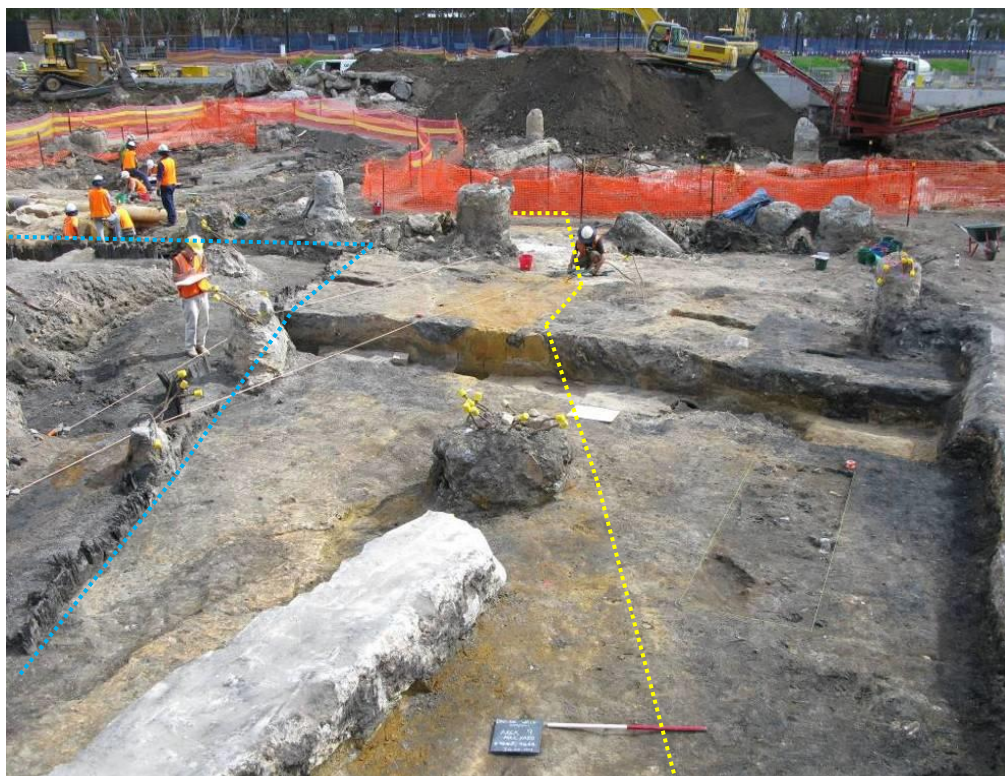
Figure 3.5.47: Clay fills forming a bank around the northern side of the mill pond. The line of the clay is indicated by the yellow dashed line and the mill pond with a blue dashed line. View to west. Scale 1m.

Surrounding the outside of the timber revetment was a clay bank or bund (Figure 3.5.47, Figure 3.5.48). The top of the bank material was located between RL 1.35m and 1.6m; around the same as the surrounding ground level. The bank was made from several bulk fills of mostly dense plastic orangish and pinkish clays recorded as contexts 9464 and 9465 on the northern side, and as 9289, 9288 and 9237 on the western side. It survived best on the northern side where it was up to 3.5m in width. In TT59, the depth of the bank material was recorded as being up to 600mm. It was formed over a general bulk fill clay-rich layer context 9466 that sealed the natural ground, located at 1.2m below the top of the bank. On the western side not much of the bank survived as it had been truncated by modern services (Figure 3.5.49, Figure 3.5.50). It was recorded in TT69 as being at least 6m in width and up to 750mm in depth.

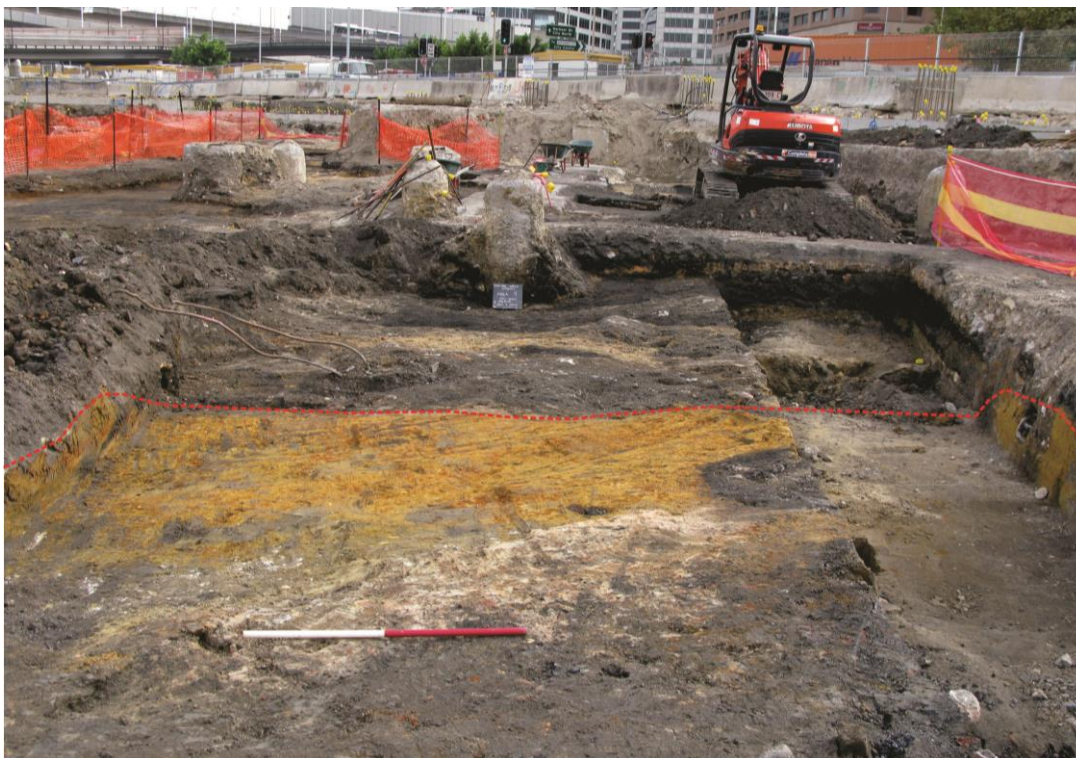
Figure 3.5.48: Clay bank on the northern side of the mill pond during excavation. This photo shows the surviving height of the bank, in the section on the left and right of the photo. View to north. Scale 1m.

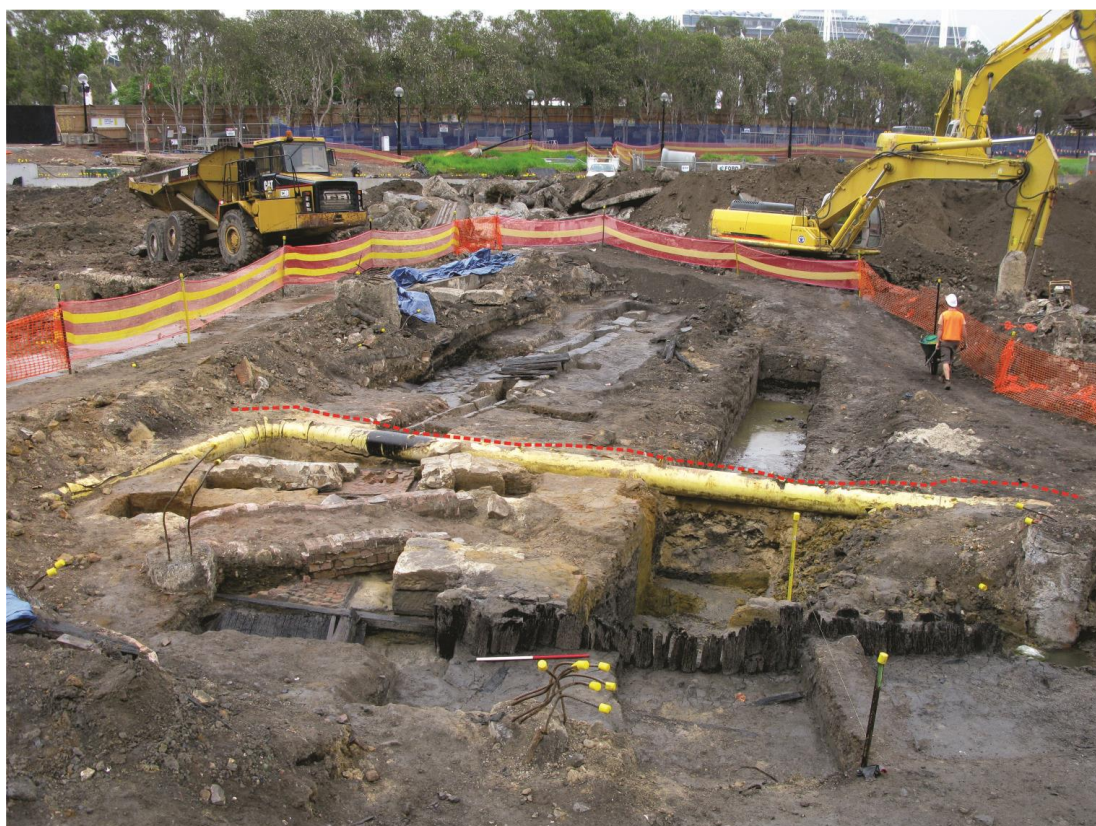
Figure 3.5.49: Photo of the western side of the mill pond and the remains of the clay bank truncated by modern services such as the yellow pipe and the brick junction pit. The extent of the clay bank is indicated with the dashed red line. View to west. Scale 1m.

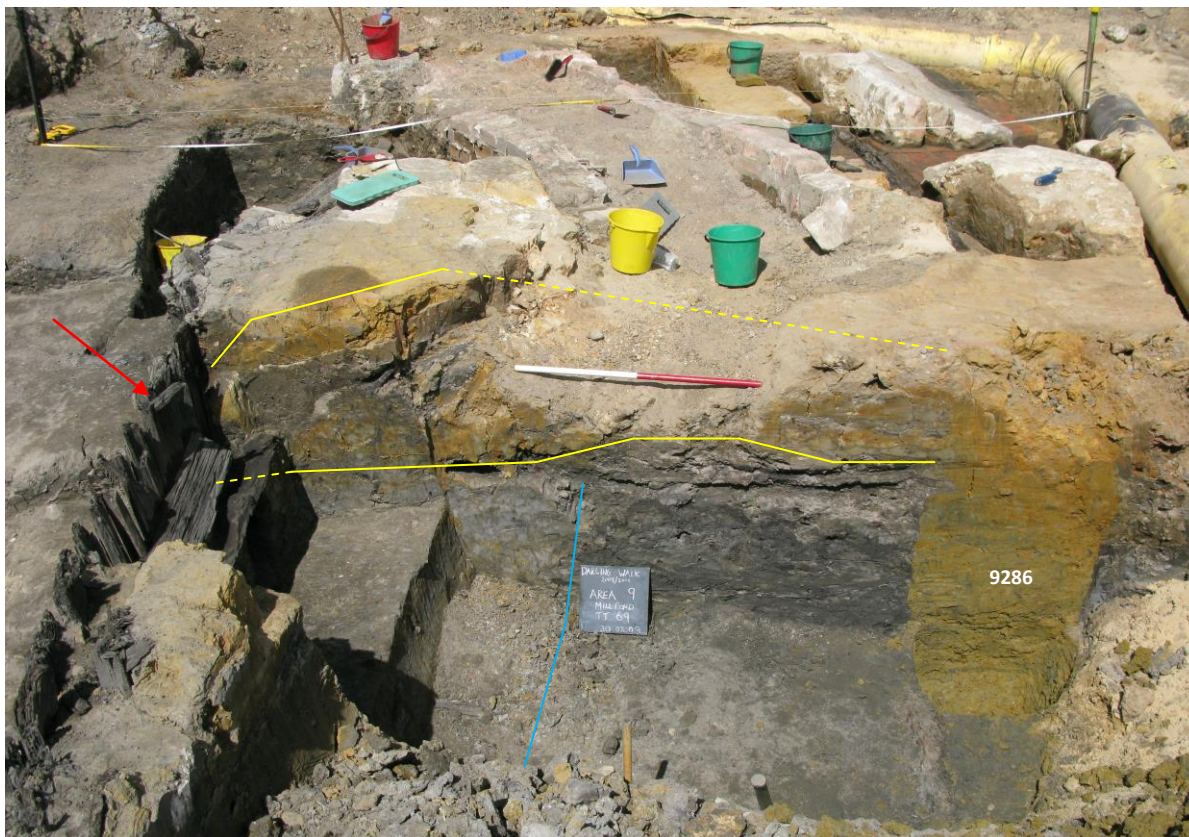
Figure 3.5.50: Eastern end of TT69 showing the clay fills 9289, 9287, 9288 and 9237 (yellow lines) that formed the bank overlying the clay lining 9290 (blue line) and abutting the timber revetment 9251. The bank is cut by a later clay filled feature 9286. View to south. Scale 1m.

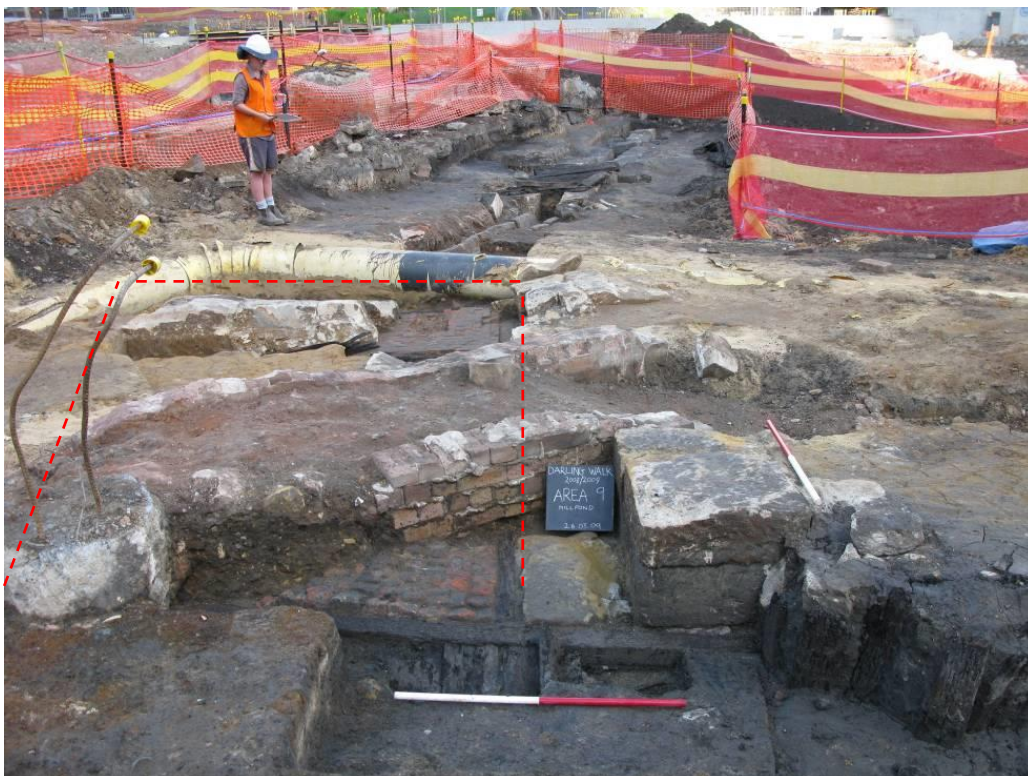
Figure 3.5.51: Structure 9241 (surviving extent indicated with dashed red lines) was located on the western edge of the mill pond revetment. It was constructed with a timber frame inlaid with sandstock bricks. This photo shows it buried beneath a modern brick structure. View to the west. Scale 1m.

Connected to western side of the mill pond were the truncated remains of a timber and brick structure (context 9241) (Figure 3.5.51, Figure 3.5.52; Vol 4: Plan 10.38, 10.41). Contemporary with the mill pond construction, it has been interpreted as perhaps being a foundation pad for a pump that brought water from the mill pond to the boilers. Overall, the structure measured 4.5m east-west by a minimum of 2.75m north-south (Figure 3.5.53). It was built into the clay bank material and consisted of a timber-frame inlaid with sandstock bricks to form a pad or foundation-type structure.

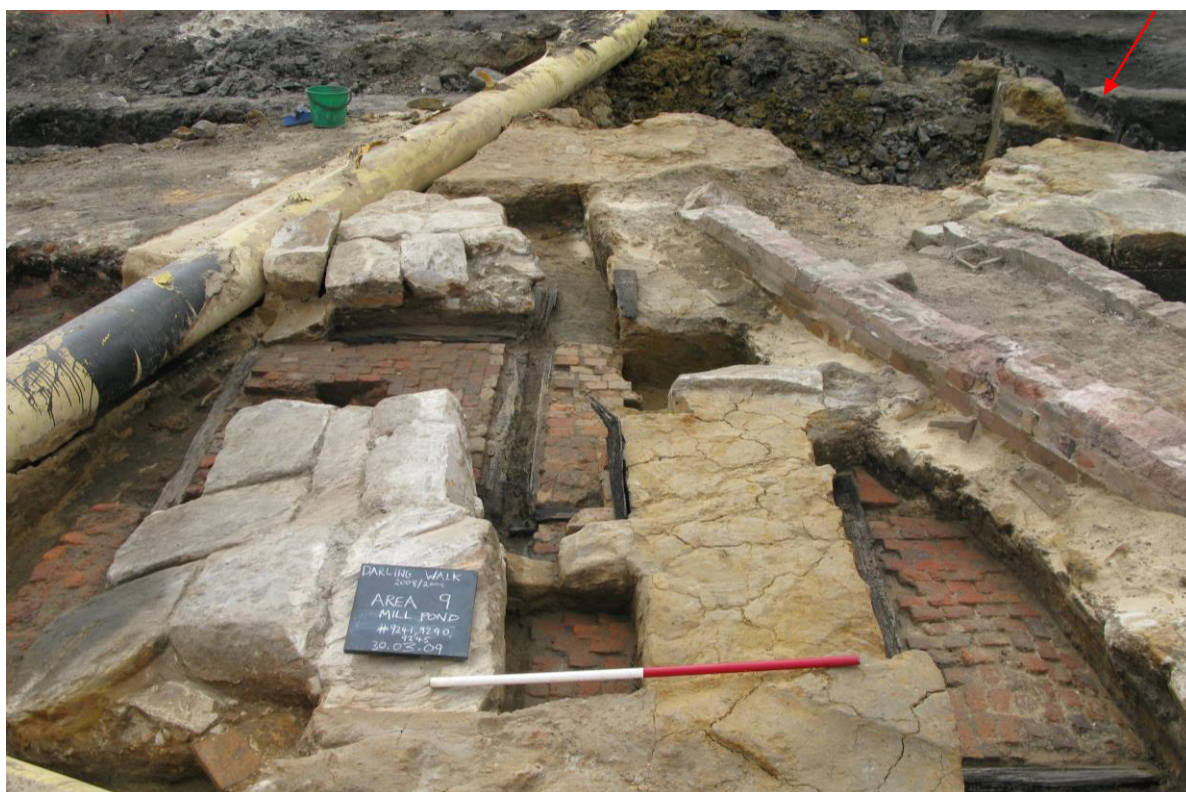
Figure 3.5.52: View of timber and brick floor structure 9241 from the south. It was truncated by a modern service pipe and brick-built culvert, and later sandstone structure 9240 was built over it. Photo taken looking north, the mill pond is located just to the right (arrow). Scale 1m.

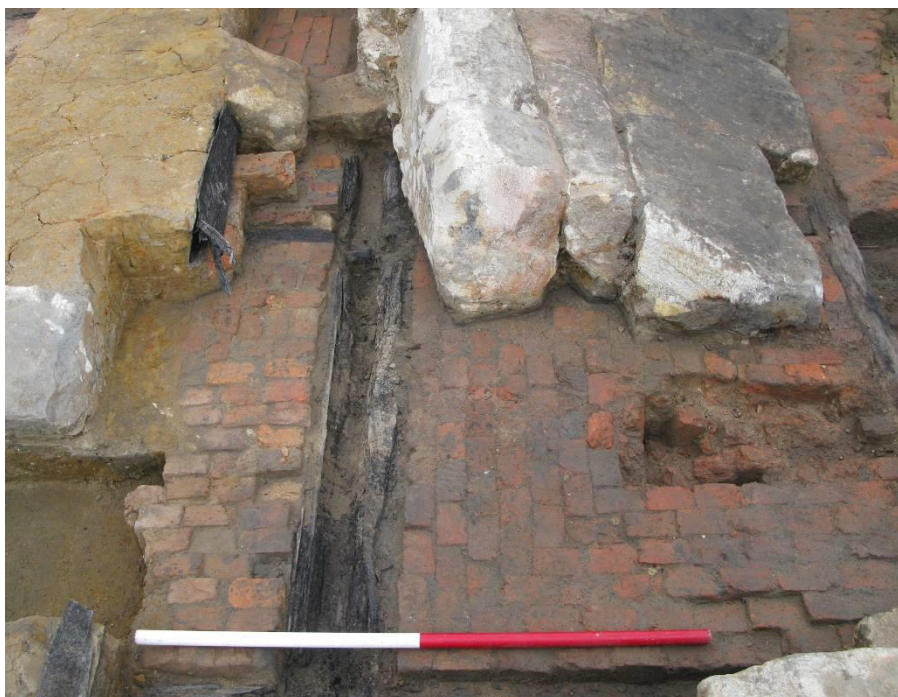
Figure 3.5.54: Detail of the sandstock brick surface inlaid within the timber frame. These were tightly set and placed on their ends with 'mud mortar' filling the gaps. Scale 1m.

Each compartment was inlaid with sandstock bricks tightly set on their ends (Figure 3.5.54). There was no overall pattern to the layout as some were placed in rows side-to-side and some face-to-face. The gaps between the bricks were packed with a greyish brown 'mud mortar', consisting of silty clay with inclusions of grit and sand. The surface created by the bricks was worn in places, reflecting variations in the quality of the bricks. Three samples of bricks were taken from 9241 (sample #s 140, 141, 142) and are dated between 1800, perhaps earlier, to the 1850s (Robyn Stocks pers. comm.). This date range fits nicely with the mill pond construction date in the late 1820s.

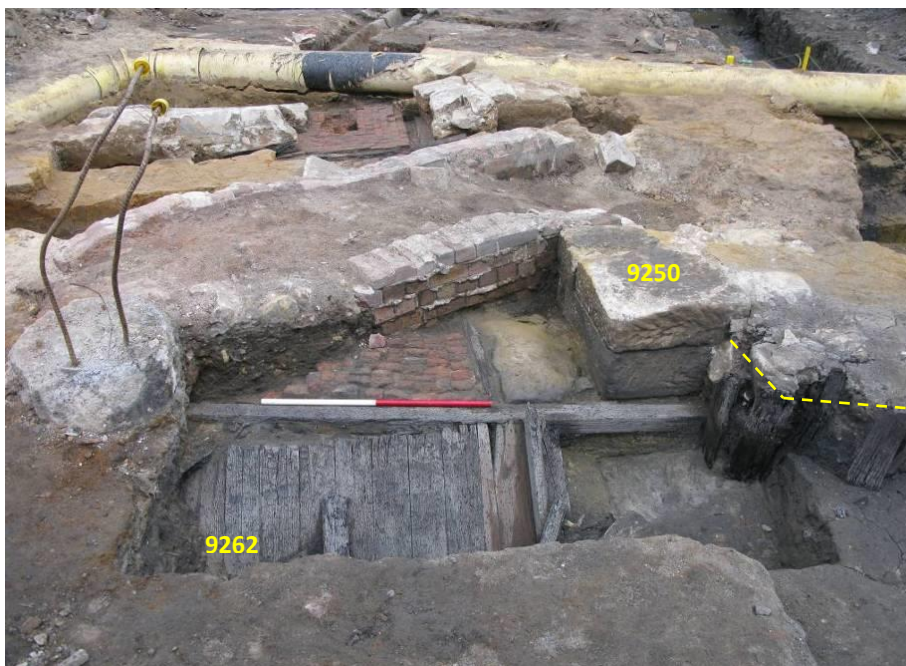
Figure 3.5.55: Two further structural elements, sandstone wall 9250 and timber ramp 9262, were associated with floor structure 9241 and these were located at the point where it joined with the mill pond revetment (yellow dashed line).

The structure was attached to the western revetment wall of the mill pond and associated with two other structural elements; a sandstone wall (context 9250) and a timber ramp (context 9262) (Figure 3.5.55). Structure 9241 was located 9.5m south of the northwest corner of the pond where there was a break in the revetment. A sandstone wall abutted both the brick pad structure and the timber revetment (Figure 3.5.56). At a height of two courses over a footing, the top of the wall was at a similar height to the revetment. It only survived for a stretch of 1.2m heading west as it was truncated by a 20th-century brick-built culvert. The wall was on the same alignment at the timber frame of 9241 and formed a 90° angle with the pond revetment 9251.

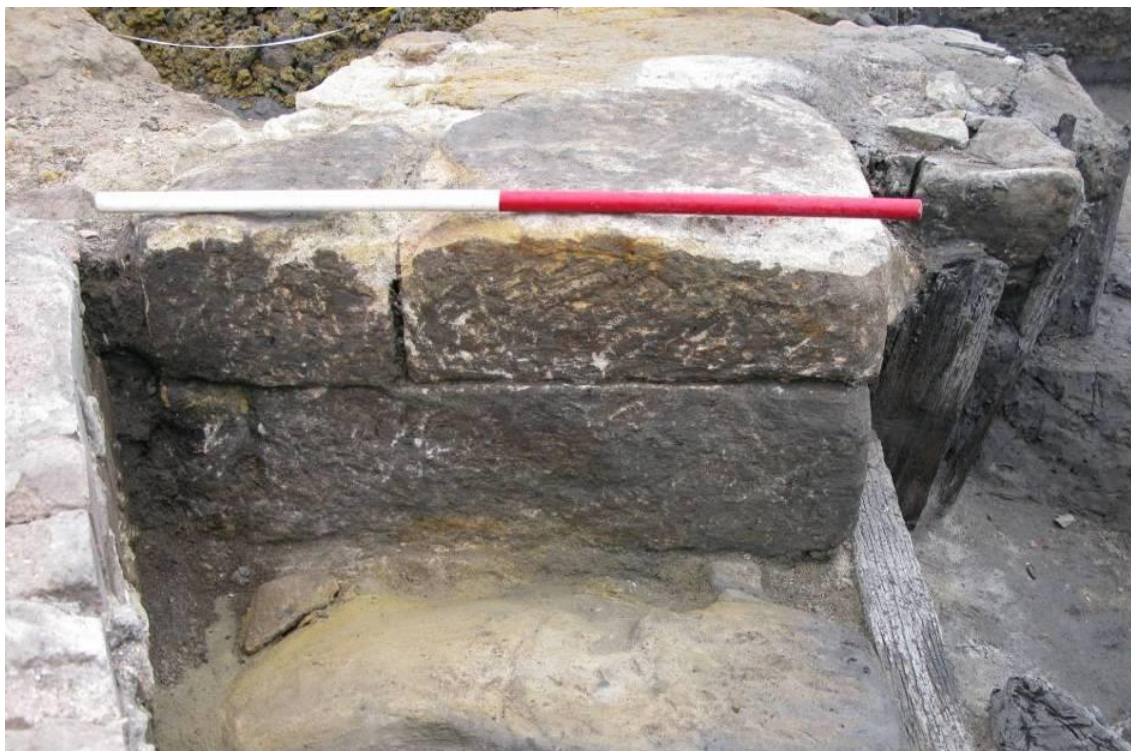
Figure 3.5.56: Detail of the internal face of sandstone walling 9250 and its junction with the timber revetment 9251. View to the north. Scale 1m.

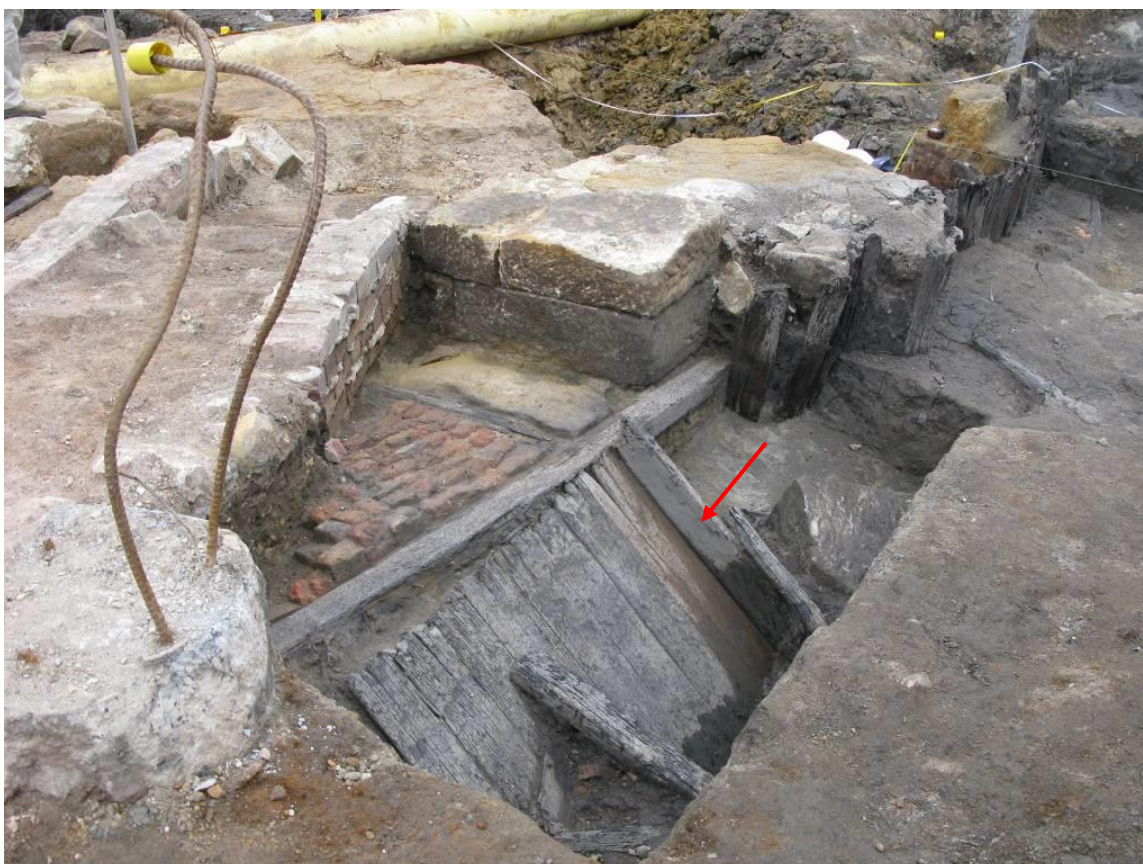
Figure 3.5.57: Timber ramp 9262 attached to the eastern element of the timber frame of 9241. Note the timber forming the northern edge (arrow). The ramp rested on packing clay 9263 and mill pond sediment had accumulated around it. View to the northwest.

Attached to the eastern end of structure 9241 and projecting into the mill pond was a timber 'ramp' 9262 (Figure 3.5.57). This was constructed using 10 timber planks laid side-by-side. The northern edge had a timber on its side forming an edge. The planks formed a ramp-like structure into the mill pond and it was at least 1m in length (Figure 3.5.58). It was set at a 45° angle and was nailed or

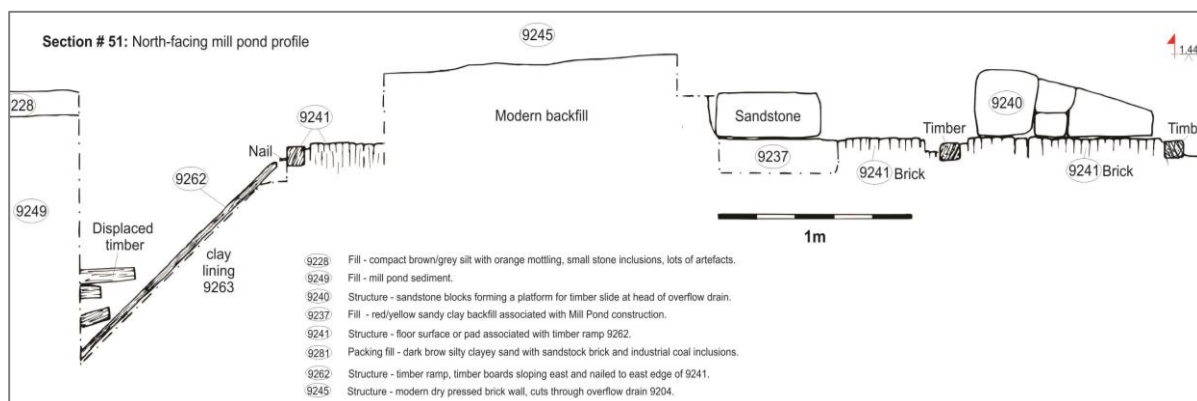
Figure 3.5.59: North-facing section through the brick and timber floor 9241 and the timber ramp 9262. Extract from Vol 4: Plan 10.41.

bolted to the timber frame of the floor 9241 (Figure 3.5.59). Behind the ramp was the clay lining, context 9263, a pale yellow and grey sandy clay. Mill pond sediment 9249 accumulated against the ramp.
